NorthernStar Natural Gas INC.

LNG Interagency Working Group
March 15, 2007

Clearwater Port LLC

Platform Grace

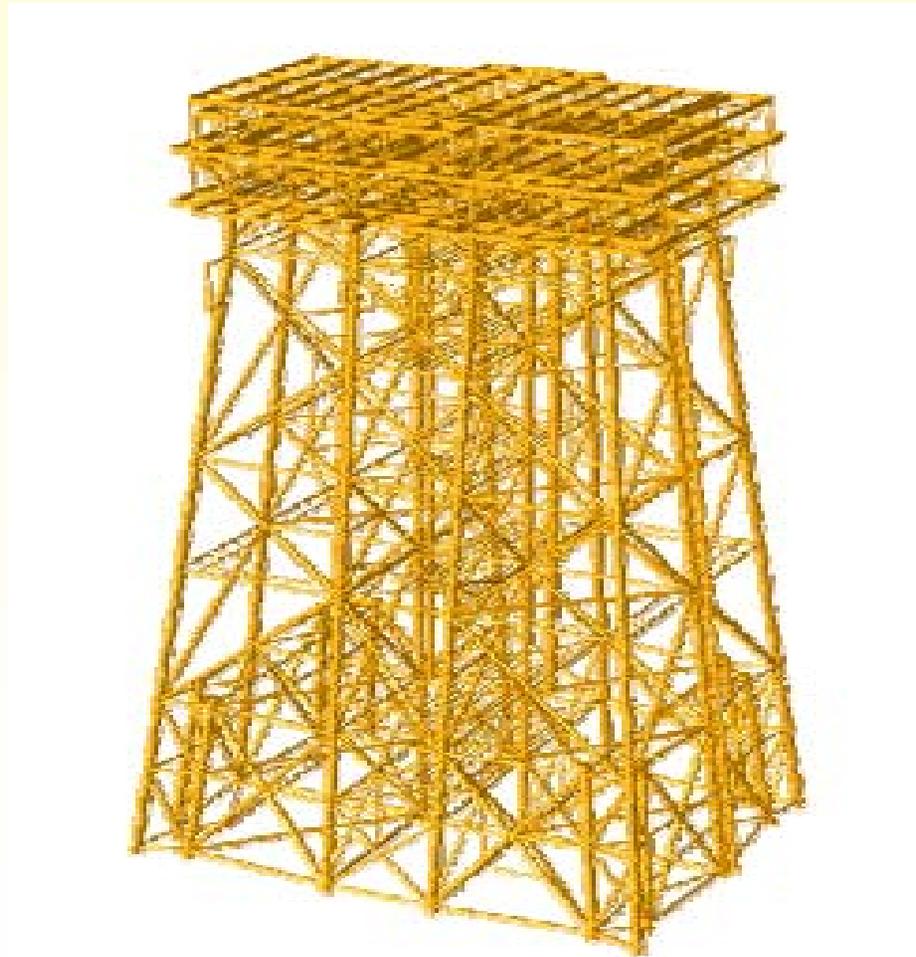
- The platform was damaged during original installation when pile segments were dropped damaging several jacket braces.
- This damage was immediately surveyed; contractor developed a repair program which was implemented.
 - This program included a replacement of two damaged members and the
 - the removal of two others.
 - Several braces that experienced minor damage were left in-place and were not repaired.

- The recent assessment has accounted for the jacket members that were replaced, removed or were damaged and not repaired.
- The analysis assumed a “worst case” assessment of these non-repaired members and assumed no structural support to the platform,
- While including the loads these damaged members placed on the structure, and demonstrated there is no significant loss of structural integrity.
- 7 visuals were conducted,
- wall thickness gauging at 56 locations
- 74 Flood Member Detection (FMD) inspections
