Report on the Step-Up Transformer Failure and Fire at Palomar Unit 1 - December 2010
August 10, 2011 Business Meeting Discussion Item

Geoff Lesh, P.E., Engineering Office
Siting, Transmission and Environmental Protection Division

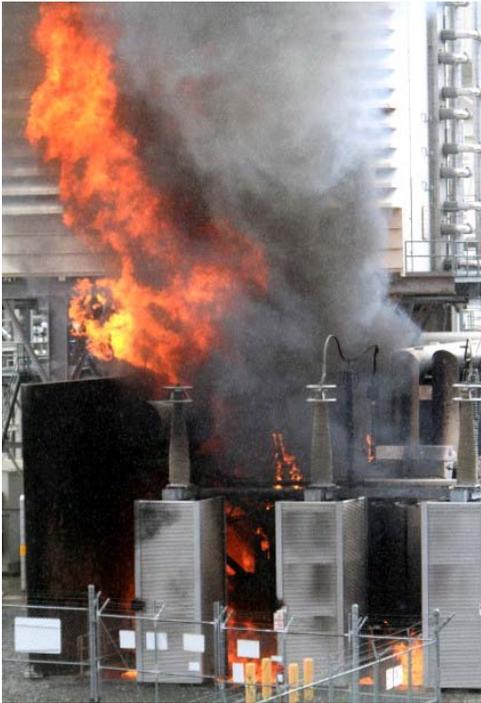
Dec 22, 2010 (Day 1)

A tear-down inspection of the transformer conducted after the fire revealed that an internal short-circuit arc had occurred resulting in a significant release of energy into the insulating oil. The resultant internal pressure burst caused an electrical bushing where current enters the transformer to rupture and the transformer case to open at a seam, starting a fire inside the transformer. Burning oil leaked from a small opening in the upper portion of the transformer. The burning oil collected within the catchment basin, and continued to burn producing a column of black smoke. The fire was extinguished by the fire department 26 hours later. While the failure and fire was catastrophic to the transformer (i.e., it was a total loss), the fire did not spread to any other parts of the power plant or cause damage beyond the transformer.

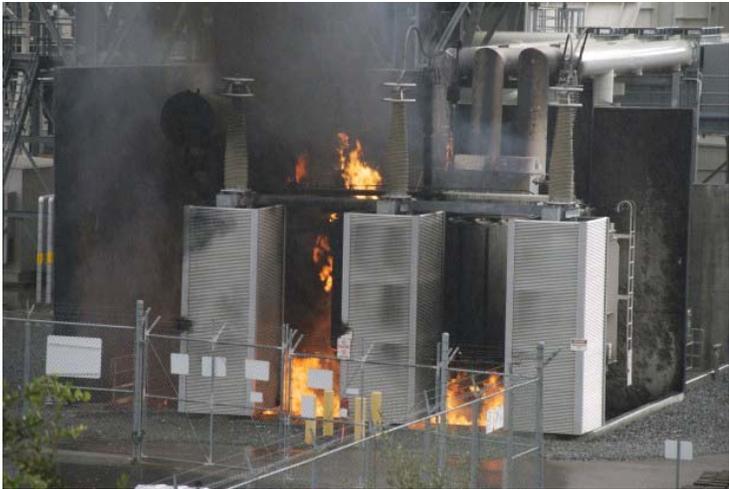
Dec 23, 2010 (Day 2)

Because the fire was now reduced in intensity, plans were made to attempt to extinguish the fire with foam once again. Fire suppression operations started at 2:05 pm. The fire in the catchment basin was out by 2:12 pm, and the fire inside the transformer was out by 2:18 pm on December 23. The fire department explained that they were successful on the second attempt because the fire was now smaller with less heat being produced so that the foam was able to hold together and finally smother the fire. At 3:16 pm a reverse-911 call was placed to all recipients of the earlier reverse-911 calls informing them that the fire was now extinguished, that it was no longer necessary to remain indoors, and that they could now resume normal activities.
