Appendix F

Photographs

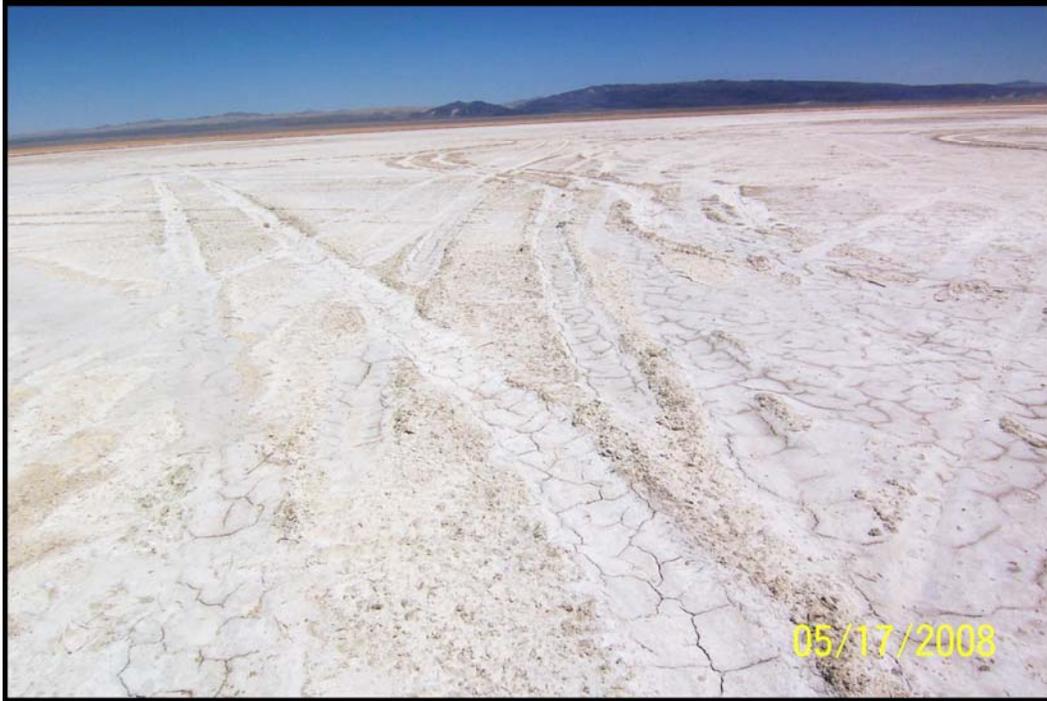
Photograph 1: View of Harper Lake showing the north shoreline. Note the mineral crust which reduces evaporation of moist, subsurface sediment.

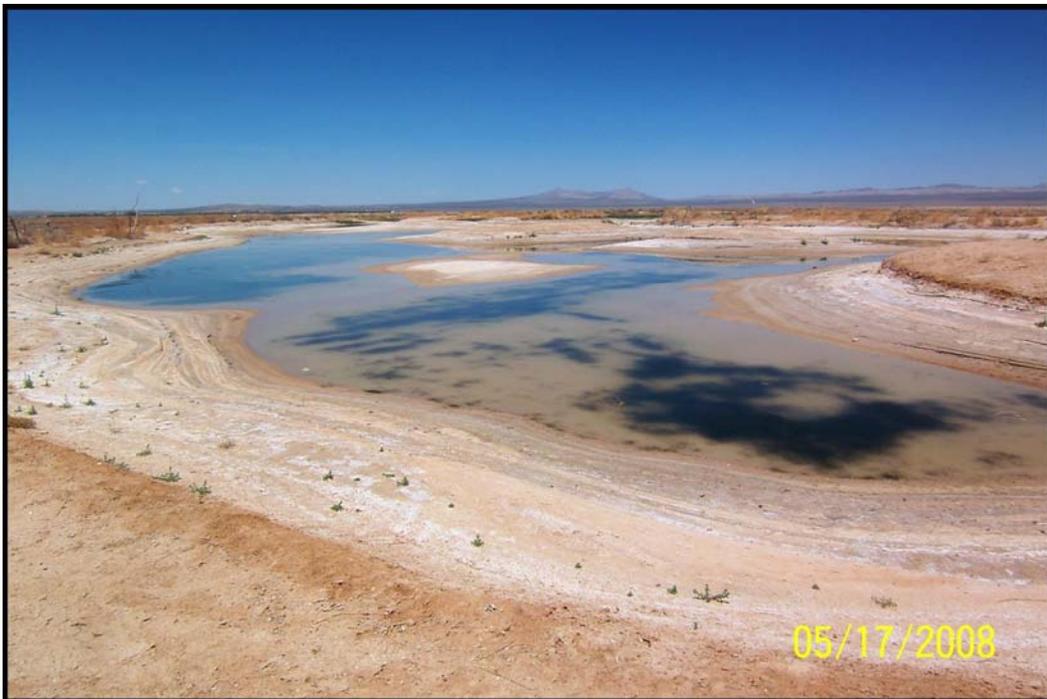
Photograph 2: View of the Harper Lake wetlands area which is maintained by the BLM. It is located on the SW side of Harper Lake. Water is supplied by the periodic pumping of groundwater from a nearby well (the Wetlands Supply Well).

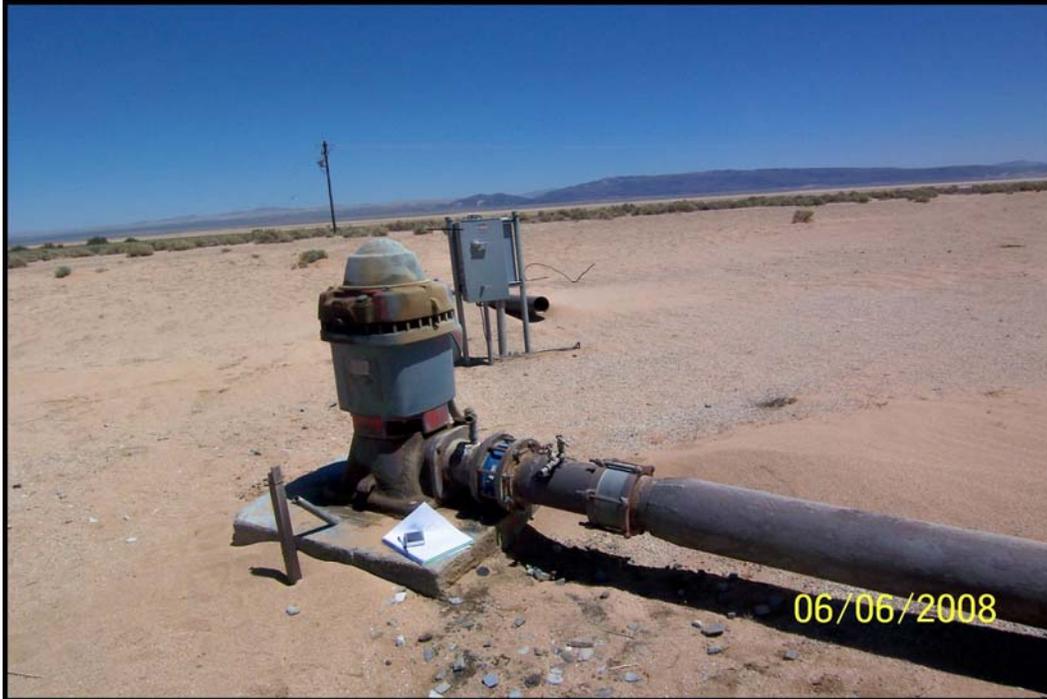
Photograph 3: Damaged Wetlands supply well prior to rehabilitation. This well is operated by the BLM and is owned by Mojave Solar One, LLC.

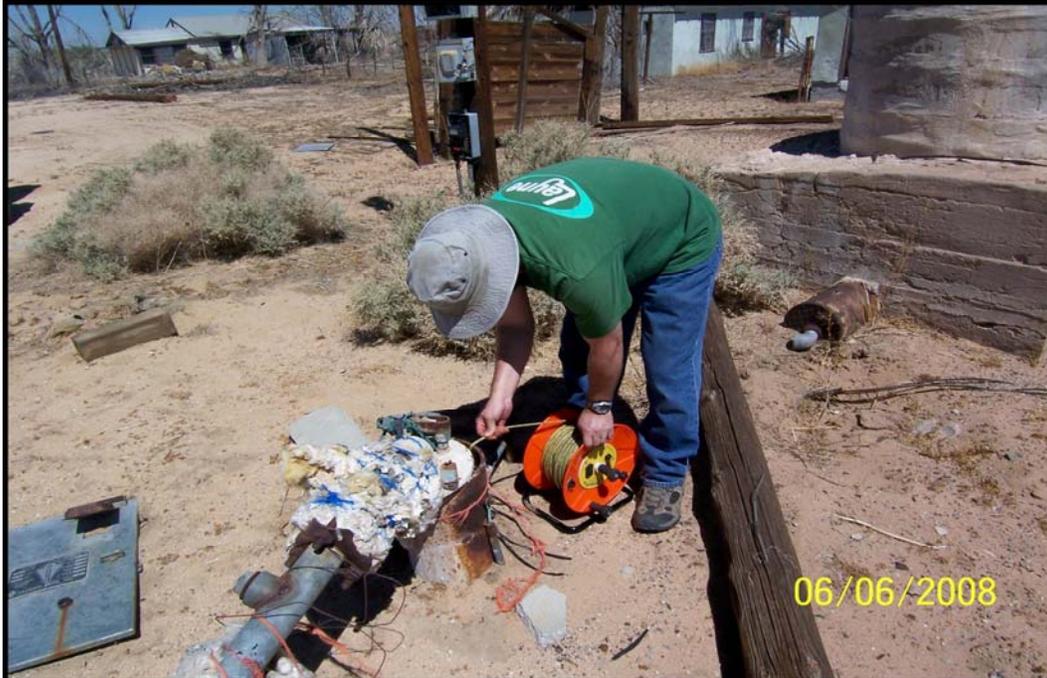
Photograph 5: Depth-to-water is obtained at the Greenhouse well positioned north of Lockhart Rd., SW of Harper Lake.

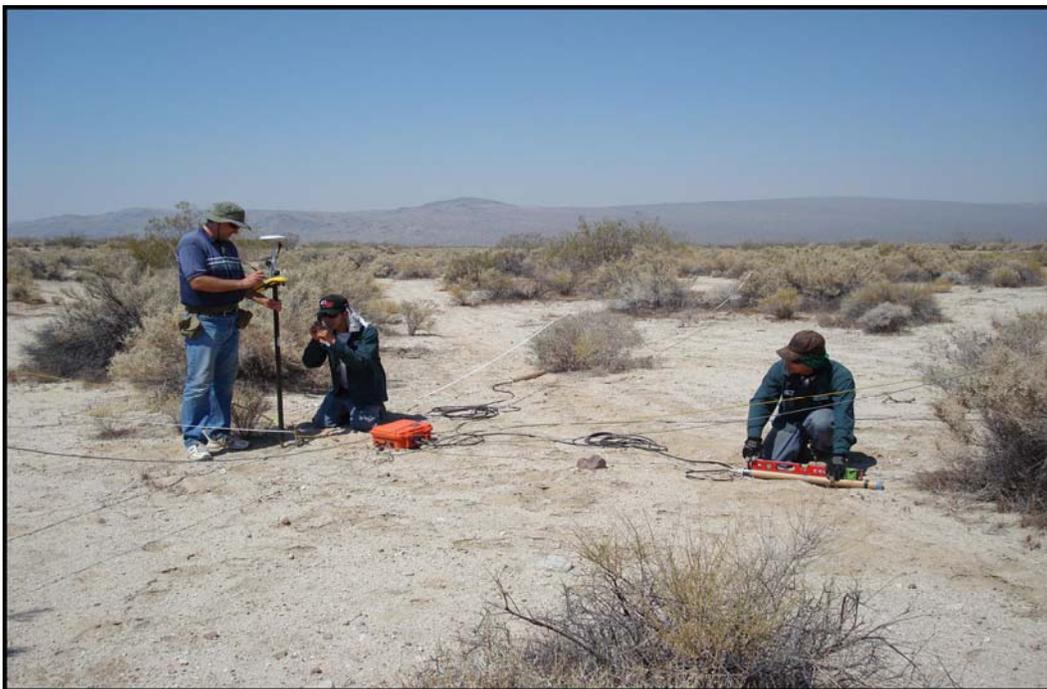
Photograph 6: Controlled Source Audio Magnetotelluric (CSAMT) geophysical survey performed by LGS north of the western edge of Harper Lake. View is looking westward. An improved understanding of depth to bedrock, along with an assessment of the perimeter position of the subsurface basalt layer and continuity is an expected outcome from analysis of geophysical information.

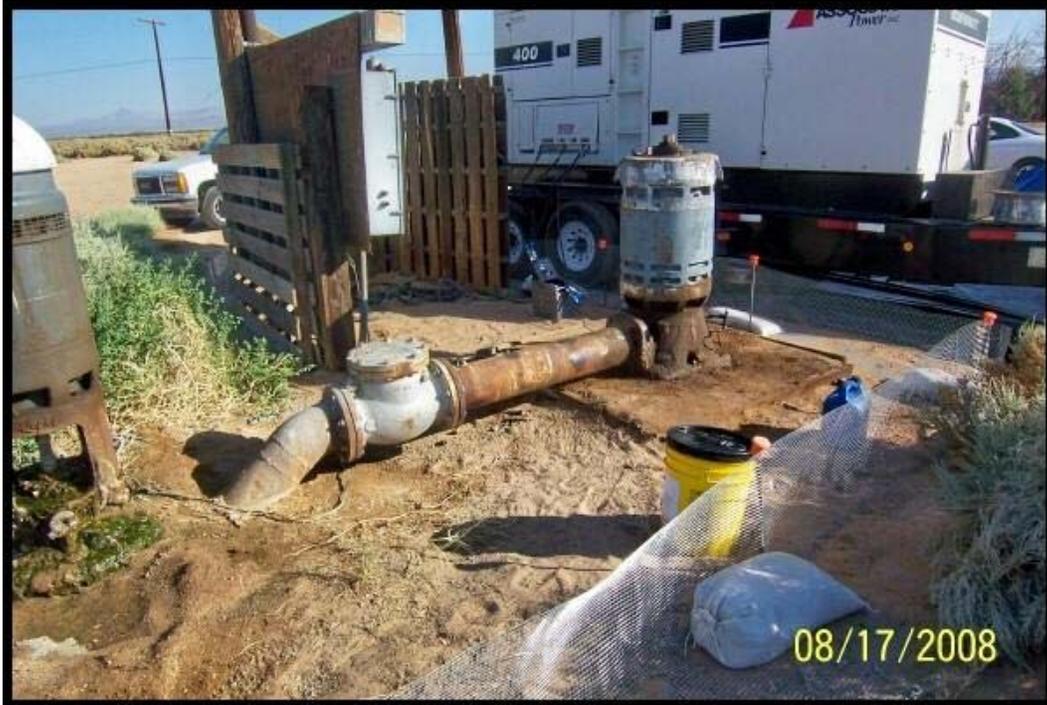
Photograph 7: The Ryken agricultural production well located southwest of Harper Lake and south of Lockhart Rd. It was used as the pumped well for an aquifer pumping test. Shown are the wellhead and booster pump motor. Note the desert tortoise exclusion fence.

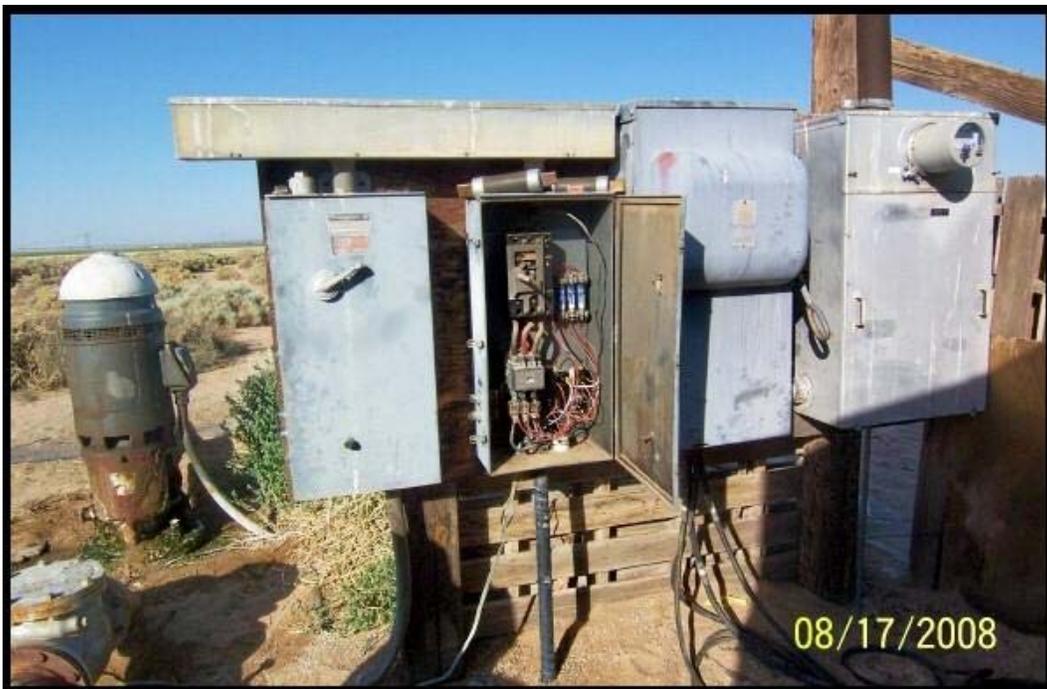
Photograph 8: The Ryken agricultural production well showing the pump power supply panel. Note the associated alfalfa field in the far horizon. View is to the west.

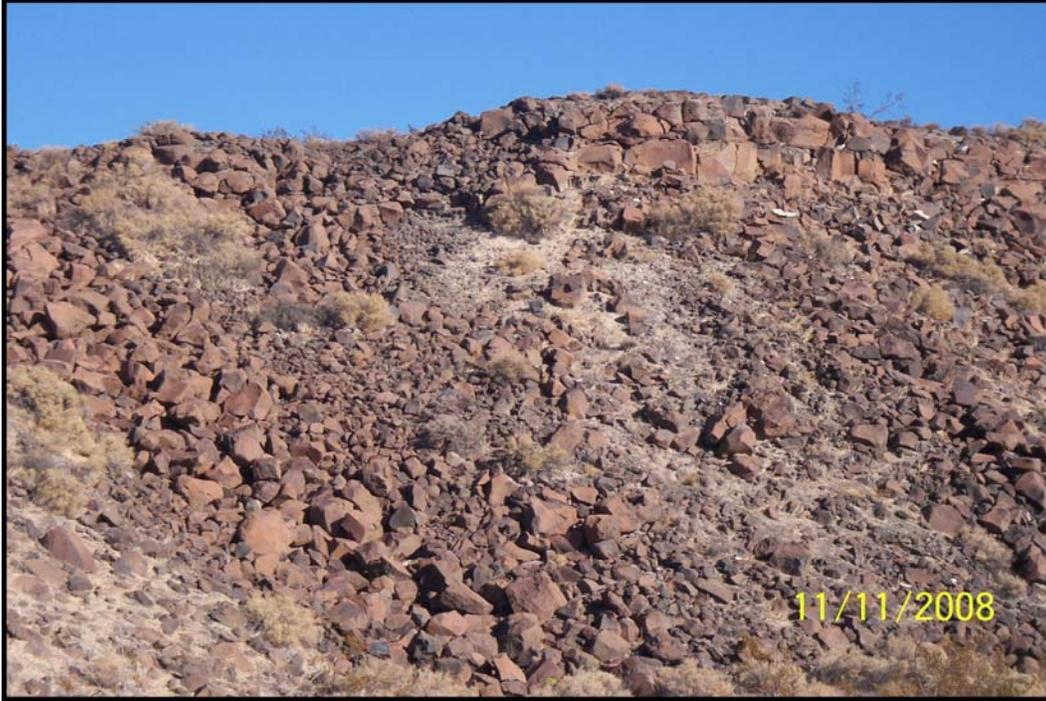
Photograph 9: Basalt veneer overlying quaternary hillslope deposits in a contact area between the HVB and adjacent Superior Basin is shown. View is looking north.

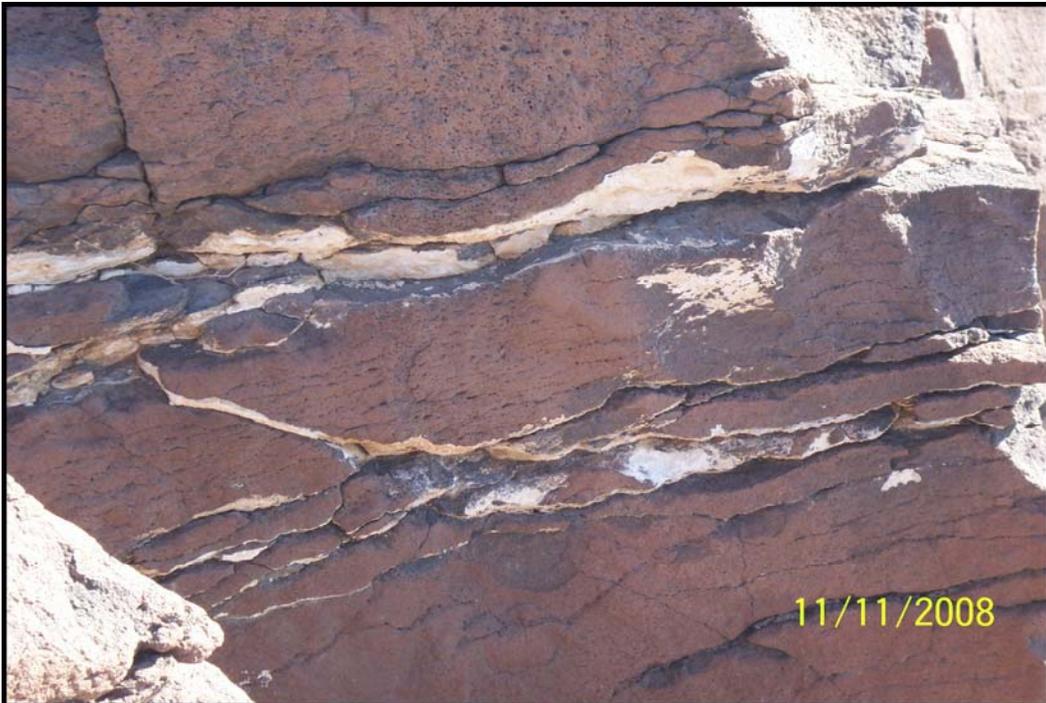
Photograph 10: Close-up view of the surface basalt showing fractures with ash and clay fill. The presence and frequency of fractures is variable. This is a close-up of the basalt veneer shown in Photograph 9. View is looking north.

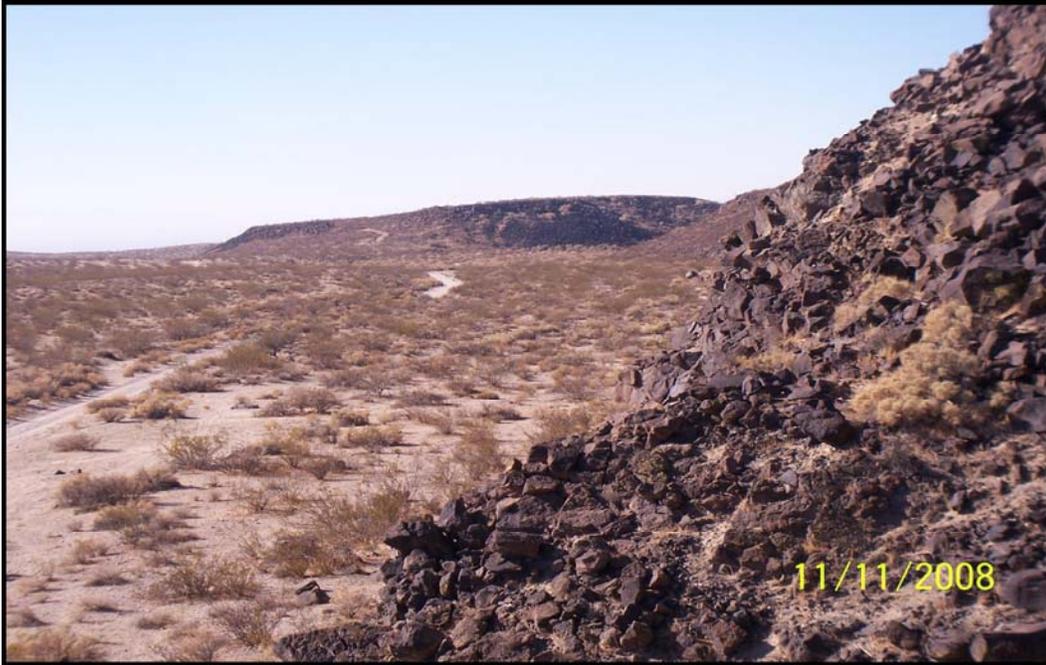
Photograph 11: View looking west down Water Valley toward Harper Lake.
Photograph taken at an elevation part of the way up the basalt-covered hillside near the HVB and the Superior Basin contact area.

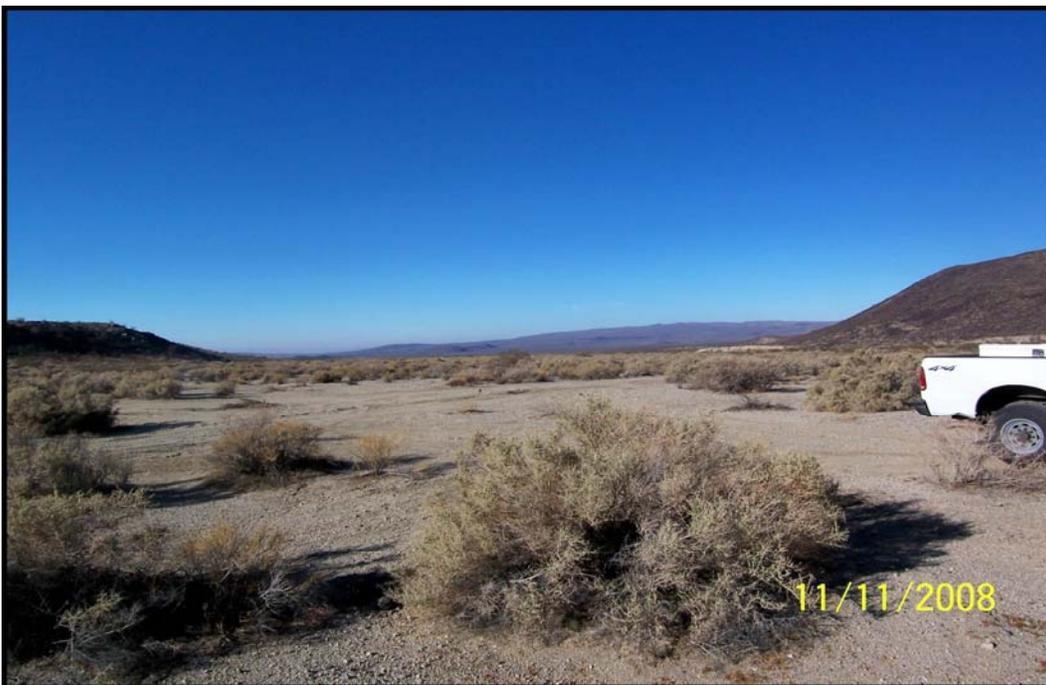
Photograph 12: View looking west down Water Valley toward Harper Lake.
Photograph taken at the bottom of the basalt-covered hillside near the HVB and the Superior Basin contact area.
