VISUAL RESOURCES - FIGURE 20B
El Segundo Power Project - Current Visual Conditions of ESGS Units 3 and 4

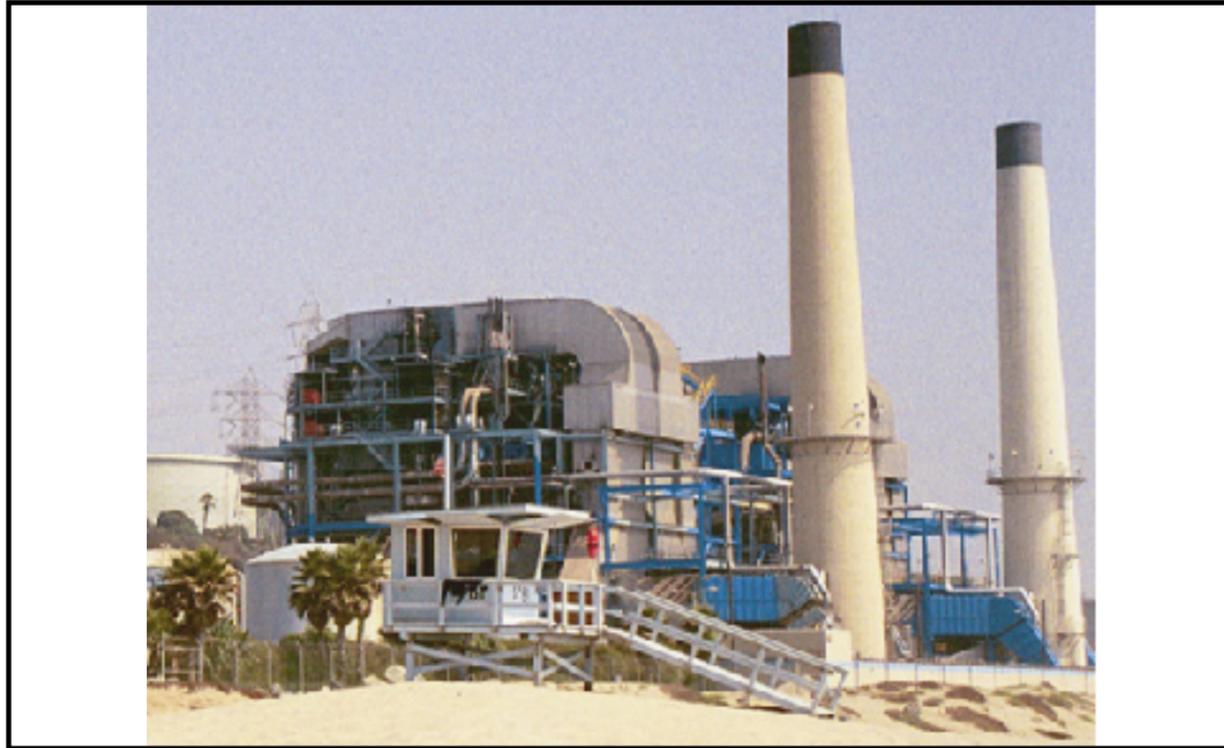
North and West Facades

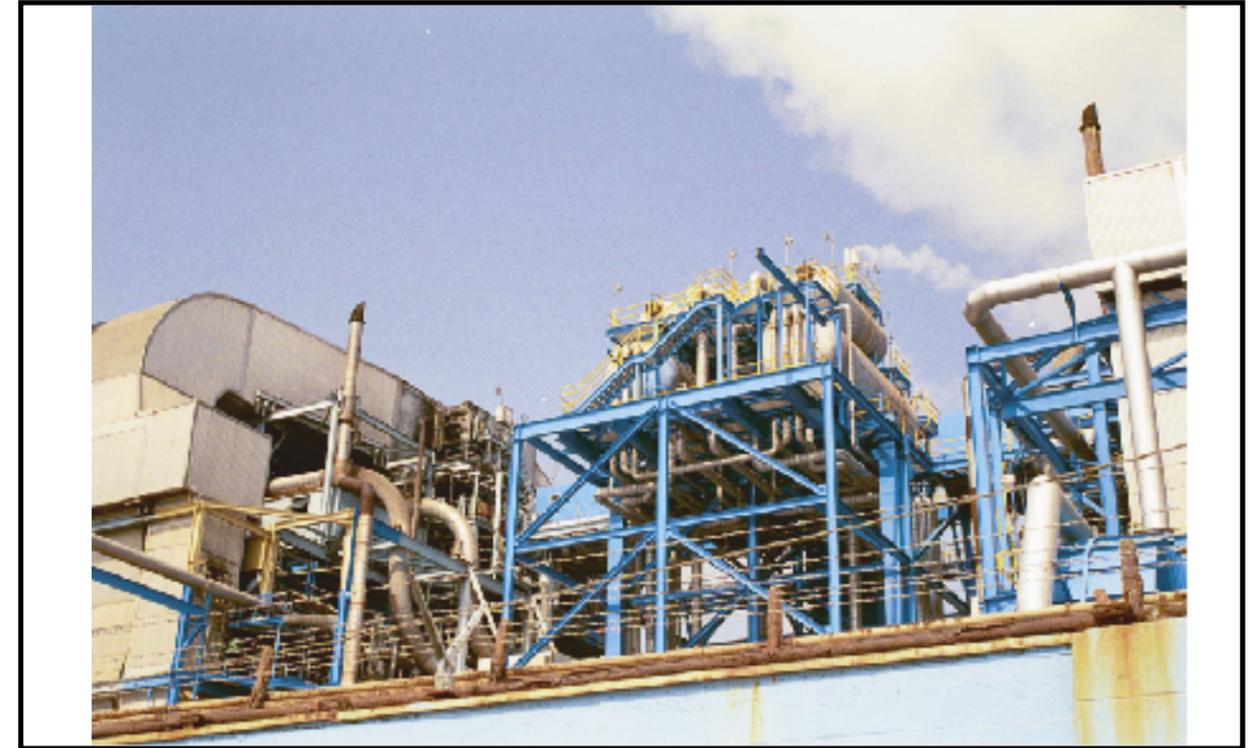
West Facade

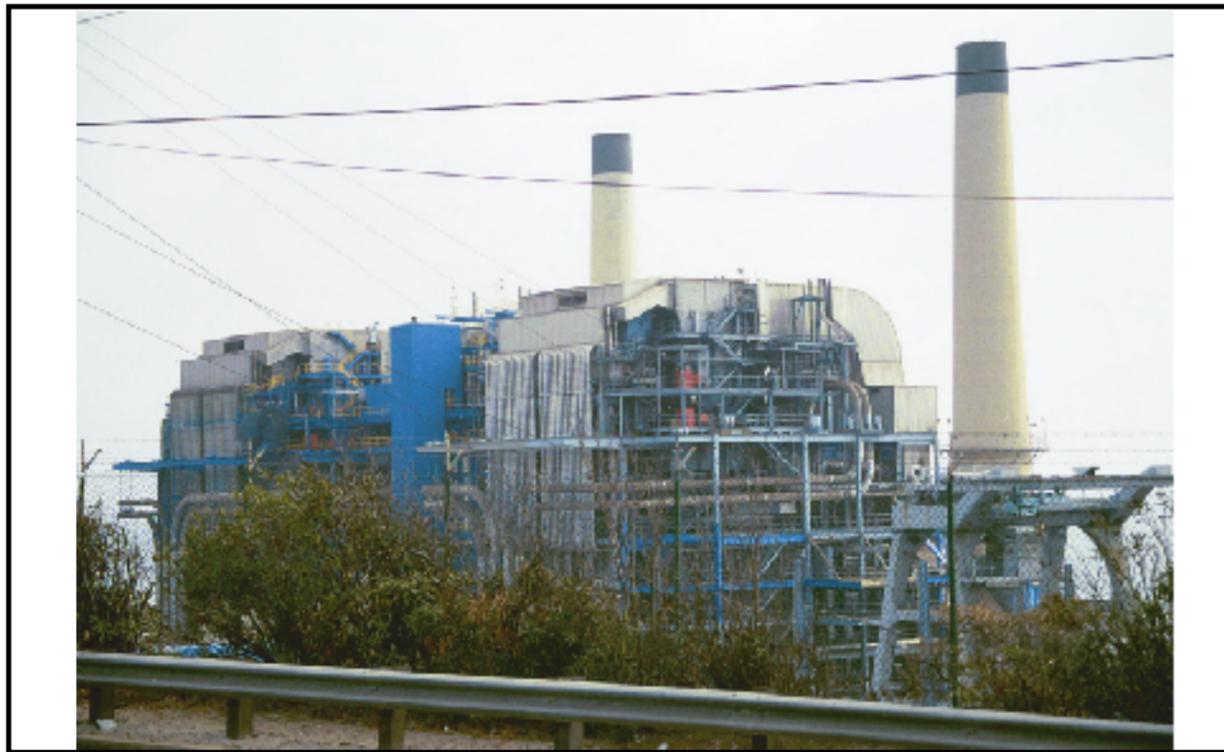
East Facade

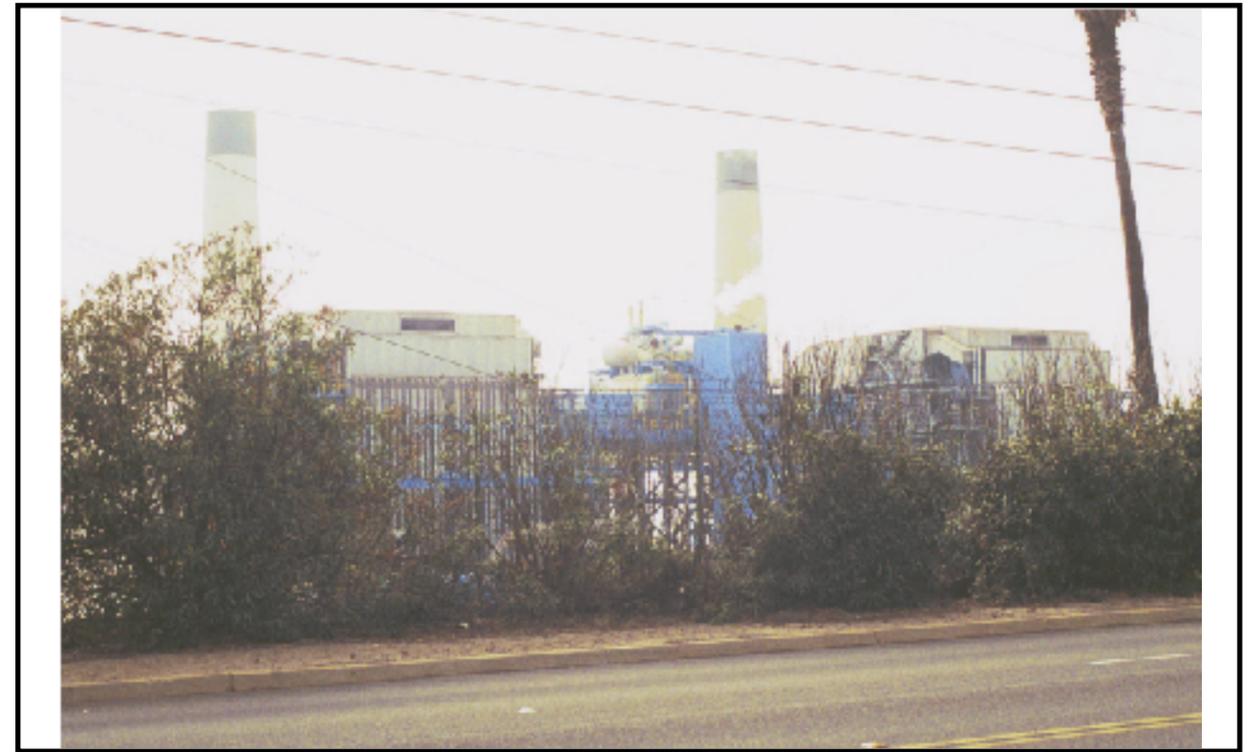
East Facade
