G-2: Fault Investigation Report

**PROPOSED POWER PLANT LOCATIONS
FOR
TESLA SUBSTATION AREA, MIDWAY
QUADRANGLE
ALAMEDA COUNTY, CALIFORNIA**

GEOCON PROJECT NO. E8062-06-01

APRIL 2001

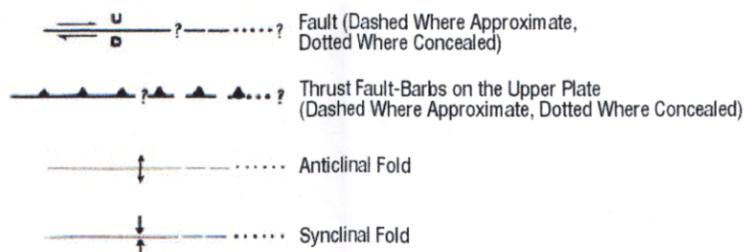
11375 SUNRISE PARK DR. - SUITE 100 - RANCHO CORDOVA, CA. 95742 PHONE 916 852-9118 - FAX 916 852-9132		
Tesla Site Investigation Alameda County, California		
REGIONAL GEOLOGIC MAP OF THE EAST SAN FRANCISCO BAY AREA		
E8062-06-01	April 2001	Figure 3

Faulting was observed in outcrop or shown on existing geologic maps on two of the three sites. The trace of the northeast trending Midway Fault is shown on the 1:24,000 Regional Geologic Map for the area (Figure 3), and runs across the Tesla North site, along the eastern side of the property. The Midway Fault is a northwest trending fault, with a trace length of approximately 6 miles. Information in a State of California Department of Water Resources report titled *Reevaluation of Seismic Hazards for Clifton Court Forebay Bethany Dams and Reservoir Patterson Reservoir Del Valle Dam and Lake Del Valle* (DWR Clifton report), states that the age of the Midway Fault cannot be determined more definitely than post Miocene, although geomorphic features such as sag ponds suggest recent surface displacements. The DWR Clifton report, the geomorphic evidence, and the occurrence of a magnitude 3.5 earthquake near the Midway Fault suggest that the fault is still active. The primary hazard associated with the Midway Fault is ground rupture. Facilities damage due to surface rupture can be minimized by locating structures at least 50 feet from the fault zone, and constructing cables and pipelines to cross the fault perpendicular to the fault trend.

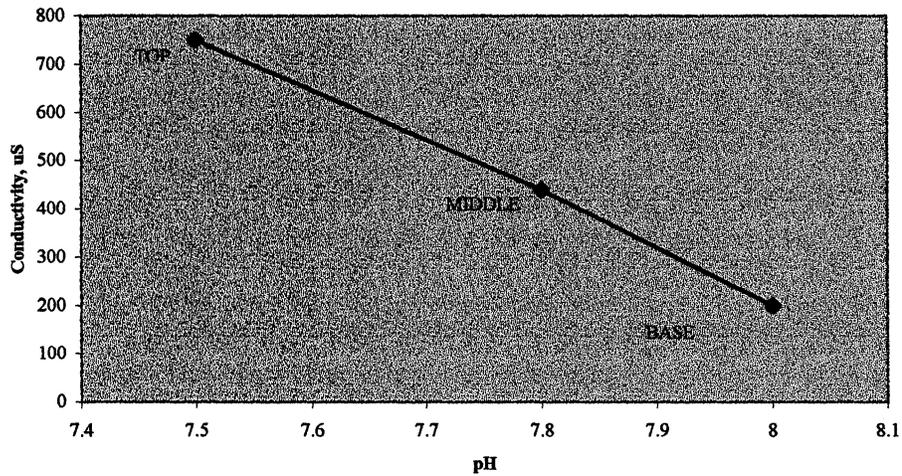
Fig. 1. Relationship between conductivity and pH in the A horizons of Soil Profile Nos. 4, 3, and 2 at the top, middle, and base of the scarp of the Midway fault.

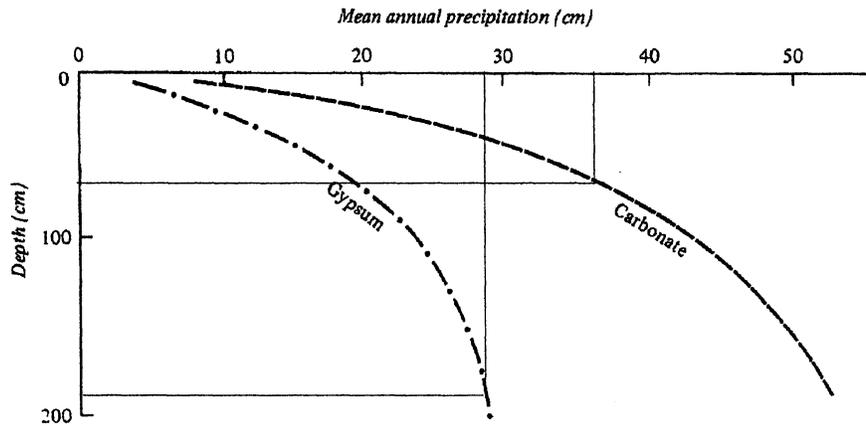
Fig. 2. Relationship between depth to top of pedogenic salt accumulation and mean annual precipitation (MAP) in modern soils of southern Israel (Dan and Yaalon, 1982) (as modified in Birkeland, 1999, p. 203). Data from Soil Profile No. 2 are plotted to yield MAP estimates ranging between 29 and 36 cm. MAP at Tracy is 28 cm (Welch, and others, 1966).
