Hydrostatic Pipeline Testing Implications on Electric System and Pipeline Integrity

**Natural Gas Stakeholders Working
Group**

California Energy Commission

Wednesday April 16, 2014

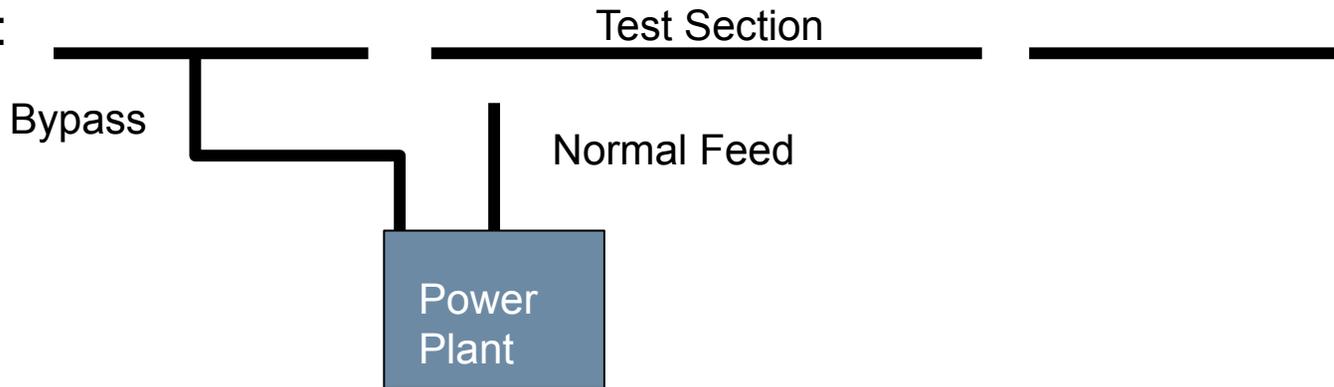
Bypass:

Power Plant Bypass and Split Test

- Independent System Operator (ISO) and PG&E Gas System Operations (GSO) coordination and planning
- Schedule tests during planned shut down for maintenance
- Schedule when the demand is low, between November and April
- Build bypass
- Split Test into two segments
- Use LNG
 - Most Plants gas consumption is too high to be supported by LNG

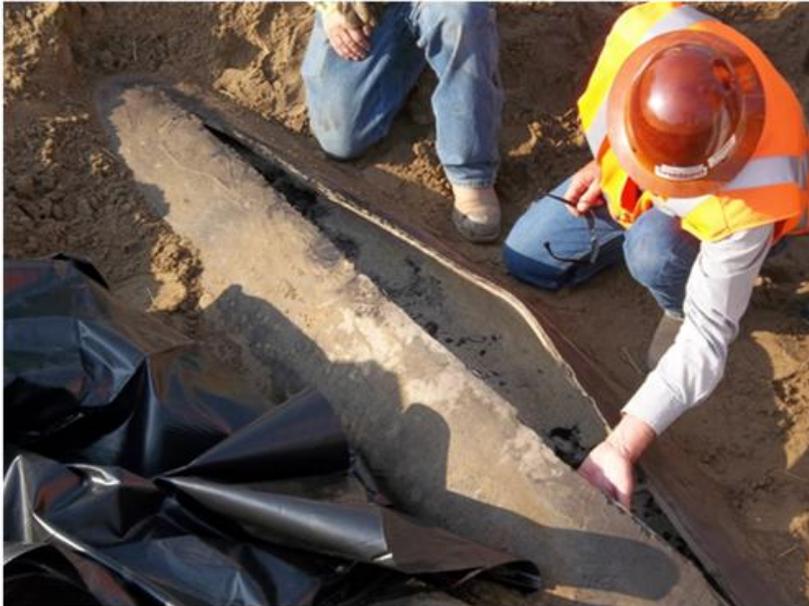
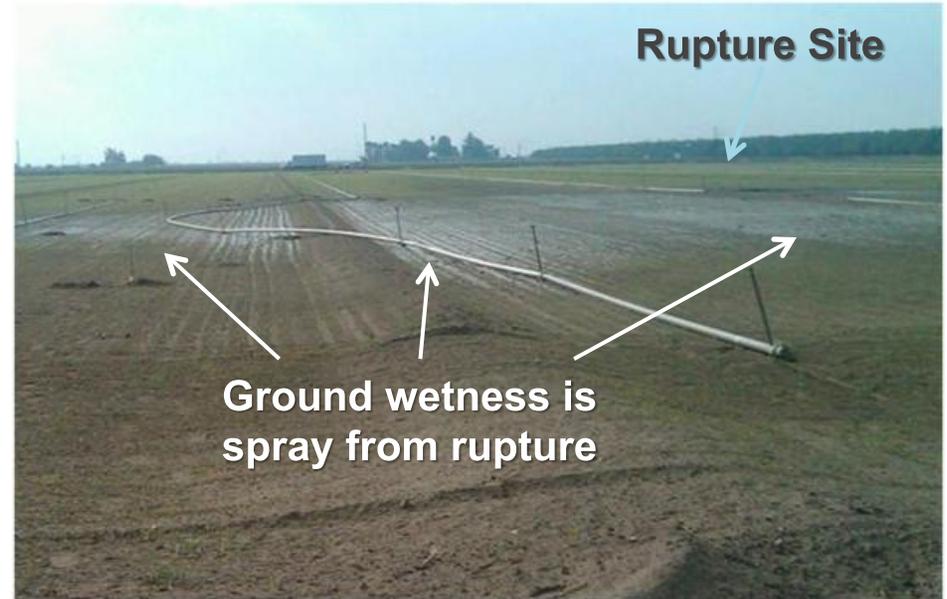
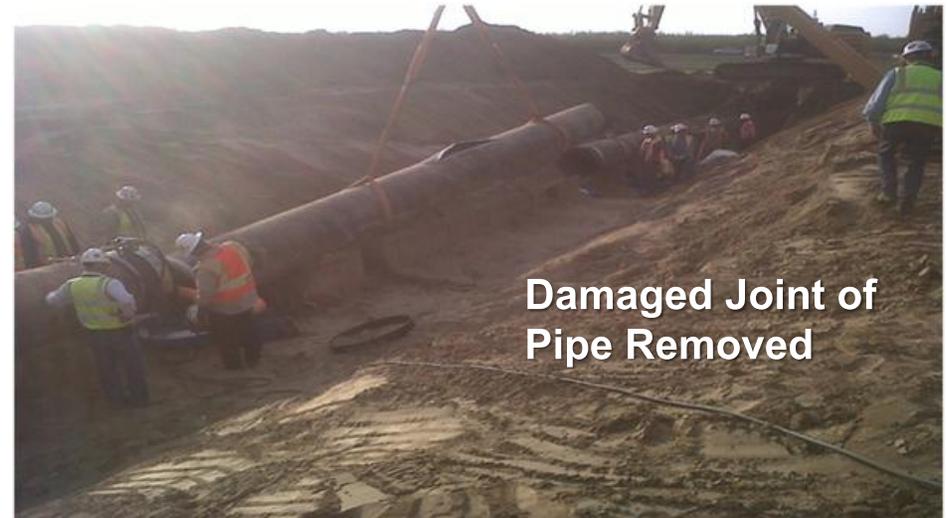
Line 300B Rupture in Bakersfield (2011)

Cause: Seam Failure – Hot crack and incomplete seam weld

Action: Replaced with 84' of new pipe

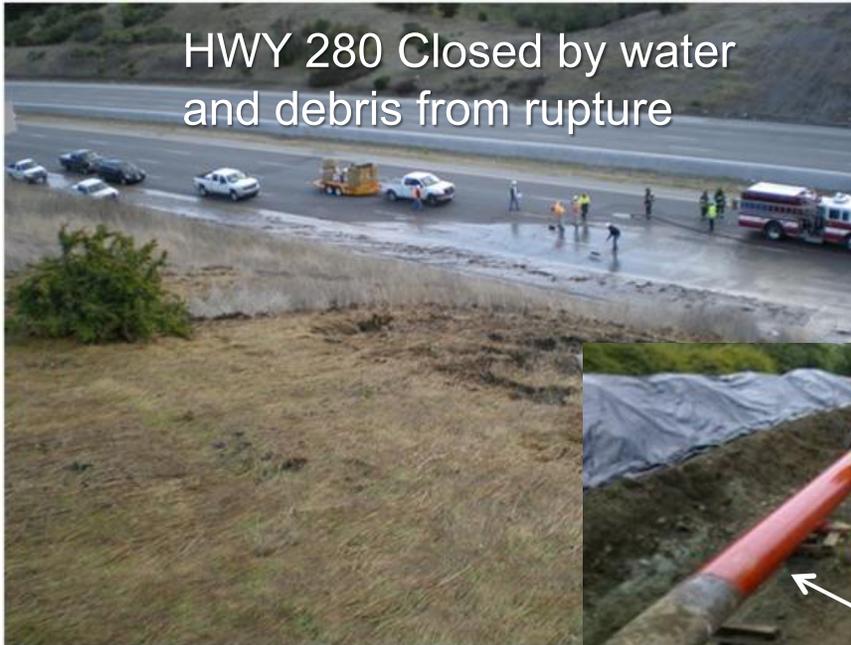
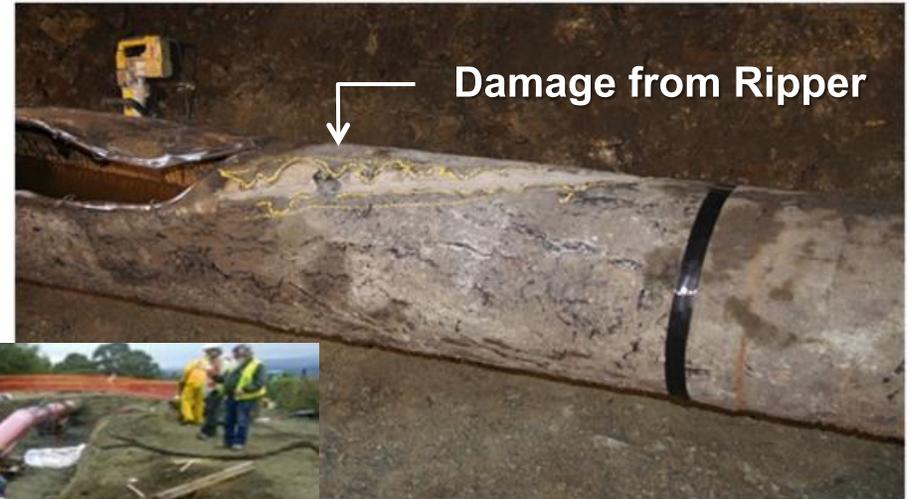
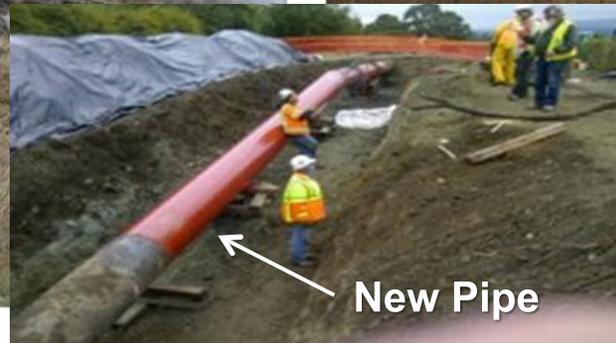
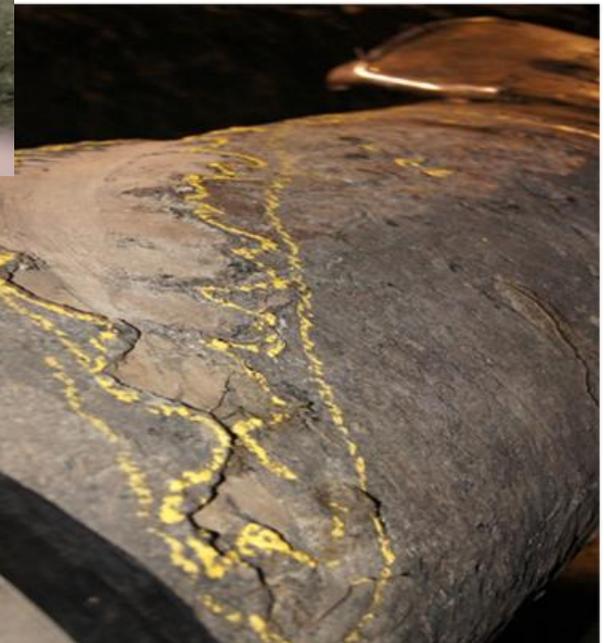
Line 132 Rupture in Woodside (2011)

Cause: Mechanical damage from equipment

Action: Replaced with 60' of new pipe

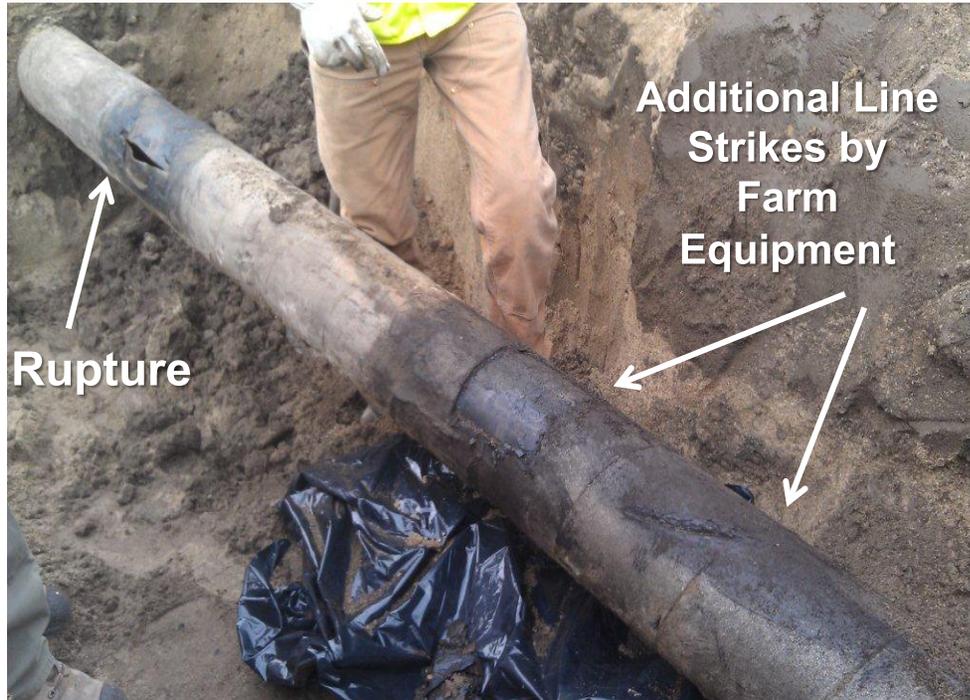
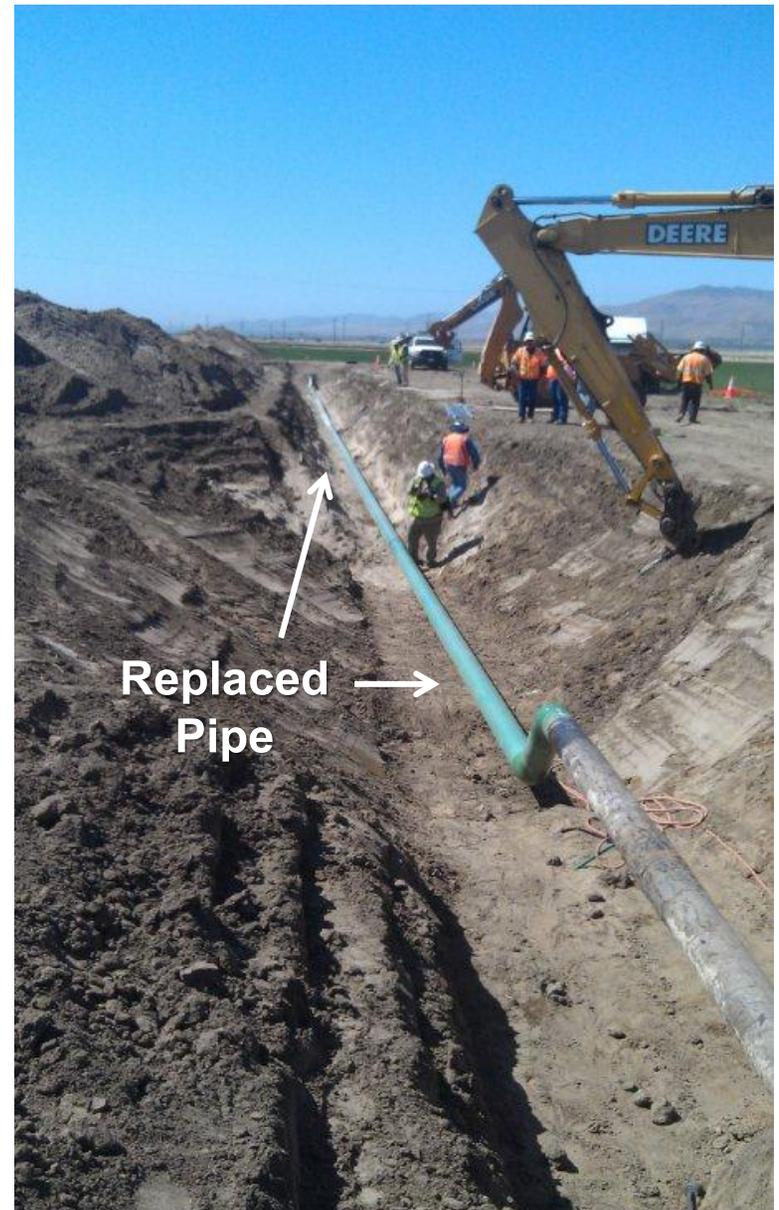
Line 187 Rupture near Soledad (2013)

Cause: Mechanical damage from farm equipment caused seam failure (13 strikes total found from farm equipment)

Action: Replaced with 250' of new deeper pipe

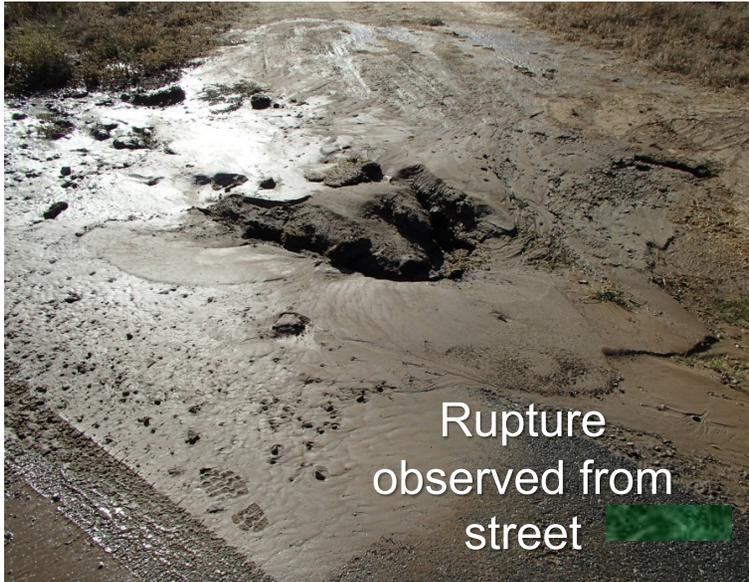
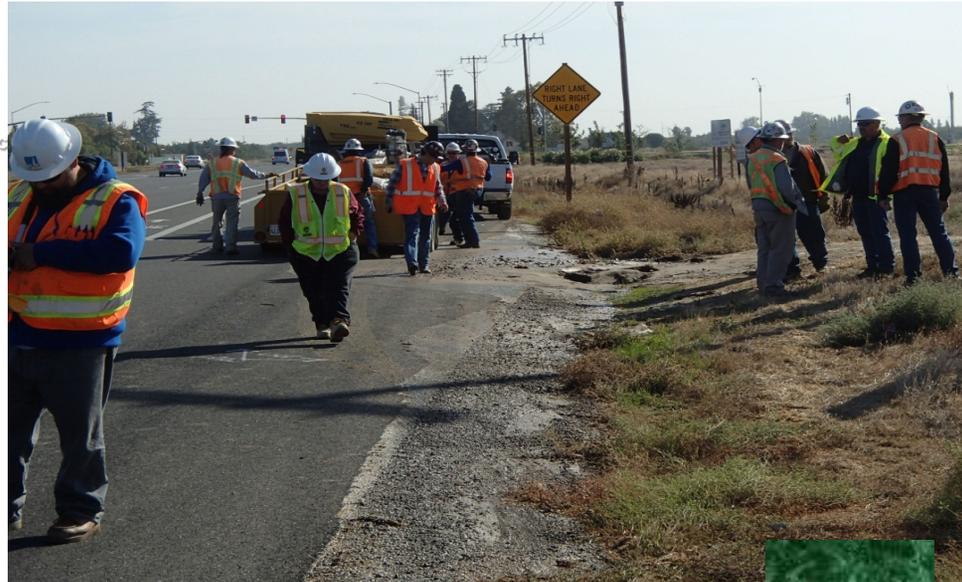
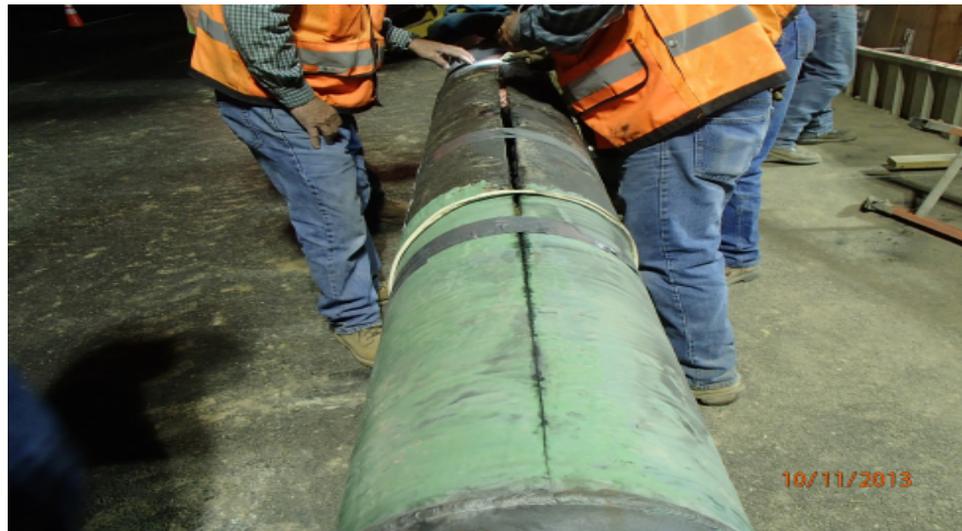
Line 1615-01 Rupture in Modesto (2013)

Cause: Seam failure

Action: Section of pipe cut out and replaced
