Site Material Sampling Report

Mojave Solar Project

Harper Dry Lake

San Bernardino County, California

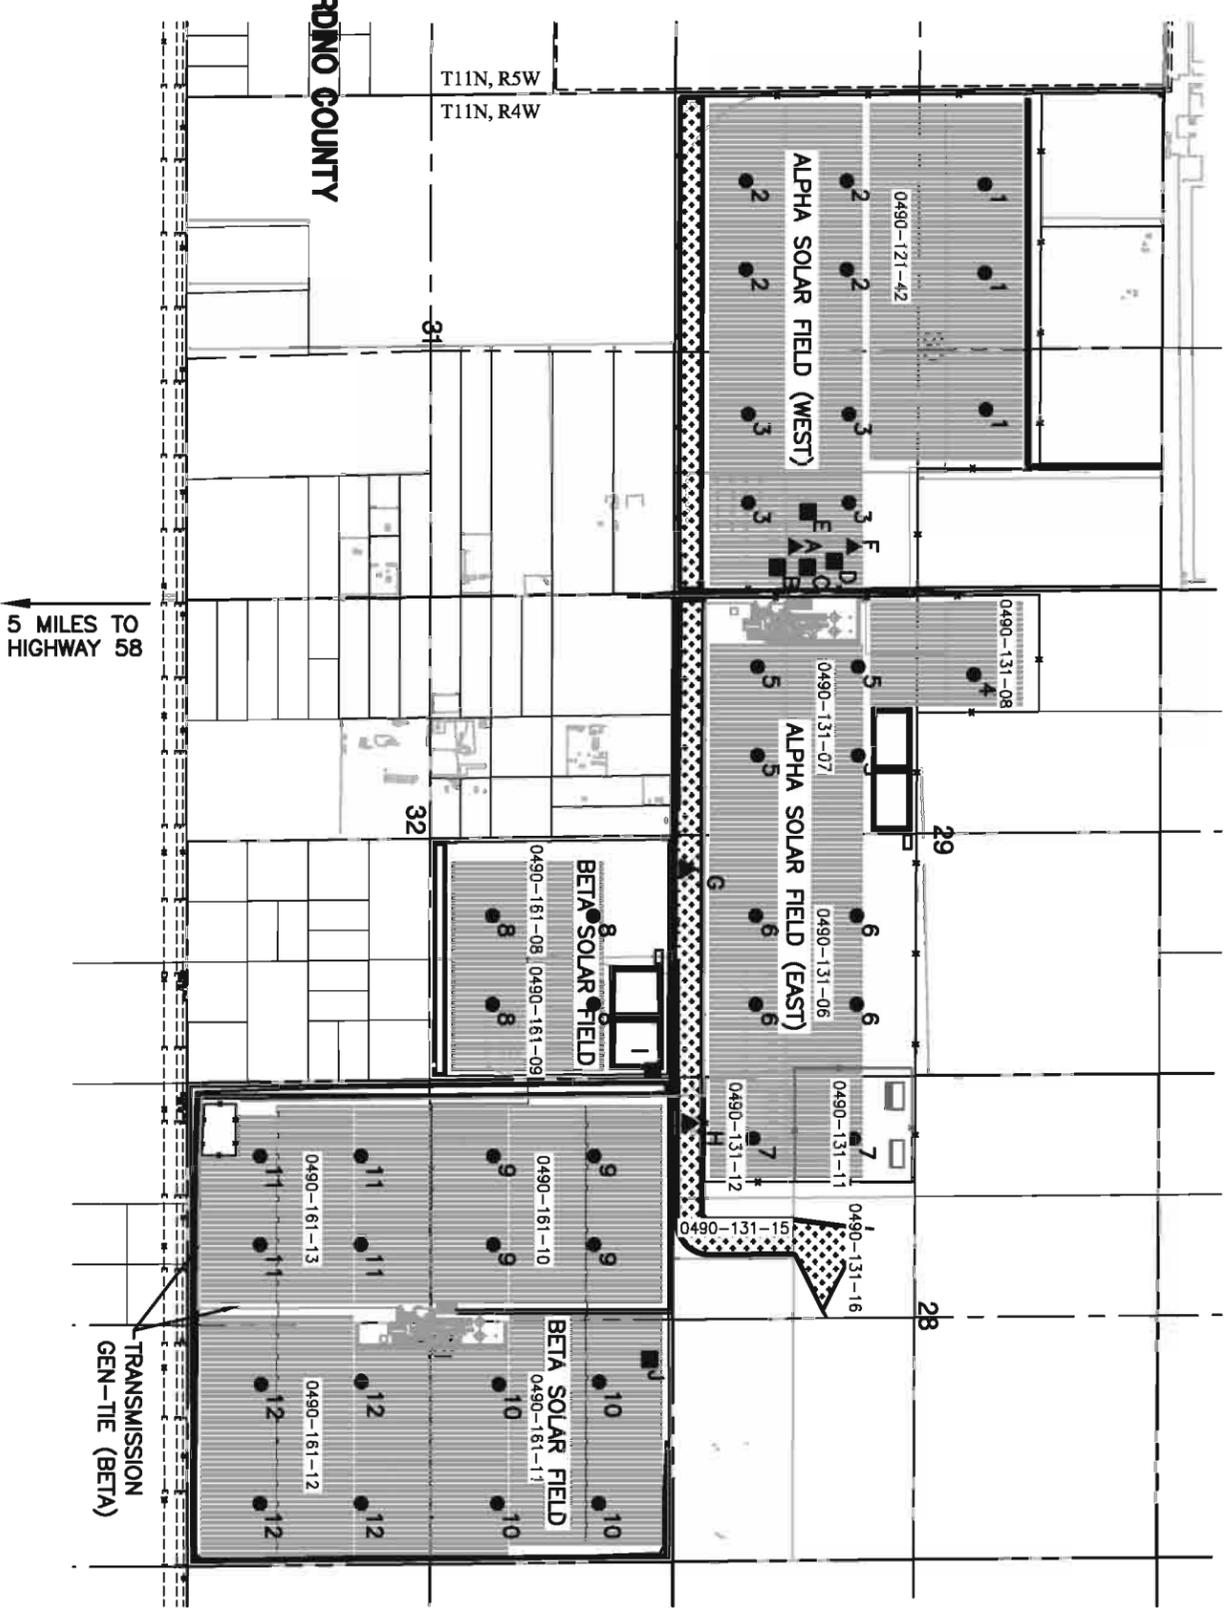
SOIL SAMPLING PLAN

- SAMPLE LOCATION TO BE TESTED FOR PESTICIDES & HERBICIDES
- # SAMPLE LOCATION CONSOLIDATED FOR LAB TESTING
- SAMPLE LOCATION TO BE TESTED FOR HYDROCARBONS
- ▲ SAMPLE LOCATION TO BE TESTED FOR LEAD & ASBESTOS

- ▲ EXISTING CONCRETE STRUCTURE – STORE
- ▲# EXISTING CONCRETE STRUCTURE – STORE
- VENT PIPES AT SOUTH STORE WALL
- PREVIOUS FUEL ISLANDS AT STORE FRONT
- PREVIOUS UG AVIATION FUEL TANK – 30' NORTHWEST OF STORE
- PREVIOUS AG FUEL TANKS – REAR OF STORE
- ▲ EXISTING WOOD STRUCTURES – VARIOUS
- ▲ WOOD STRUCTURES AT SW CORNER – VACANT HOMES
- ▲ WOOD STRUCTURES AT SOUTH – VACANT FARM BUILDINGS
- ACTIVE WELL AT NE CORNER – RYKEN WELL
- ACTIVE WELL AT NW CORNER – WETLANDS WE- WETLANDS WELL

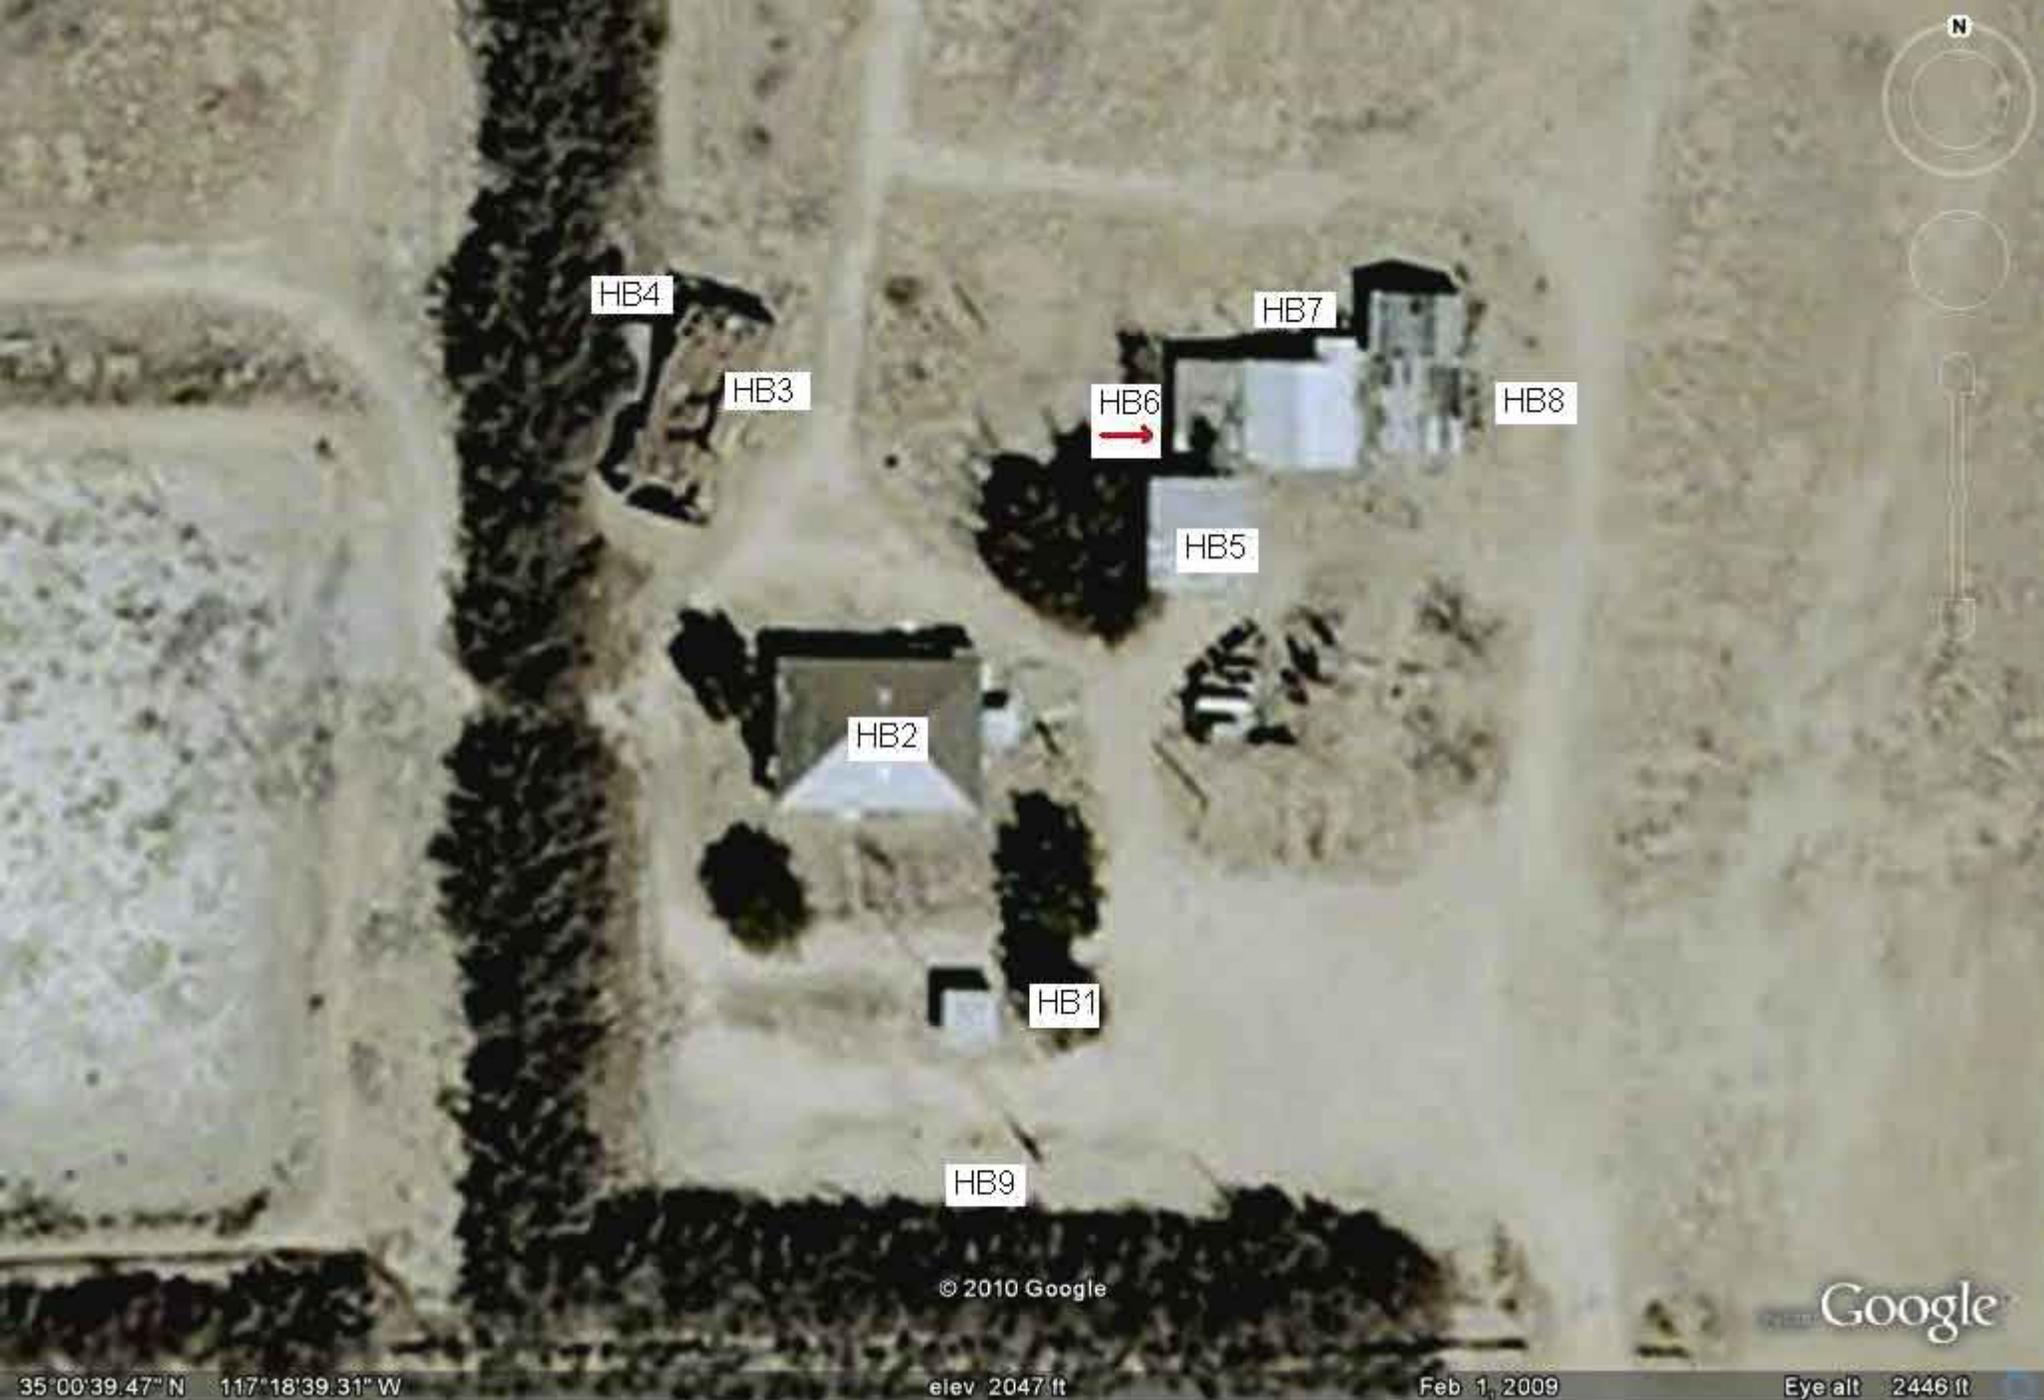
- 1 Fuel leak at former fuel dispenser island; entire piping should be investigated per County Fire regulations
- 1 Fuel leak at former northern AV gas tank
- 1 Transite piece exterior southwest corner
- 1 Transite pieces exterior southwest corner
- 1 Drum storage in basement
- 1 West from building; two stage clarifier
- 1 Potential for lead solder in 4" cast iron pipe joints
- 1 Elevator brake shoes likely asbestos
- All Fluorescent light ballasts need to be inspected for PCBs
- 5 South exterior waste grease and oil drums
- 6 Herbicide bag inside building
- 8 West from building; potential former hydraulic lifts with hydrocarbon building-up
- HB5 Potential former Mechanic's Pit in garage

- The general store's former fueling system should be investigated, as well as the former aviation fuel ("AV") tank on the northern side of the building. Mitigation procedures should be interfaced with the appropriate governing agencies having jurisdiction over the project site.

- The hazardous materials/wastes located in the General Store's basement and by Building 5 need to be properly managed and disposed/recycled.
