Phase I Environmental Site Assessment

ALMOND 2 POWER PLANT

Ceres, Stanislaus County, California

February 9, 2009

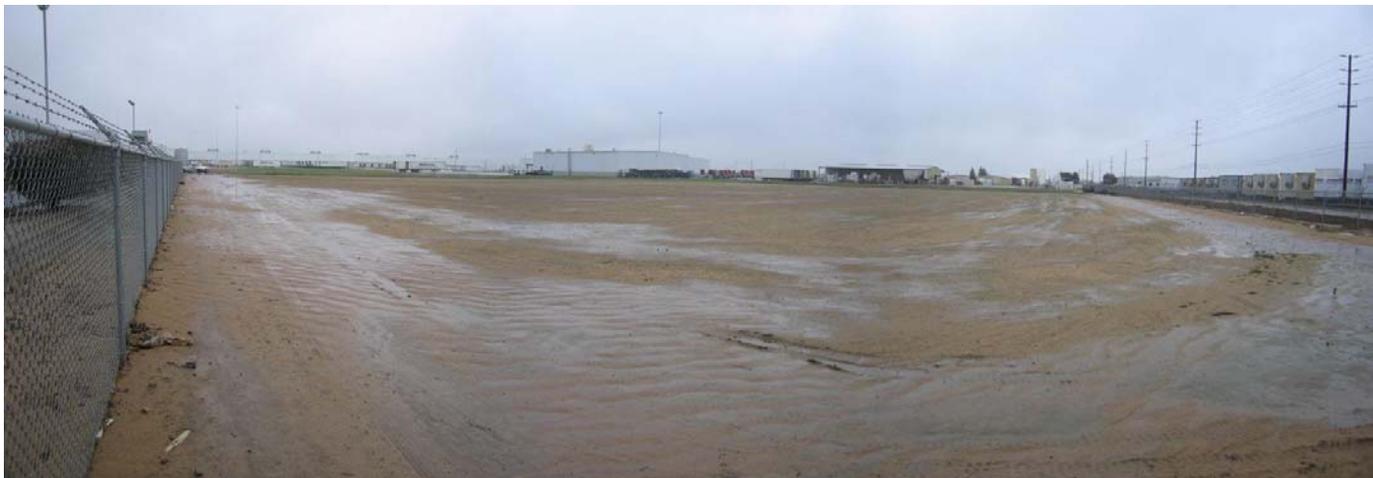
View of the site looking west (left side of photo) to north (right side of photo) as seen from near the southeastern corner.

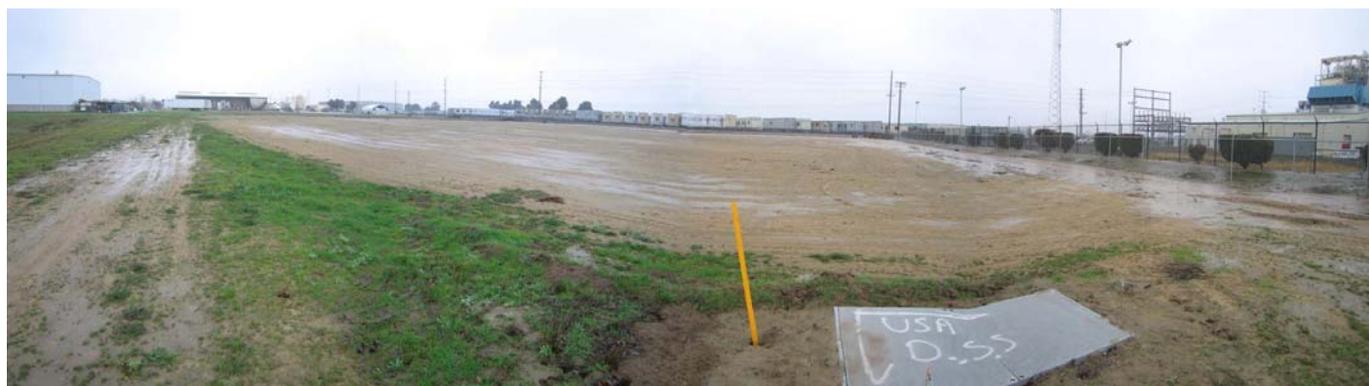
View of the site looking north (left side of photo) to east (right side of photo) as seen from near the southwestern corner. The existing Almond Power Plant is visible on the right.

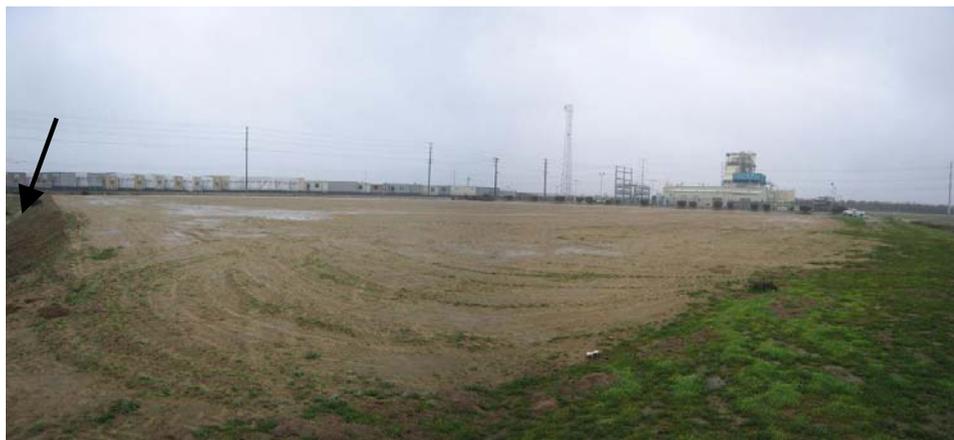
View of the site looking west (left side of photo) to south (right side of photo) as seen from near the northwestern corner. The existing Almond Power Plant is visible in the right-hand background. The adjacent stormwater detention basin to the north is indicated by the arrow.
