**FIGURE 5.13-8  
SCENIC ATTRACTIVENESS EVALUATION FORM FOR  
SENSITIVE VIEW AREA AND KOP NO. 1**

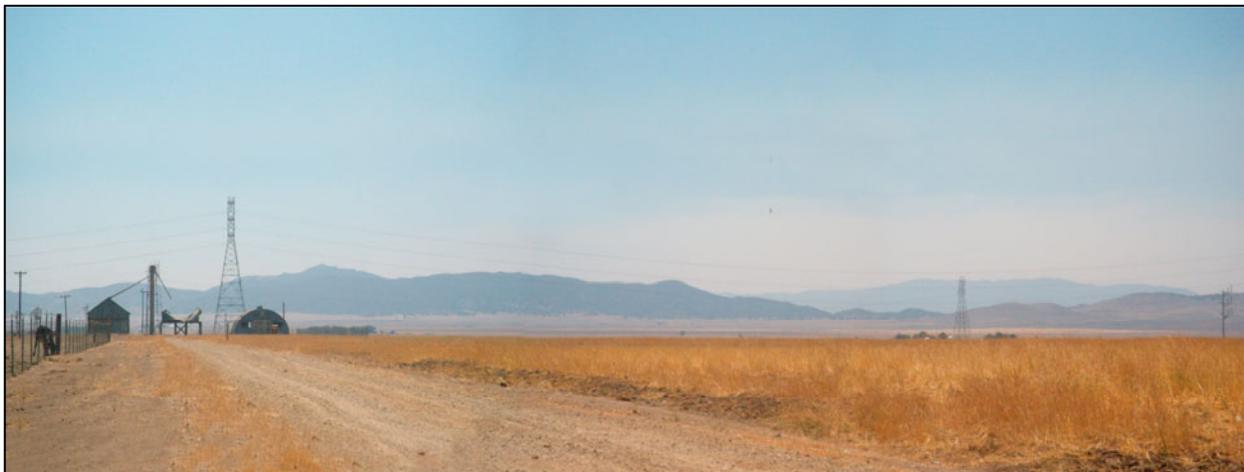
Landform	H (5)	H/M (4)	M (3)	M/L (2)	<b><u>L (1)</u></b>
Vegetation	H (5)	H/M (4)	M (3)	M/L (2)	<b><u>L (1)</u></b>
Water	H (5)	H/M (4)	M (3)	M/L (2)	<b><u>L (1)</u></b>
Color	H (5)	H/M (4)	M (3)	<b><u>M/L (2)</u></b>	L (1)
Adjacent Scenery	H (5)	H/M (4)	<b><u>M (3)</u></b>	M/L (2)	L (1)
Scarcity	H (5)	<b><u>H/M (4)</u></b>	M (3)	M/L (2)	L (1)
Modifications*	H (2)	H/M (1)	M (0)	<b><u>M/L (-2)</u></b>	L (-4)
<b>Scenic Attractiveness Class C (10)</b>

**Narrative Landscape Description and Photograph.** Sensitive Viewing Area and KOP No. 1 (Figure 5.13-12, see also Figure 5.13-1 for KOP location) was taken from the front yard view of the closest residence approximately 0.3-mile to the north looking south towards the CESF site. As this is the closest residence to the north of the site, this view is representative of “worst case” residential views from the north. The terrain is generally flat, varying little in distinctive setting. Unique forms are created only by the mountains in the background. Open/panoramic views add to the visual appeal of the area. Cultural modifications include transmission lines/towers, the existing PG&E substation, property fencing, and dilapidated/abandoned farm structures in the foreground. The area is characterized by sparse vegetation and little color variations (mainly from tan barren landscape with dry grasslands), and low contrast of generally mute tones offering little diversity to the visual setting. The color may vary slightly during spring months. There are no water sources within the immediate Project vicinity or within view from this KOP.

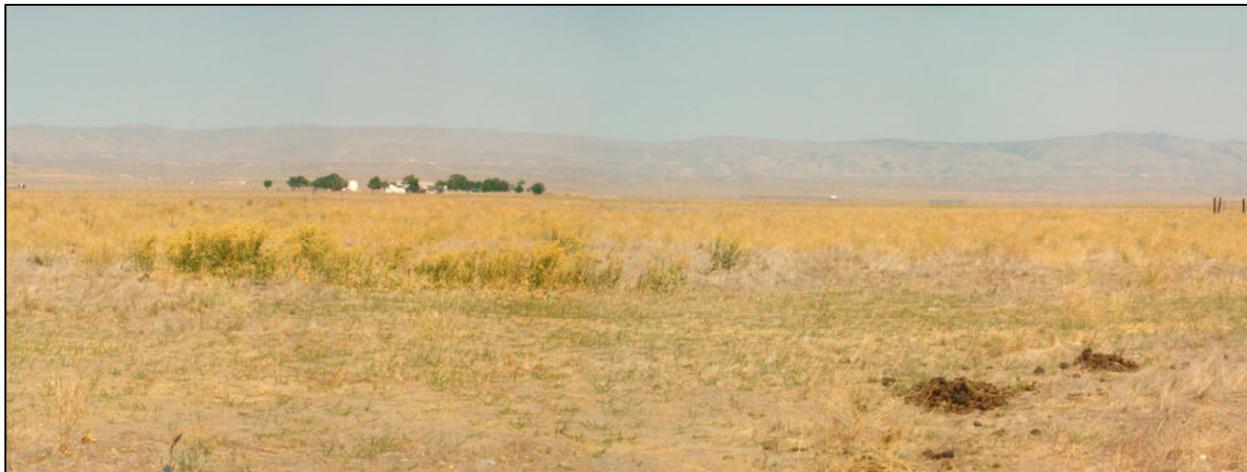
**FIGURE 5.13-9  
SCENIC ATTRACTIVENESS EVALUATION FORM FOR  
SENSITIVE VIEW AREA AND KOP NO. 2**

Landform	H (5)	H/M (4)	M (3)	M/L (2)	<b><u>L (1)</u></b>
Vegetation	H (5)	H/M (4)	M (3)	M/L (2)	<b><u>L (1)</u></b>
Water	H (5)	H/M (4)	M (3)	M/L (2)	<b><u>L (1)</u></b>
Color	H (5)	H/M (4)	M (3)	<b><u>M/L (2)</u></b>	L (1)
Adjacent Scenery	H (5)	H/M (4)	M (3)	<b><u>M/L (2)</u></b>	L (1)
Scarcity	H (5)	<b><u>H/M (4)</u></b>	M (3)	M/L (2)	L (1)
Modifications*	H (2)	H/M (1)	<b><u>M (0)</u></b>	M/L (-2)	L (-4)
Scenic Attractiveness Class C (11)

**Narrative Landscape Description and Photograph.** Sensitive Viewing Area and KOP No. 2 (Figure 5.13-14, see also Figure 5.13-1 for KOP location) was taken from the front yard of the closest residence to the west along SR-58, approximately 0.2-mile to the west looking east towards the CESF site. As this is the closest residence to the west of the site, this view is representative of “worst case” residential views from the west. The terrain, color, vegetation and general form to the area virtually mirrors that of KOP 1. Topographic relief across the setting is minimal, adding limited visual appeal to form and line characteristics. Like KOP 1, open/panoramic views add to the visual appeal of the area. Cultural modifications include SR-58, power transmission lines/towers, telephone lines/poles, abandoned farm structures currently on-site surrounded by a line of trees, property fencing, and other surrounding farming/residential structures. There are no water sources within the immediate Project vicinity or within view from this KOP. This landscape is considered interesting within its setting, but fairly common within the region. It should be noted that views to the site from some of the other residences to the west are partially screened by vegetation and/or other residences in the foreground (see Figure 5.13-4 for a character shot of this residence).

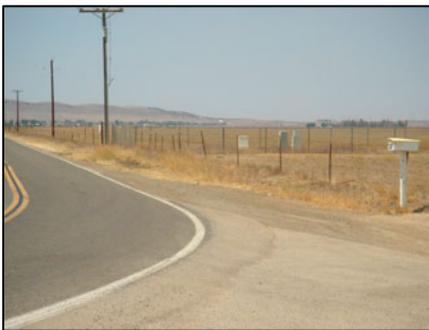
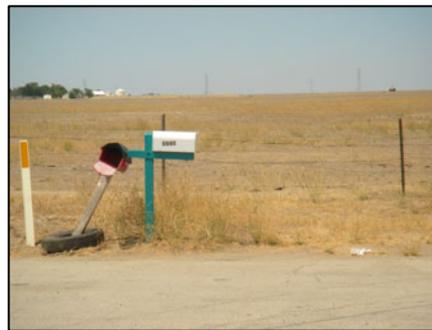
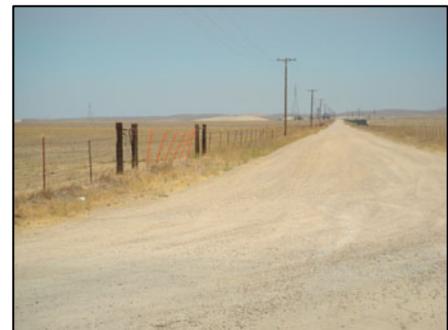
**FIGURE 5.13-10  
SCENIC ATTRACTIVENESS EVALUATION FORM FOR  
SENSITIVE VIEW AREA NO. 3**

Landform	H (5)	H/M (4)	M (3)	M/L (2)	<u><b>L (1)</b></u>
Vegetation	H (5)	H/M (4)	M (3)	M/L (2)	<u><b>L (1)</b></u>
Water	H (5)	H/M (4)	M (3)	M/L (2)	<u><b>L (1)</b></u>
Color	H (5)	H/M (4)	M (3)	<u><b>M/L (2)</b></u>	L (1)
Adjacent Scenery	H (5)	H/M (4)	M (3)	<u><b>M/L (2)</b></u>	L (1)
Scarcity	H (5)	H/M (4)	<u><b>M (3)</b></u>	M/L (2)	L (1)
Modifications*	H (2)	H/M (1)	M (0)	<u><b>M/L (-2)</b></u>	L (-4)
Scenic Attractiveness Class C (8)

**Narrative Landscape Description and Photograph.** Sensitive Viewing Area and KOP No. 3 (Figures 5.13-16 and 5.13-18, see also Figure 5.13-1 for KOP location) was taken from the intersection of SR-58 and Tracy Lane looking north-northwest towards the site. This view is representative of the nearest, and therefore worst-case, traveler view along this highway. The terrain, color, vegetation and general form to the area virtually mirrors that of KOPs 1 and 2. However, the zigzag or “Z” shape of the highway in the Project area, offers slight variations in views from the highway in the northern and western directions. Cultural modifications (including the paved highway itself, associated signage, gravel/dirt Tracy Lane, transmission and telephone lines, abandoned farm structures currently on-site surrounded by trees, property fencing, and other surrounding farming/residential structures. Like KOPs 1 and 2, all contrasts to form and line are created from views of distant mountains.

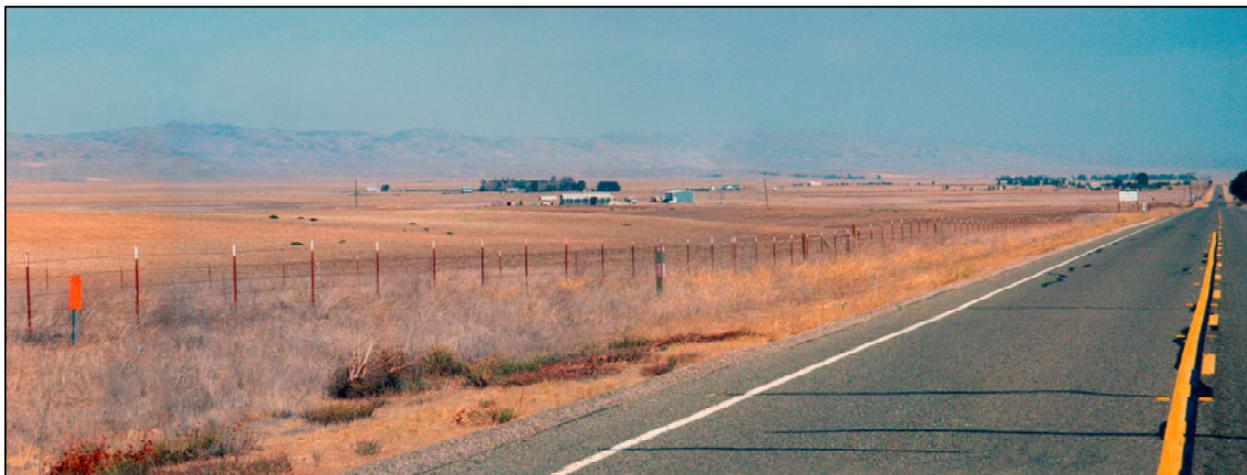
**FIGURE 5.13-11  
SCENIC ATTRACTIVENESS EVALUATION FORM FOR  
SENSITIVE VIEW AREA AND KOP NO. 4**

Landform	H (5)	H/M (4)	<b><u>M (3)</u></b>	M/L (2)	L (1)
Vegetation	H (5)	H/M (4)	M (3)	M/L (2)	<b><u>L (1)</u></b>
Water	H (5)	H/M (4)	M (3)	M/L (2)	<b><u>L (1)</u></b>
Color	H (5)	H/M (4)	M (3)	M/L (2)	<b><u>L (1)</u></b>
Adjacent Scenery	H (5)	H/M (4)	<b><u>M (3)</u></b>	M/L (2)	L (1)
Scarcity	H (5)	H/M (4)	<b><u>M (3)</u></b>	M/L (2)	L (1)
Modifications*	H (2)	H/M (1)	<b><u>M (0)</u></b>	M/L (-2)	L (-4)
Scenic Attractiveness Class B (12)

**Narrative Landscape Description and Photograph.** Sensitive Viewing Area and KOP No. 4 (Figure 5.13-20, see also Figure 5.13-1 for KOP location) was taken approximately 2.5 miles west of the site along SR-58 (west of Bitterwater Road) to represent potential recreational user views from the Hubbard Hill-Freeborn Mountain open space/SRA area as well as elevated traveler views along SR-58. A topographic rise of this area allows for more open, expansive views into the Carrizo Plain. The area east of Hubbard Hill-Freeborn Mountain consists of flat plains lands with distant views of the Temblor Range. The plain is scattered with sparse residential structures and dry-farming/agricultural activities. The mountains in the distant background provide little to form and line characteristics in the area. However a persistent haze, characteristic of the air quality in the area, impairs clarity in distant views. The main visual interest and/or draw for the area is essentially created by the open expanses of land and the panoramic view of grasslands. There is some variety in colors and contrast of the area; however, this is largely created by cultural modifications and is not a dominant scenic element.
