**Final Phase I Environmental Site Assessment
Humboldt Bay Repowering Project**

**FINAL
PHASE I ENVIRONMENTAL SITE ASSESSMENT
Humboldt Bay Re-Powering Project (HBRP)**

Humboldt Bay, California

Prepared by
E2 Consulting Engineers, Inc.
1900 Powell Avenue, Suite 250
Emeryville, CA 94608

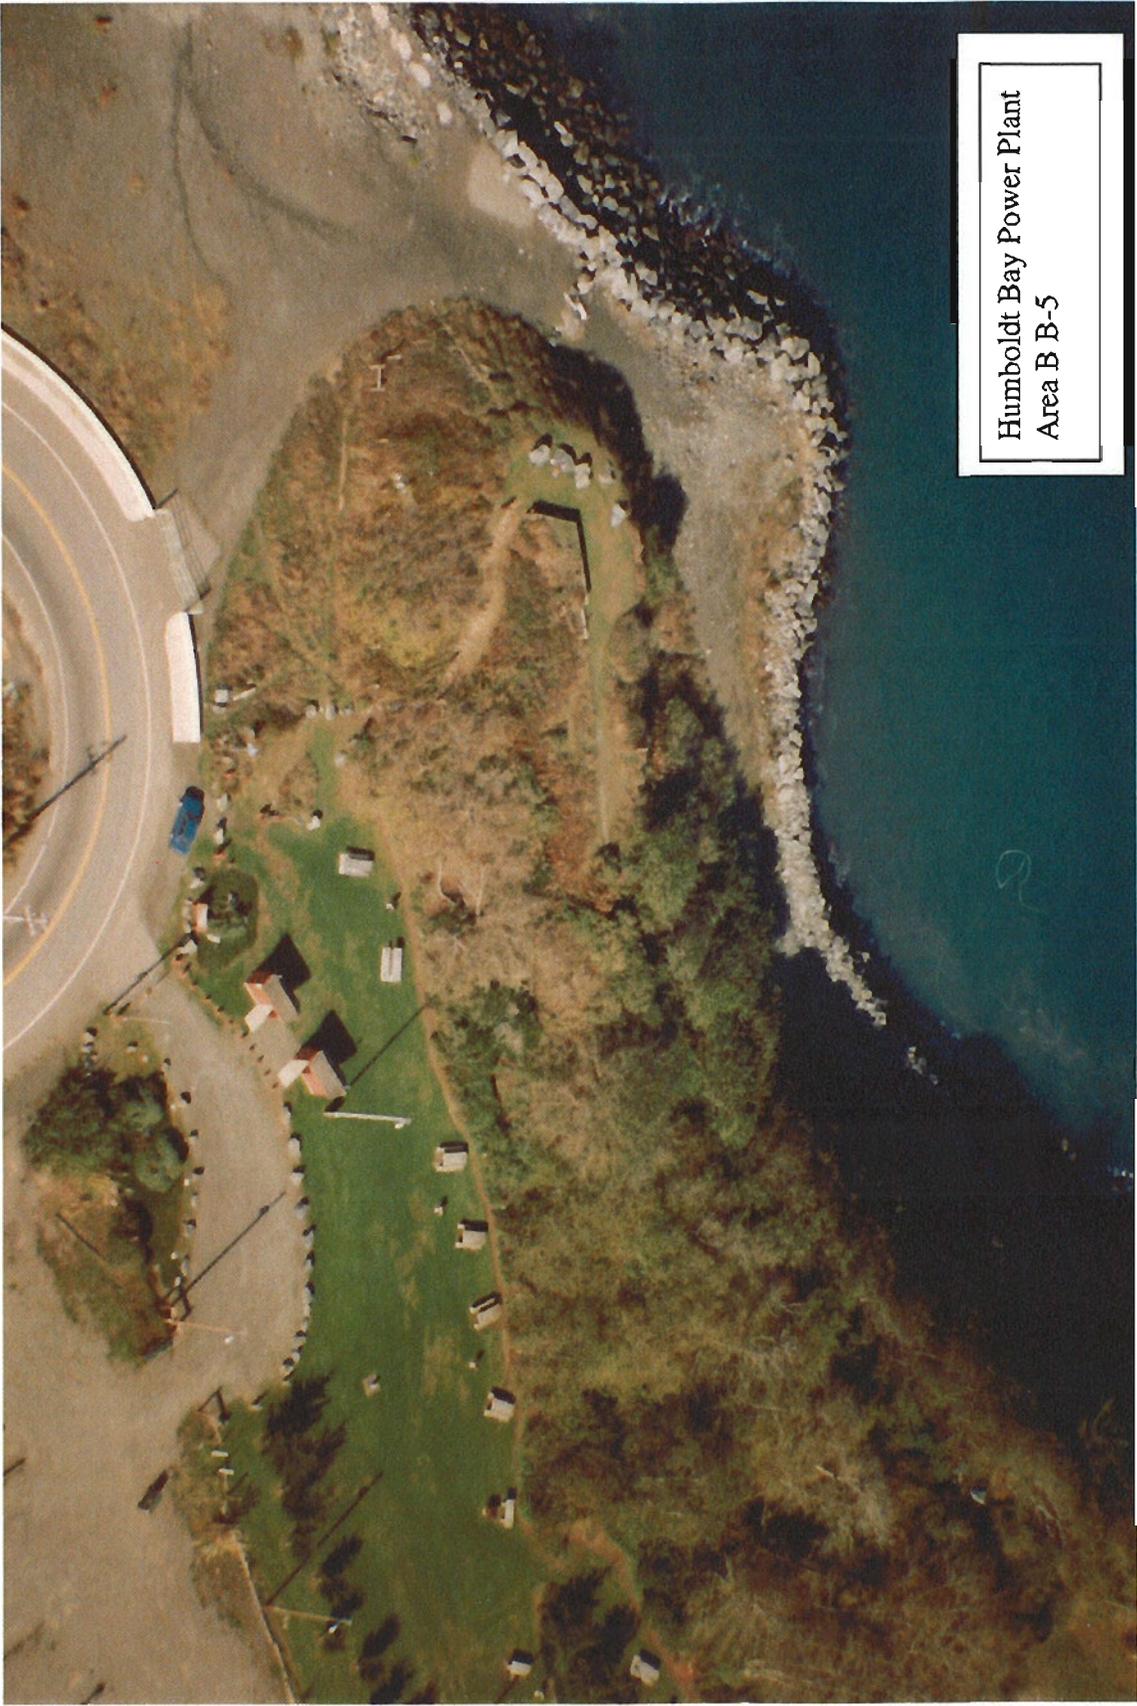
Humboldt Bay Power Plant
Area B B-5

Based on the previous uses (recreational park), visual survey, and future reuse (parking), conditions at Area B, there are not information supporting Recognized Environmental Conditions that could result in risk to human health and the environment.

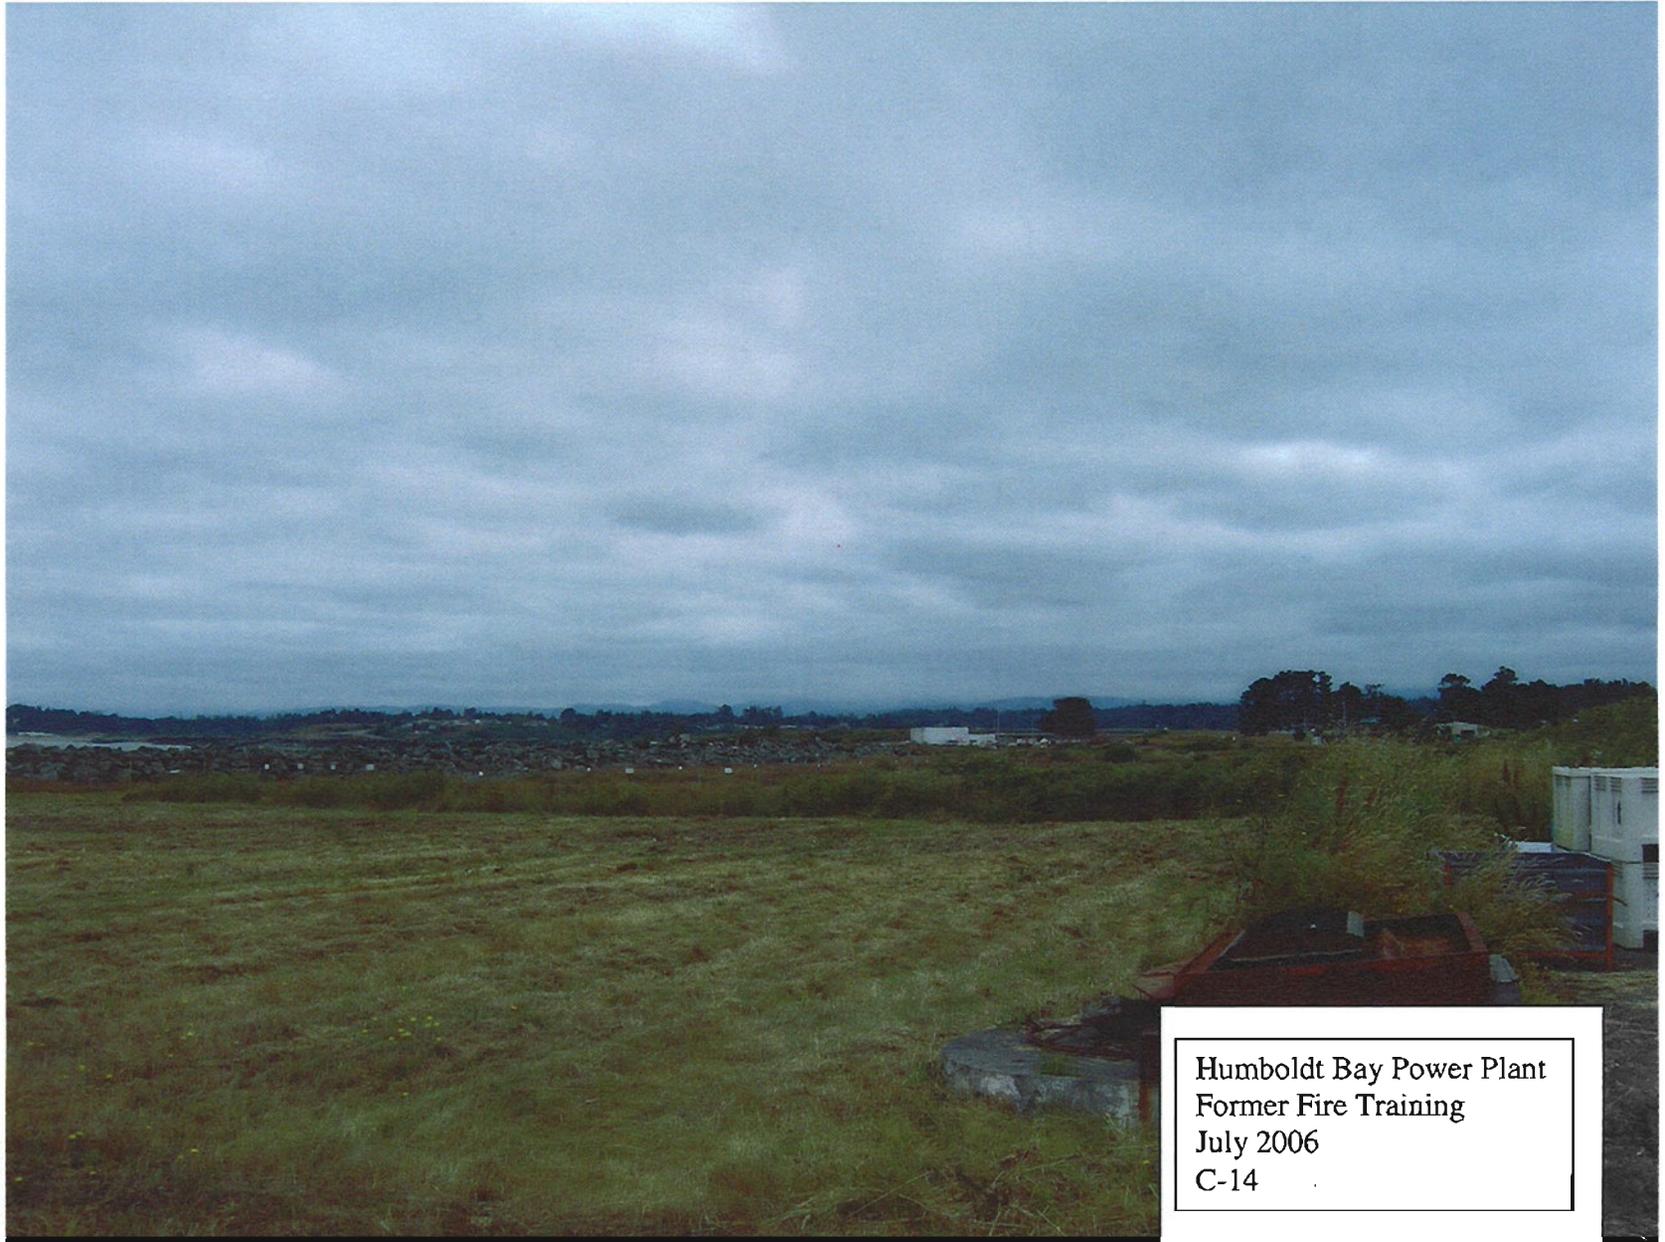
Humboldt Bay Power Plant
Former Fire Training
July 2006
C-14

Past releases from this unit cannot be evaluated due to the lack of information on the Former Fire Training Area and Soil/Seaweed Fill Area. There is information supporting Recognized Environmental Conditions that could (based on land use) result in risk to human health and the environment.

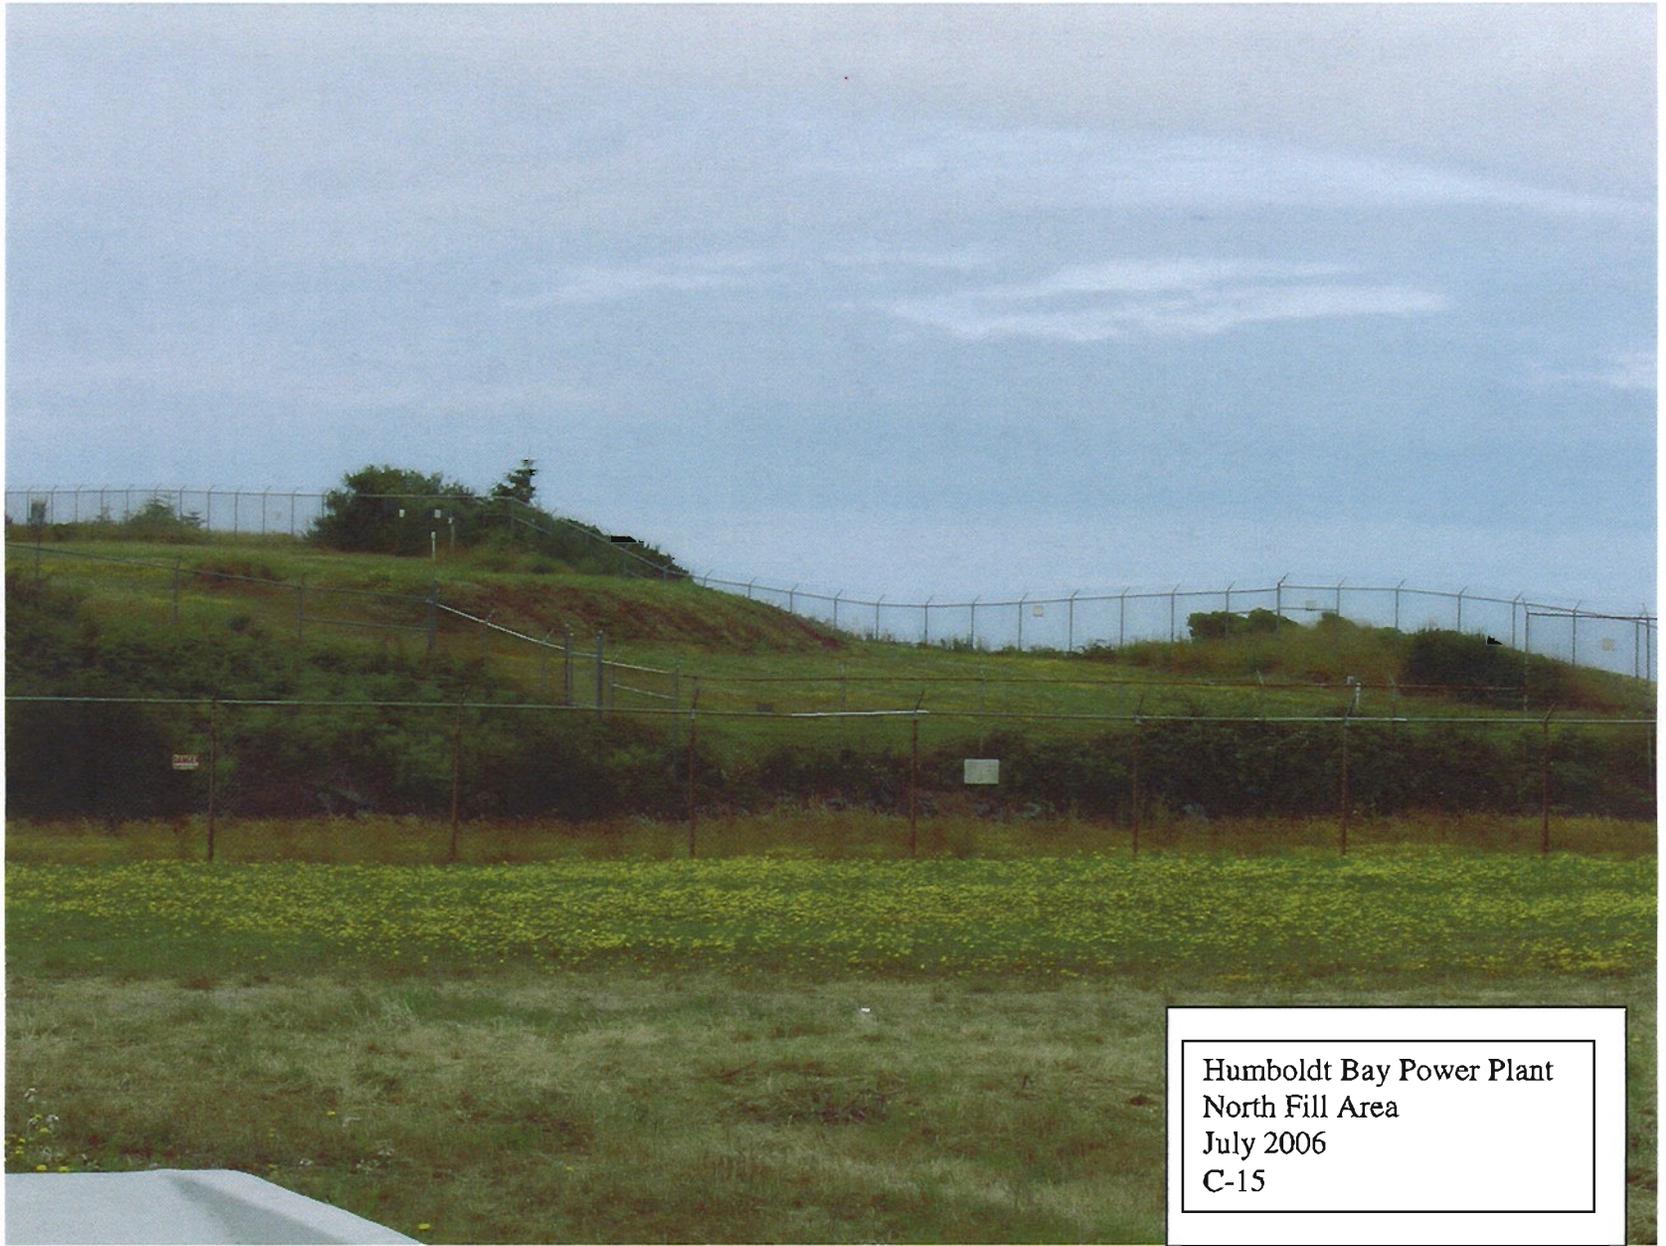
Humboldt Bay Power Plant
North Fill Area
July 2006
C-15

Past releases from this unit cannot be evaluated due to the lack of information of the area. The North Fill Area is not within the boundary of the HBRP but the topography of the area is up gradient of the surface flow to the future site of the HBRP. There is information supporting Recognized Environmental Conditions that could (based on land use) result in risk to human health and the environment.

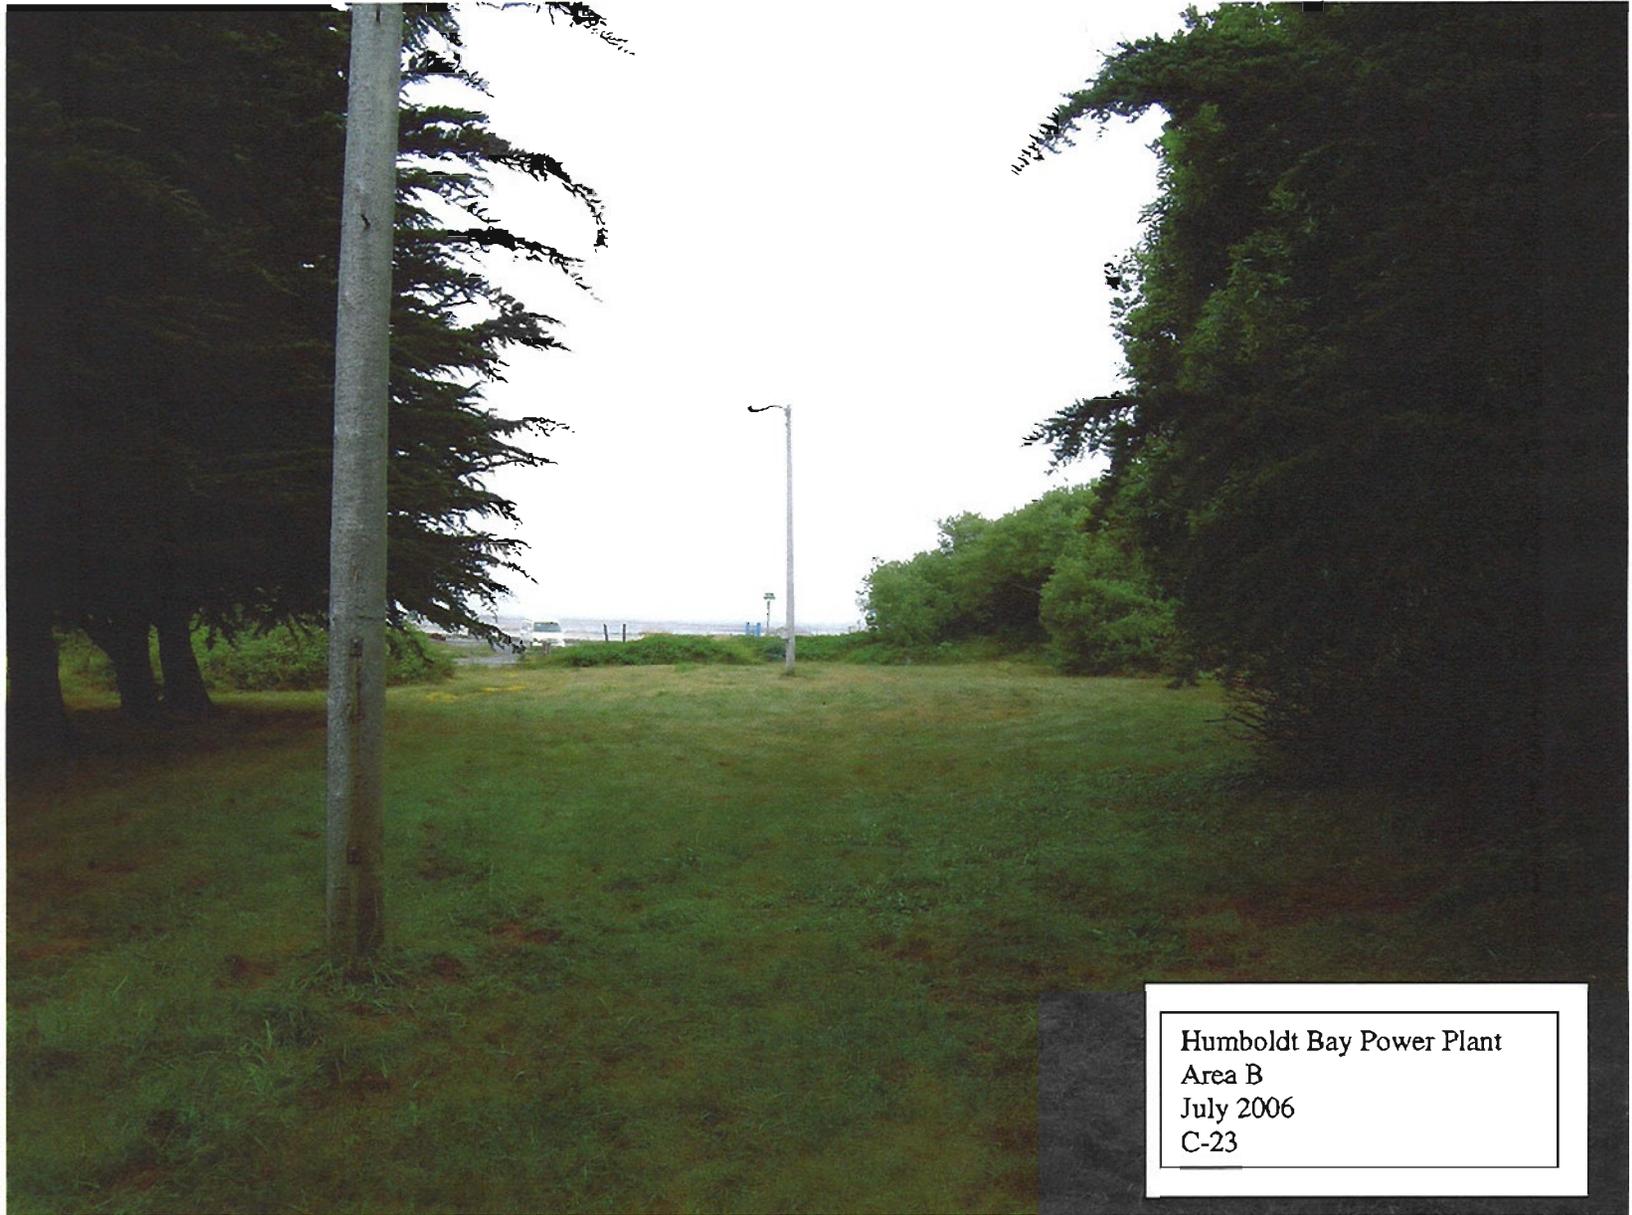
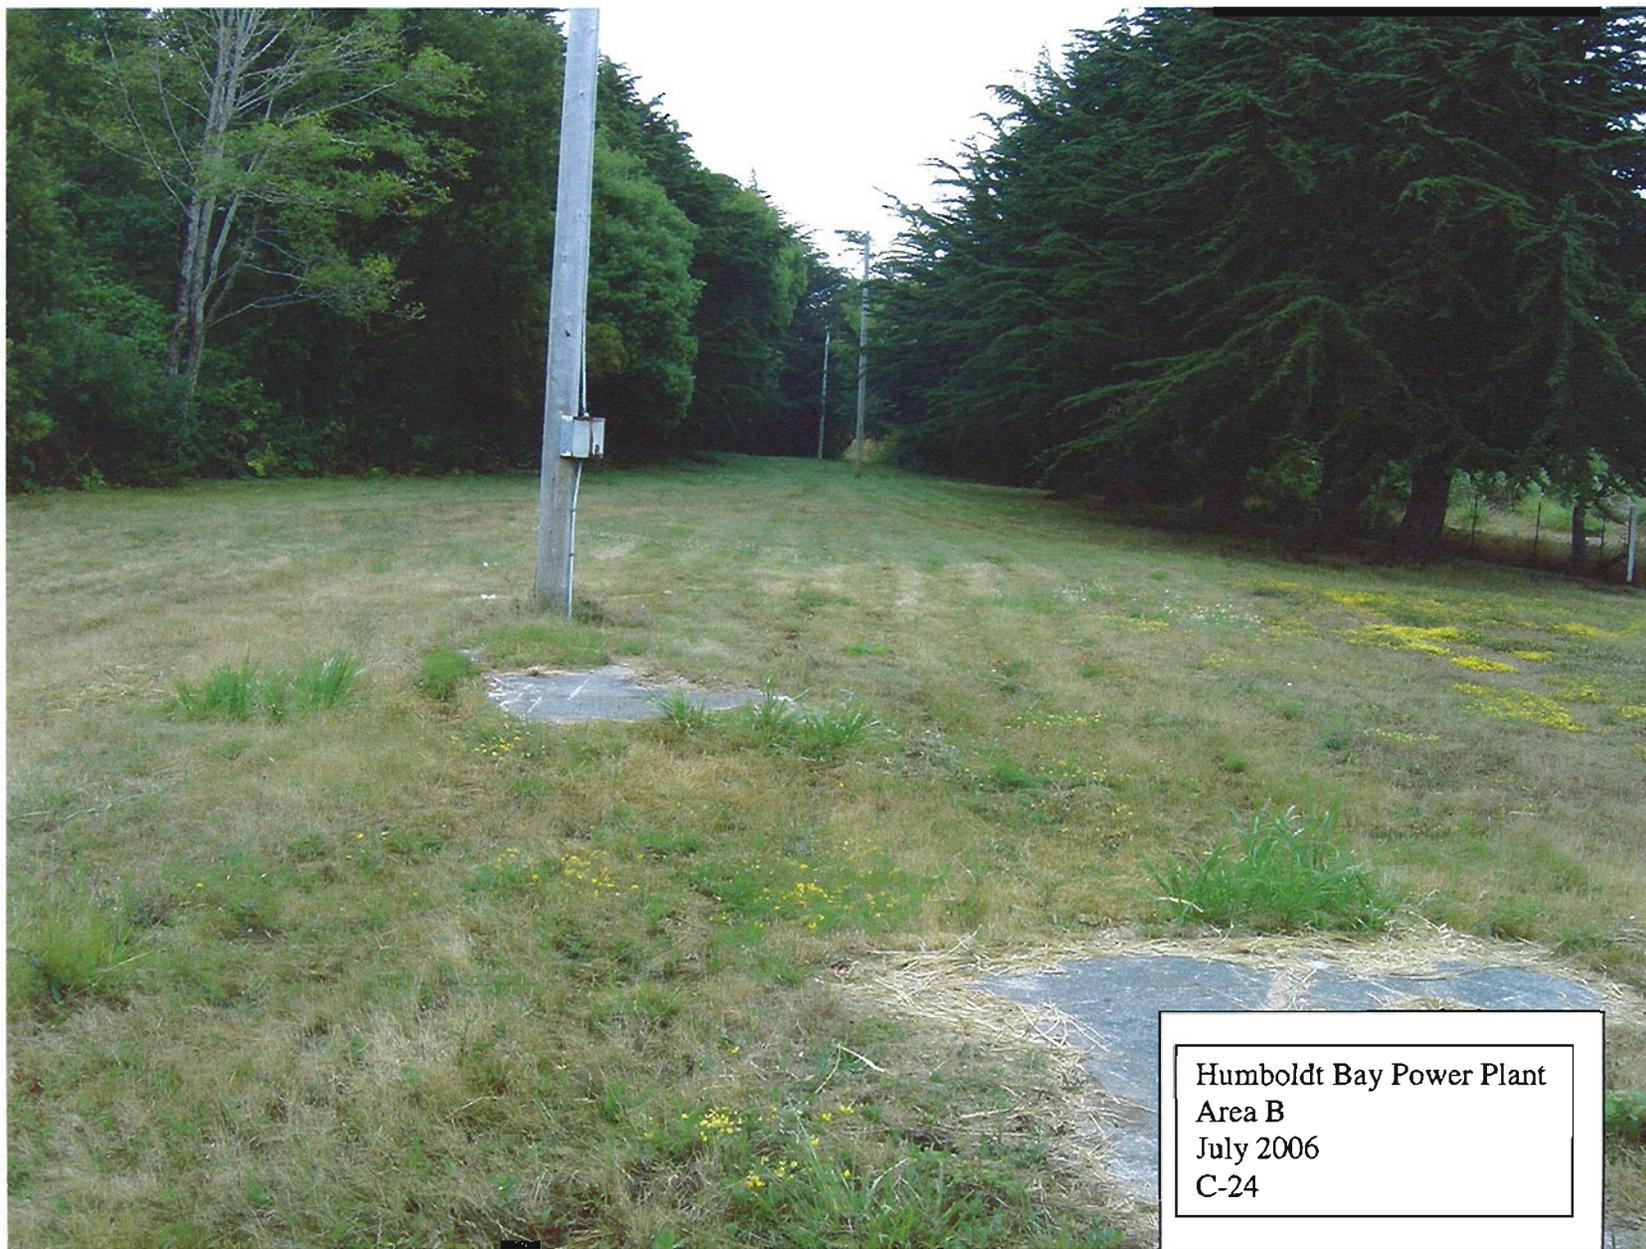
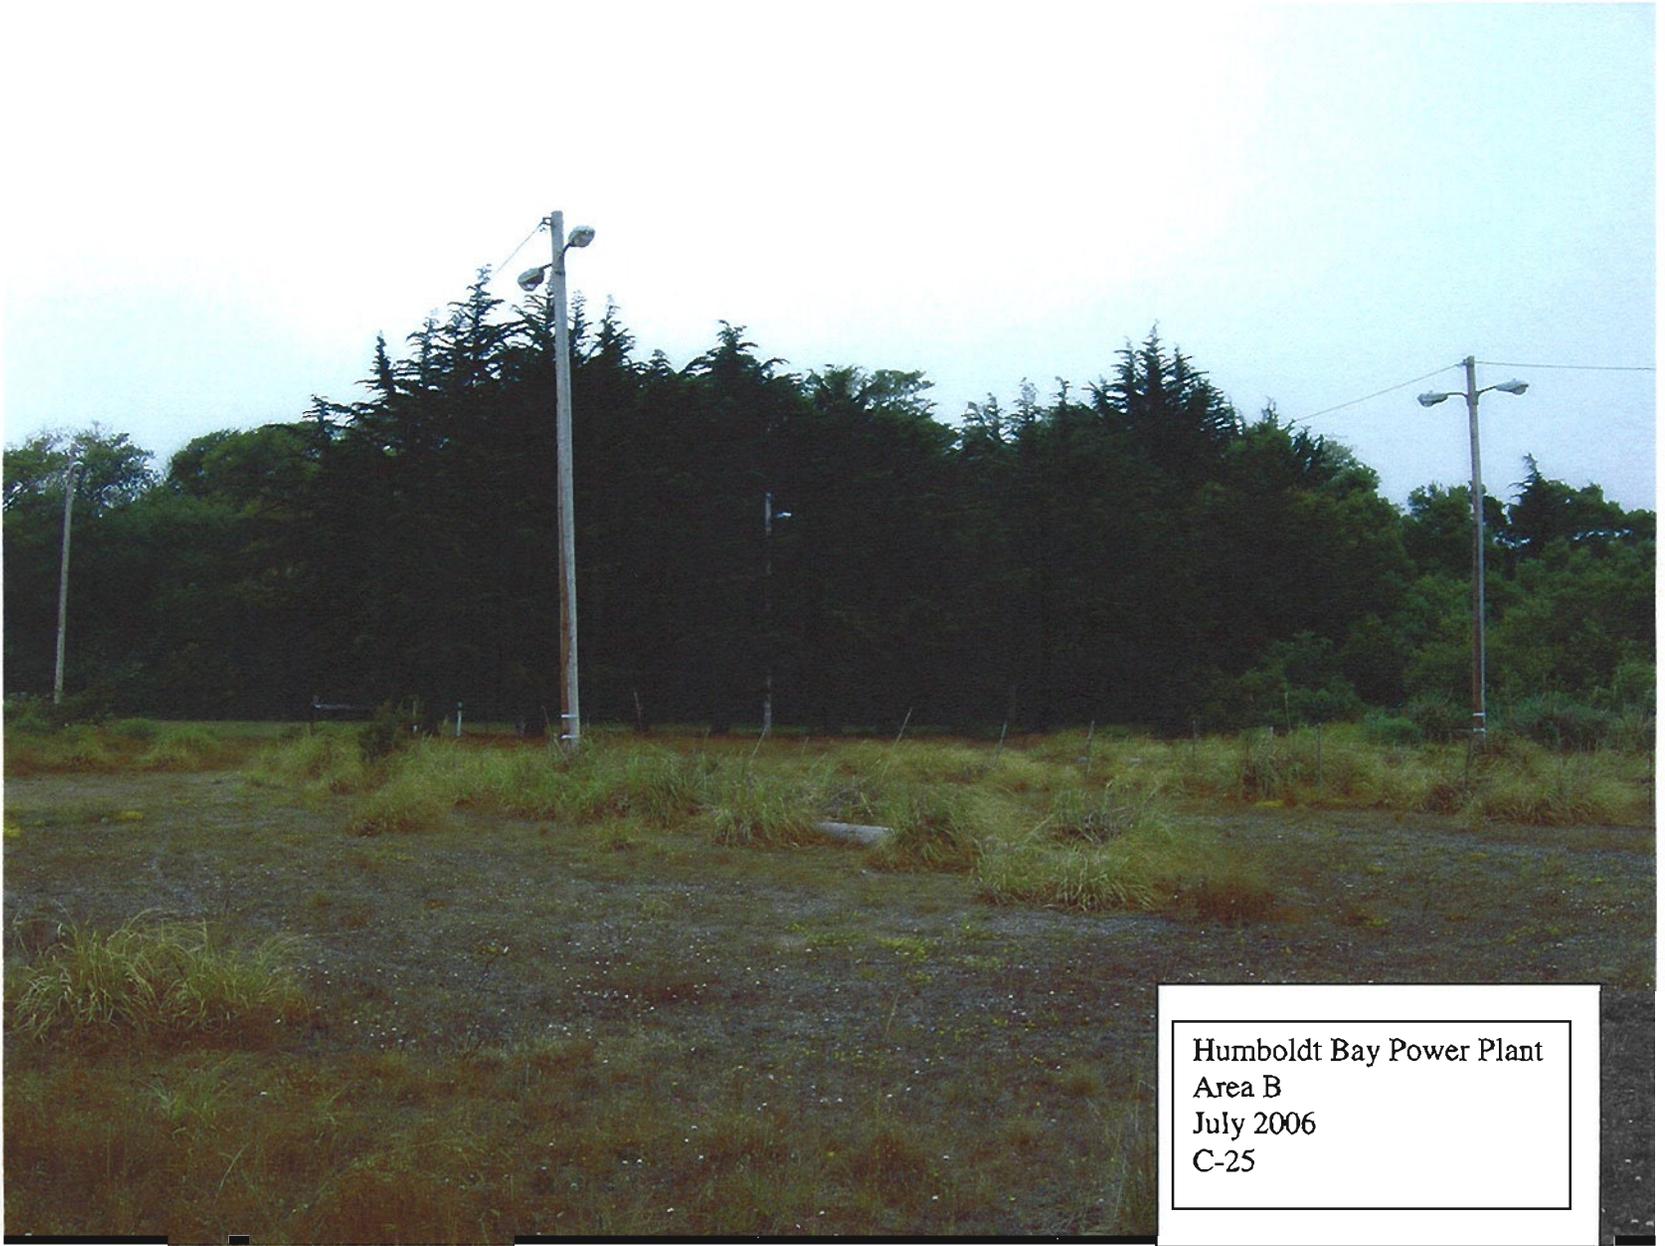
Humboldt Bay Power Plant
Area B
July 2006
C-23

Humboldt Bay Power Plant
Area B
July 2006
C-24

Humboldt Bay Power Plant
Area B
July 2006
C-25
