LOS ESTEROS CRITICAL ENERGY FACILITY: PHASE 2

Condition of Certification WASTE-6 Soils Management Plan

Soils Management Plan Los Esteros Critical Energy Facility: Phase 2

CH2MHILL
2485 Natomas Park Drive, Suite 600
Sacramento, CA 95833

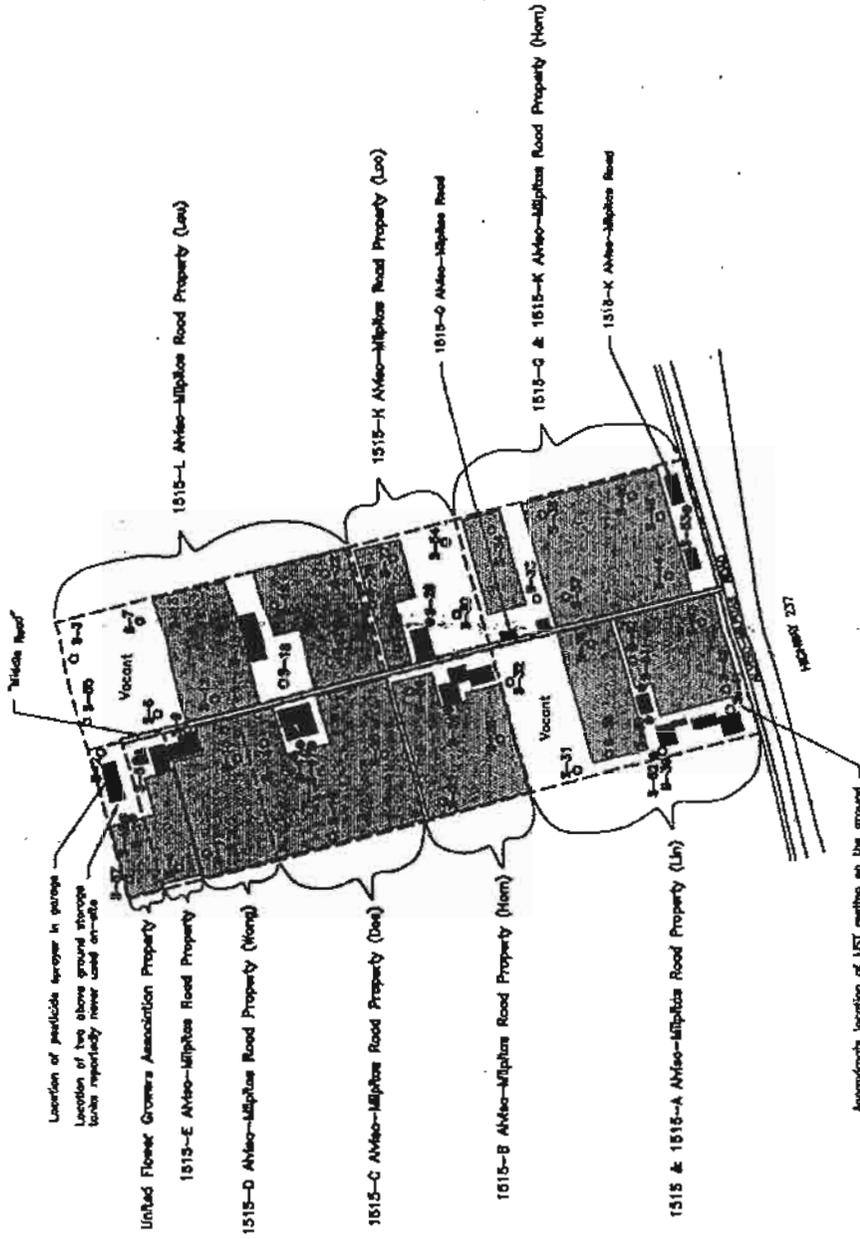
Location of pesticide sprayer in garage
 Location of two above ground storage tanks reportedly never used on-site

Approximate location of UST meeting on the ground

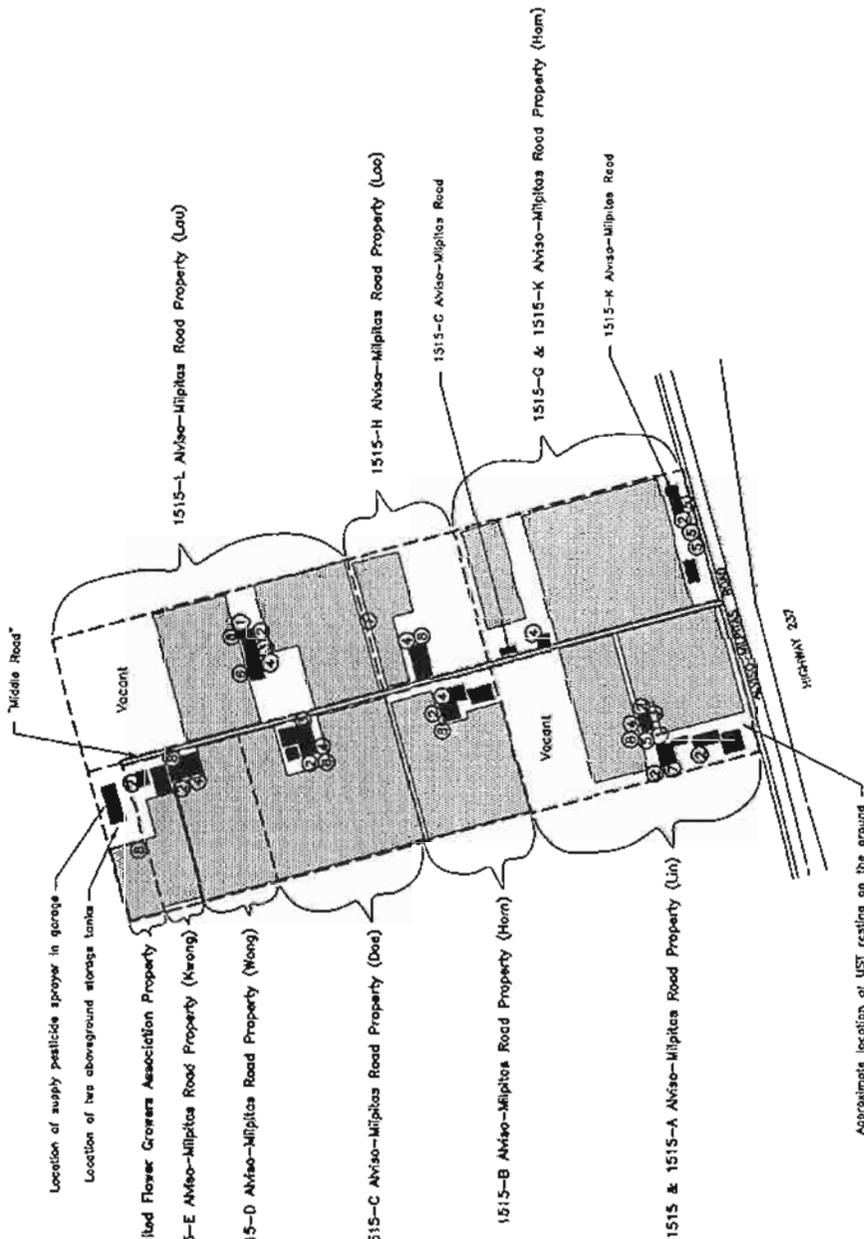
LOWNEY ASSOCIATES
 Environmental/Geotechnical/Engineering Services
 FIGURE 3
 587-12D

SITE PLAN
 HIGHWAY 237/COYOTE CREEK 55-ACRE PARCEL
 San Jose, California

- ① - Approximate location of pole-mounted transformer
- ② - Approximate location of pesticide storage shed
- ③ - Approximate location of diesel UST
- ④ - Approximate location of boiler
- ⑤ - Approximate location of water supply well observed by Lowney Associates
- ⑥ - Approximate location of water supply well reported by others but not observed by Lowney Associates
- ⑦ - Approximate location of gasoline UST
- ⑧ - Approximate location of agricultural chemical mixer

An agricultural chemical storage shed was present approximately 10 feet north of the location of the gasoline UST (Figure 3). The wood-framed and metal-sided storage shed contained several gallon containers of fertilizers and 50-pound bags of dry fertilizers. Several of the containers and bags had been damaged exposing virgin fertilizer to the shelves and dirt flooring within the shed. Although, no pesticides were observed within the shed, a sign posted on the front door of the shed read "Pesticide Storage Area."

A second pesticide storage shed was located approximately 25 feet east of the boiler structure (Figure 3). The shed contained pesticides and herbicides including Subdue fungicide, Botani Gard ES, Mycainsecticide, Mavrik Insecticide, Enstar, Daconil, 2787 WDG, Phyton 27, and Micro Lin. The agricultural chemicals were stored within the shed on shelving, in containers no larger than 1 gallon or 5 pounds. A pesticide mixer was observed in the shed and appeared empty. Metal piping ran from the pesticide mixer into the surrounding greenhouses. The dirt floor of the pesticide shed appeared to have been impacted with agricultural chemicals.

The wood floored pesticide storage and mixing shed was located adjacent to the northwest of the boiler structure (Figure 3). Less than 5 pounds of pesticides (Dispel 2x) were observed to be stored on shelving within the shed. A pesticide mixer was located in the center of the shed. The mixer was empty and rested directly on the wood floor of the shed. Metal piping ran from the mixer to the greenhouses adjacent to the west.

The approximately 6-acre property was occupied by a living quarters, boiler and water tank structure, pesticide storage and mixing shed, and greenhouses (Figure 3). The approximately 12,000-square-foot, wood framed and metal sided living quarters was located on the west side of the middle road and reportedly contained 10 bedrooms. Observations of the interior of the living quarters were not made. The southeastern corner of the living quarters contained a concrete floored garage. A vehicle, tractor, and household items including clothing, furniture, and trash were observed in the garage area.

The concrete-floored, wood framed and metal-sided boiler structure was located near the northwestern corner of the property, near the middle road (Figure 3). The natural gas fueled, metal boiler tank was mounted on a metal stand; a metal water return tank was located adjacent to the east. The southern side of the boiler structure contained a single roomed living quarters. A 5-gallon bucket of apparent gear lube was observed on the south side of the boiler structure. The greenhouses were located adjacent to the east of the boiler structure. Mr. Tuck Lin reported that the greenhouses were currently used to grow mushrooms. No pesticides were reportedly used on the mushrooms within the greenhouses. The greenhouses appeared to be in poor condition and some areas had collapsed.

Two active water supply wells, one reportedly inactive water supply well, and an apparent water AST were observed on the southern portion of the property along Alviso-Milpitas Road (Figure 3). One of the water supply wells was located approximately 40 feet west of the 1515-K Alviso-Milpitas Road living quarters structure; metal and PVC piping ran from the well to the apparent water AST which was located approximately five feet to the north of the well. The second active water supply well was located approximately 50 feet west of the first. The well had metal and PVC piping extending to the apparent water tank. The inactive water supply well was observed approximately 25 feet south of the un-numbered living quarters located along Alviso-Milpitas Road. The apparent well was located adjacent to a 4-foot by 4-foot wooden shed that contained two empty 55-gallon drums. No cover was observed on the well; a tape measure was used to determine that the well was open to a depth greater than 25 feet.

Ms. Elizabeth Lin and Mr. Wilson Doe reported that a diesel UST was located on the southern side of the boiler structure (Figure 3). A vent pipe apparently associated with the UST was observed on the southern side of the boiler structure.

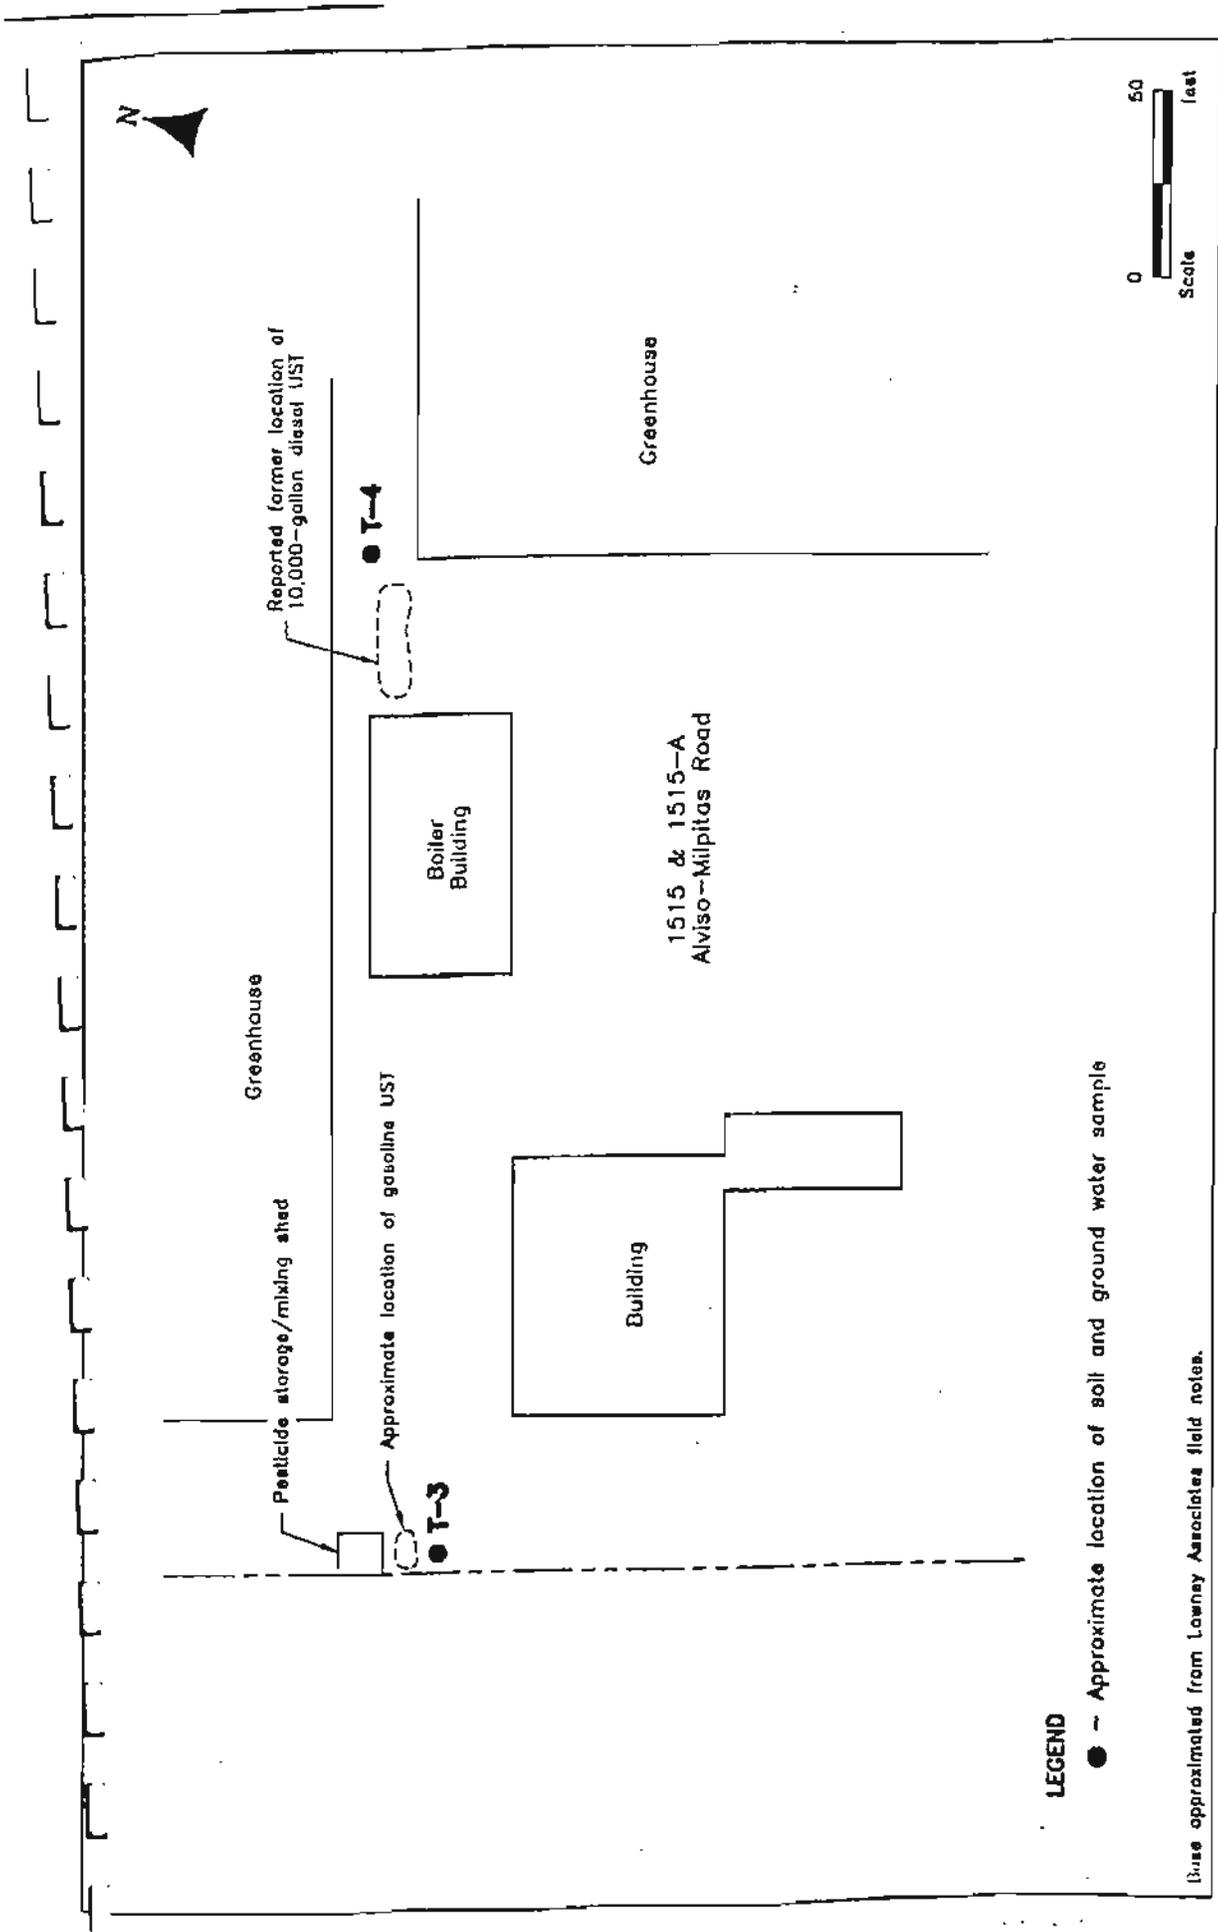
LEGEND

● - Approximate location of soil and ground water sample

SITE PLAN
55-ACRE LIN/HOM PROPERTY
 San Jose, California

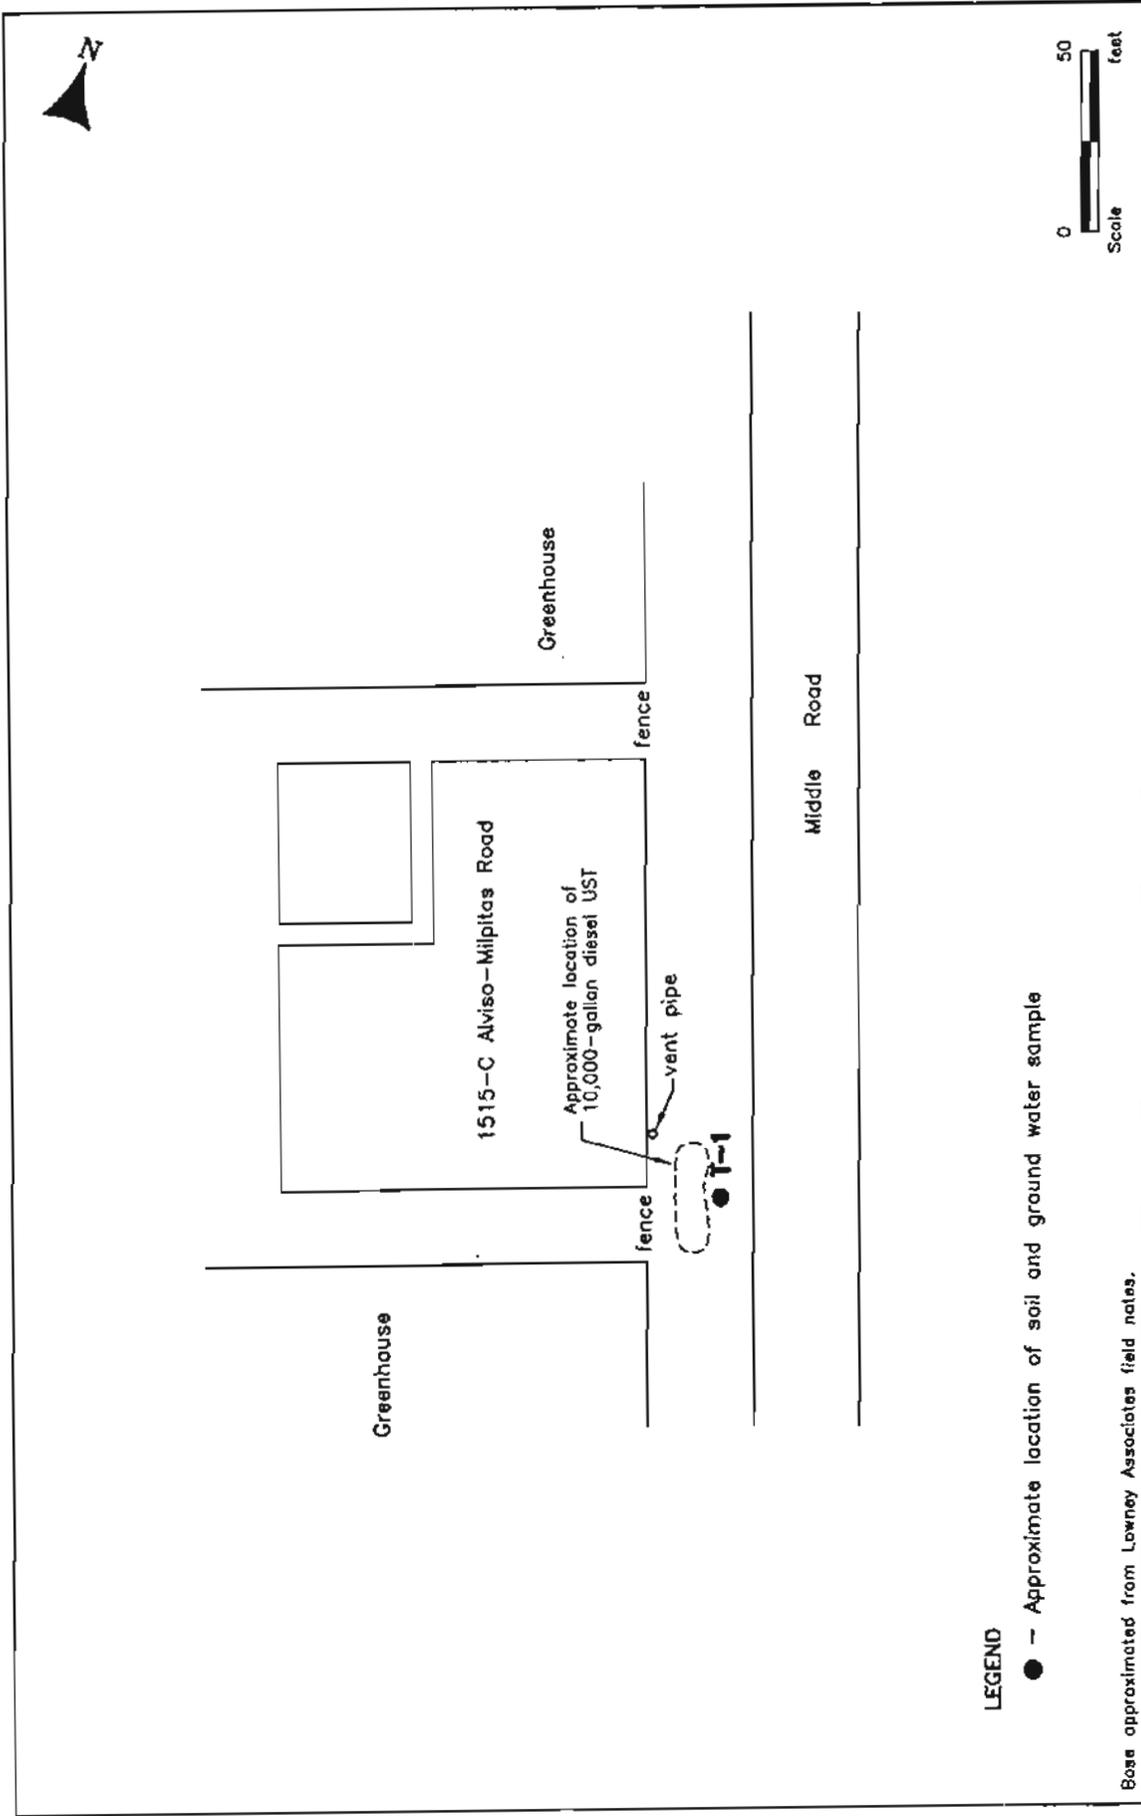
FIGURE 5
587-12F

LEGEND

- - Approximate location of soil and ground water sample

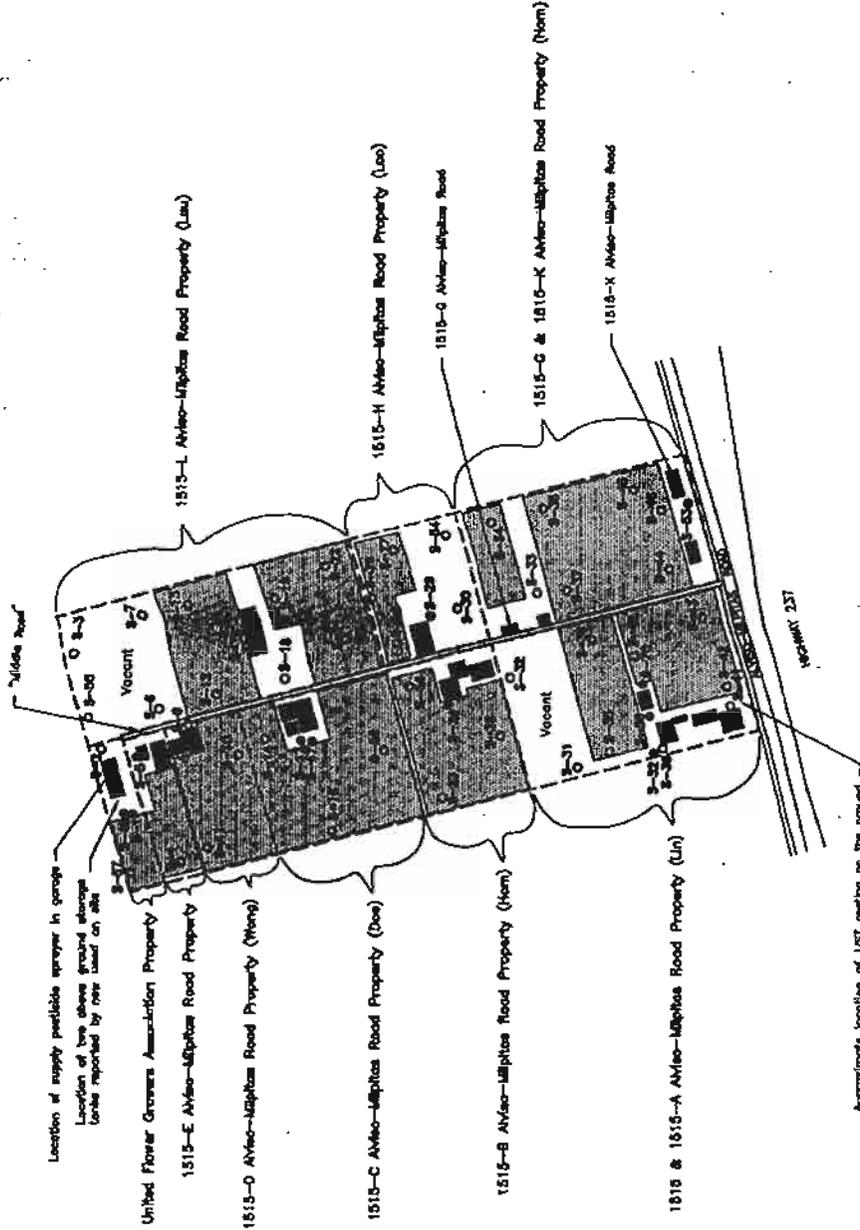
LEGEND

- - Approximate location of greenhouse area/former agricultural area soil sample
- - Approximate location of pesticide mixing/storage area soil sample and ground water sample (if applicable)
- ▨ - Approximate location of on-site greenhouse/nursery
- - Approximate location of on-site structures

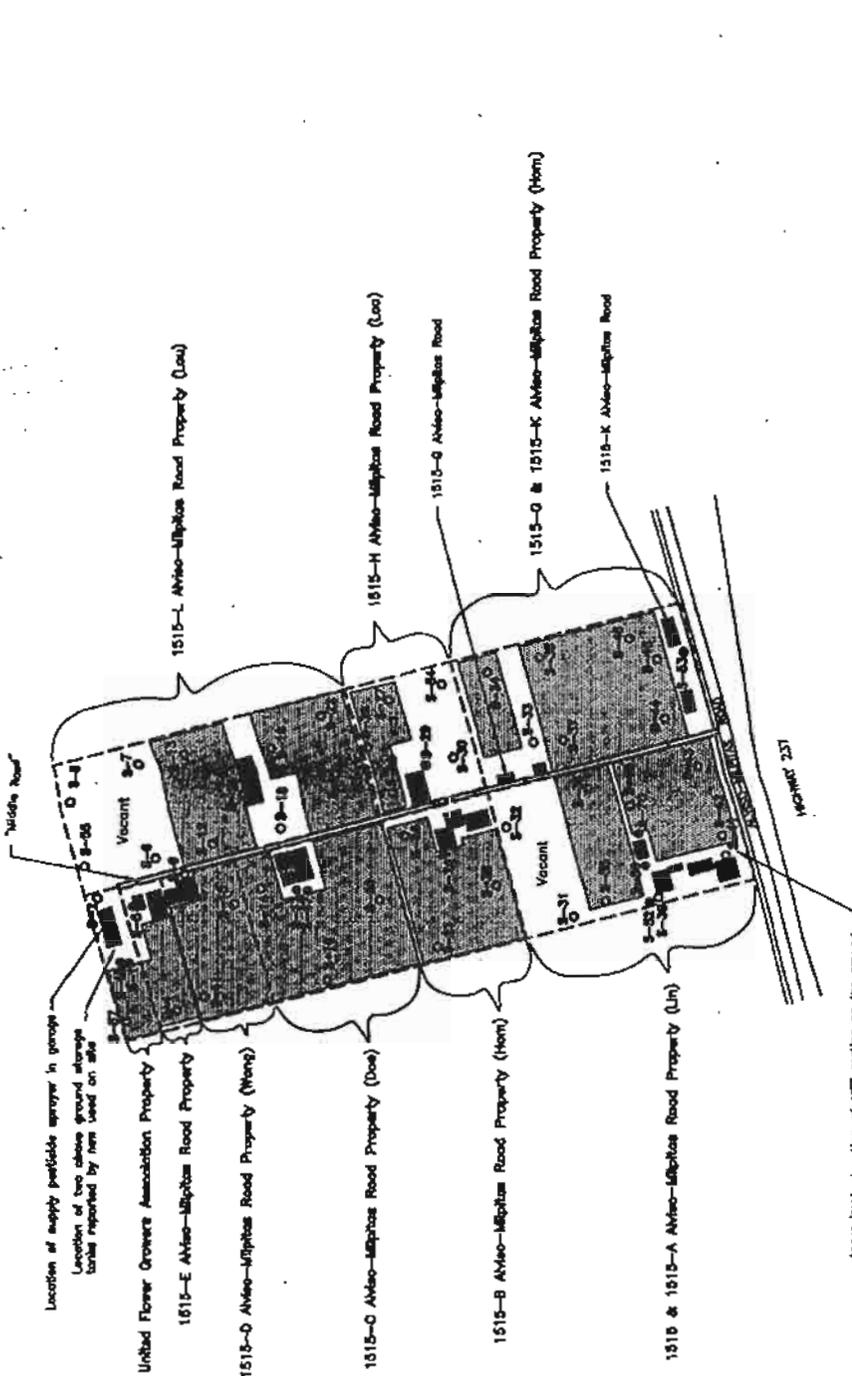
Location of supply pesticide sprayer in garage
 Location of two above ground storage tanks reported by firm used on site

- - Approximate location of greenhouse area/former agricultural area soil sample
- - Approximate location of pesticide mixing/storage area soil sample and ground water sample (if applicable)
- - Approximate location of on-site greenhouse/nursery
- - Approximate location of on-site structures
