APPENDIX 6.5-B
JURISDICTIONAL WATERS AND WETLAND DELINEATION REPORT

Jurisdictional Waters and Wetland Delineation

Orange Grove Project

April 2008

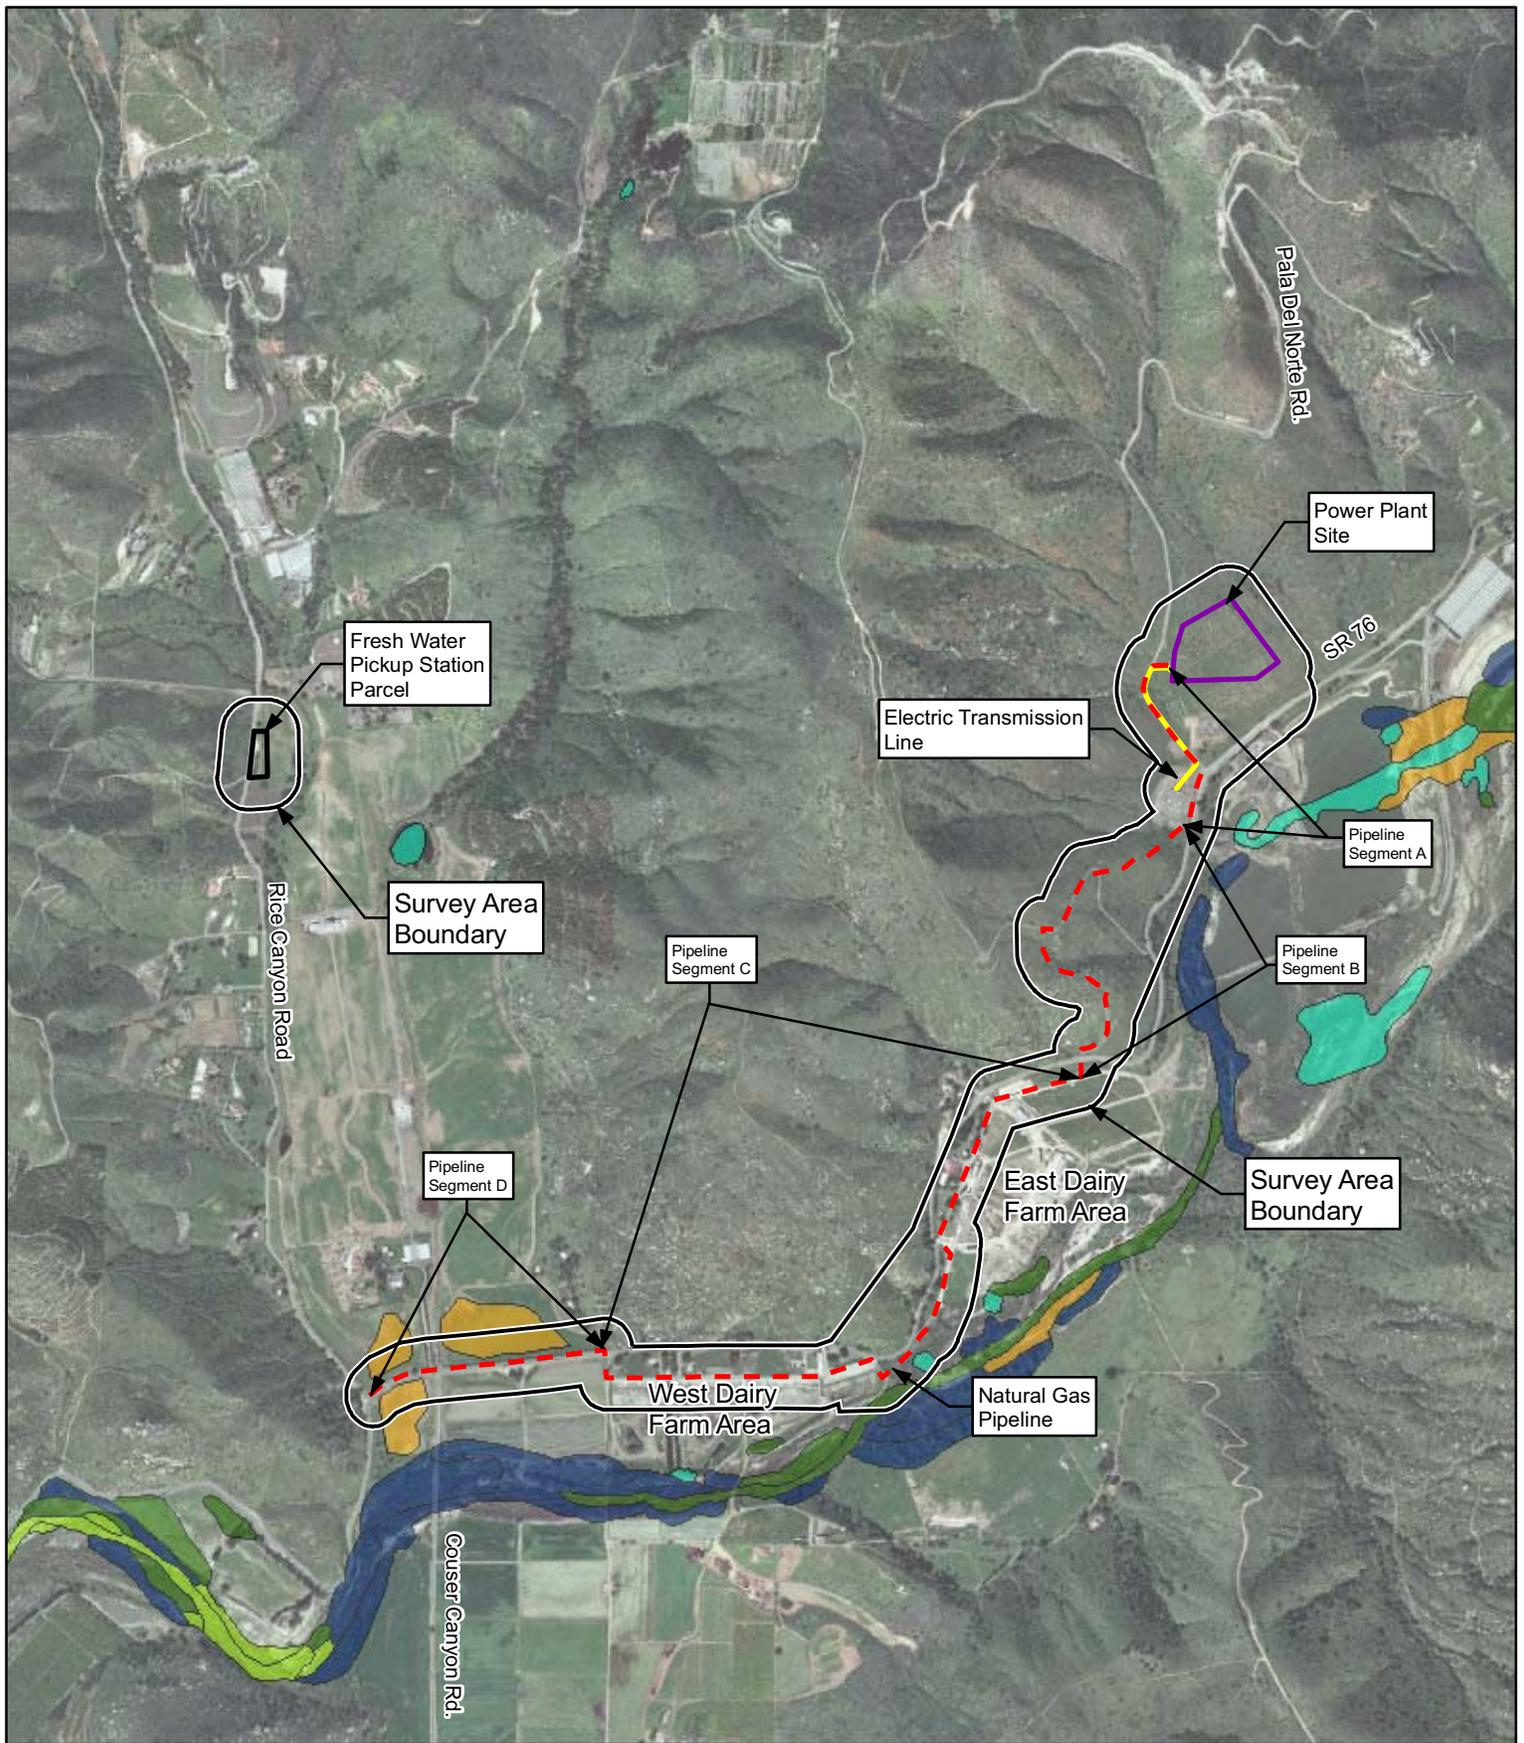
Source:
Aerial Photography from ESRI Imagery_World_2D
Wetlands data from National Wetlands Inventory (<http://www.fws.gov/nwi/>)
USGS Topographical Quadrangles: Pala, Bonsall

The NWI mapping identifies three areas of "Other Wetland" within the Survey Area along SR 76 adjacent to pipeline Segment D (Attachment A, Figure 6, Sheet 3). These three areas are identified by the NWI as Palustrine wetlands. Landowner permission was not granted to survey these areas. Therefore, observations were made from SR 76, Couser Canyon Road, and Rice Canyon Road. The two areas north of SR 76 are mapped as Agriculture (Holland classification 18000) and were observed as being actively maintained agricultural fields currently utilized for grazing. There were no visible signs of wetland hydrology or vegetation from the roads. Based on the absence of these indicators, the two NWI-mapped wetlands north of SR 76 are not considered likely to be Corps jurisdictional wetlands. The area south of SR 76 is also mapped as Agriculture and appears to be an actively maintained field, but fallowed at the time of field studies. Vegetation observed in this area during the plant blooming period included non-native

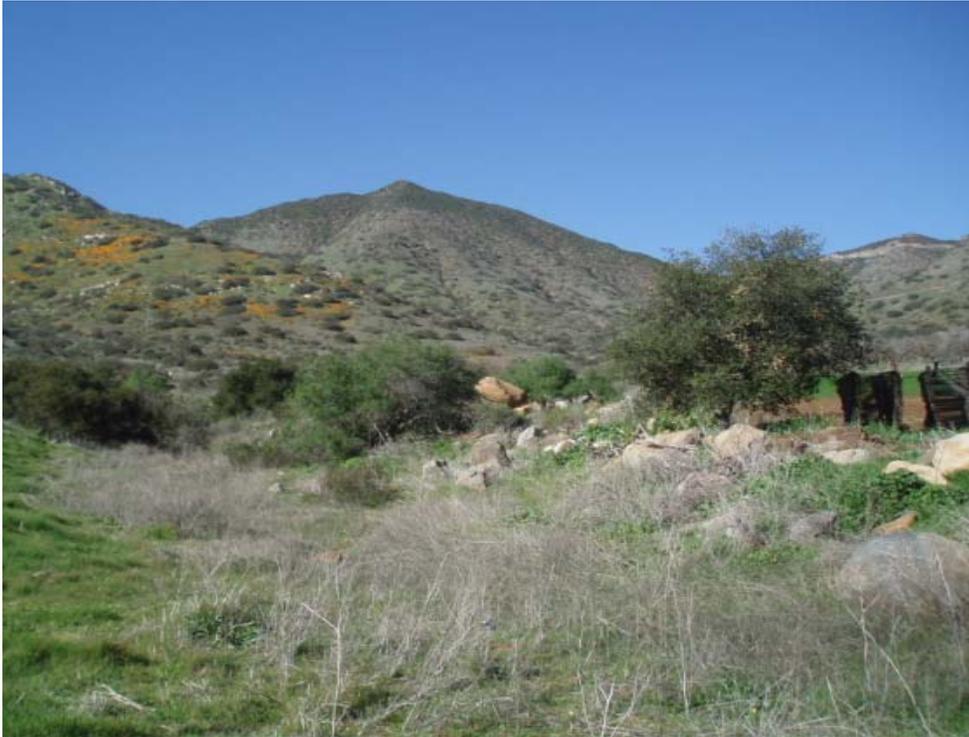
PS 1 – Drainage 1 north of SR 76, facing northwest (upstream). Taken on 2/12/08.

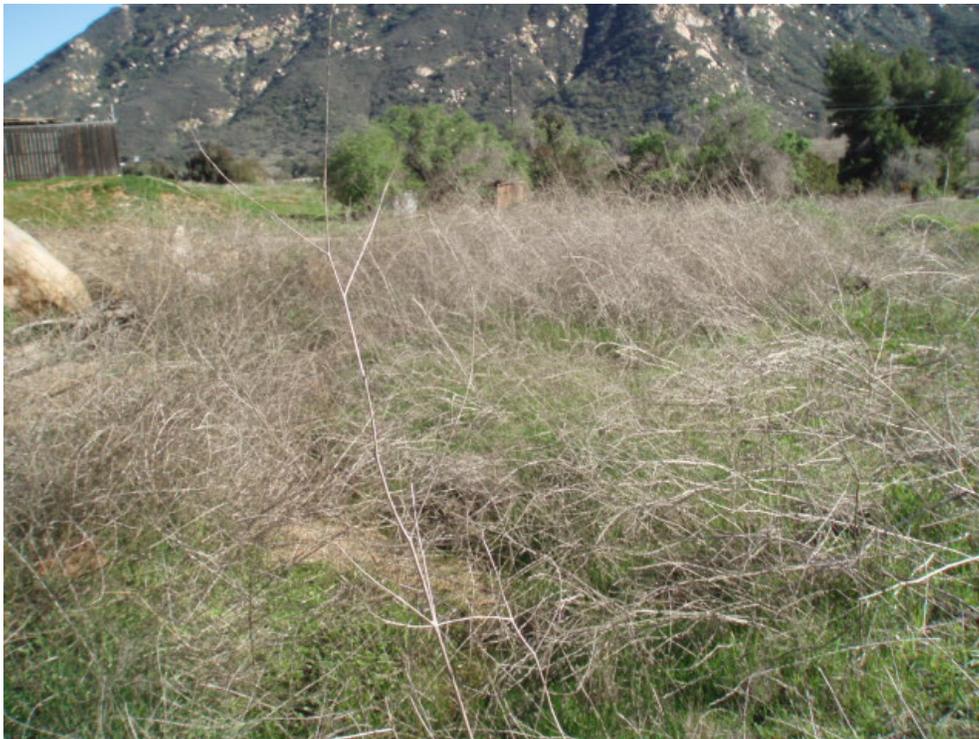
PS 2 – Drainage 1 north of SR 76, facing southeast (downstream). Taken on 2/12/08.

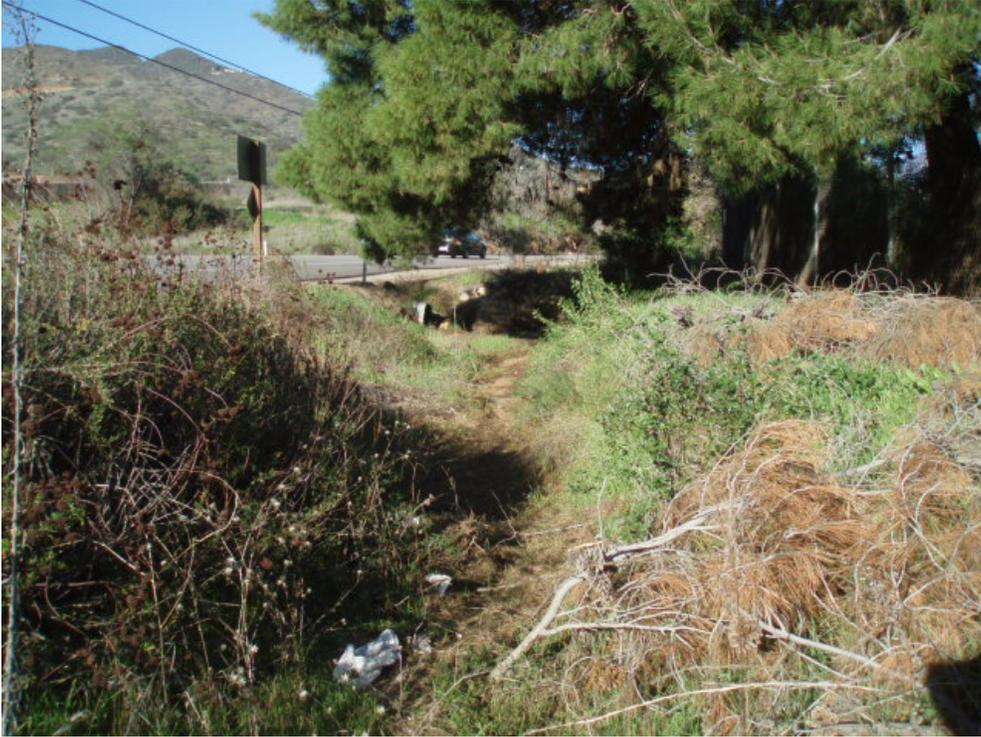
PS 3 - Drainage 1 south of SR 76 (channelized ditch), facing northeast (upstream). Taken on 2/12/08.

Data Point south of SR 76: This data point was taken just south of the culvert under SR 76. Dominant species were noted as storksbill filaree (*Erodium cicutarium*) (non-native, no wetland indicator status) in the herb stratum and California buckwheat (*Eriogonum fasciculatum*) (native, no wetland indicator status) in the shrub stratum. Sediment deposits were observed, but no hydric soils or hydrophytic vegetation were found at the data point. Based on these observations, the drainage was not characterized as a wetland. The width of “waters of the U.S.” was measured as 2 feet and “waters of the State” as 7 feet.

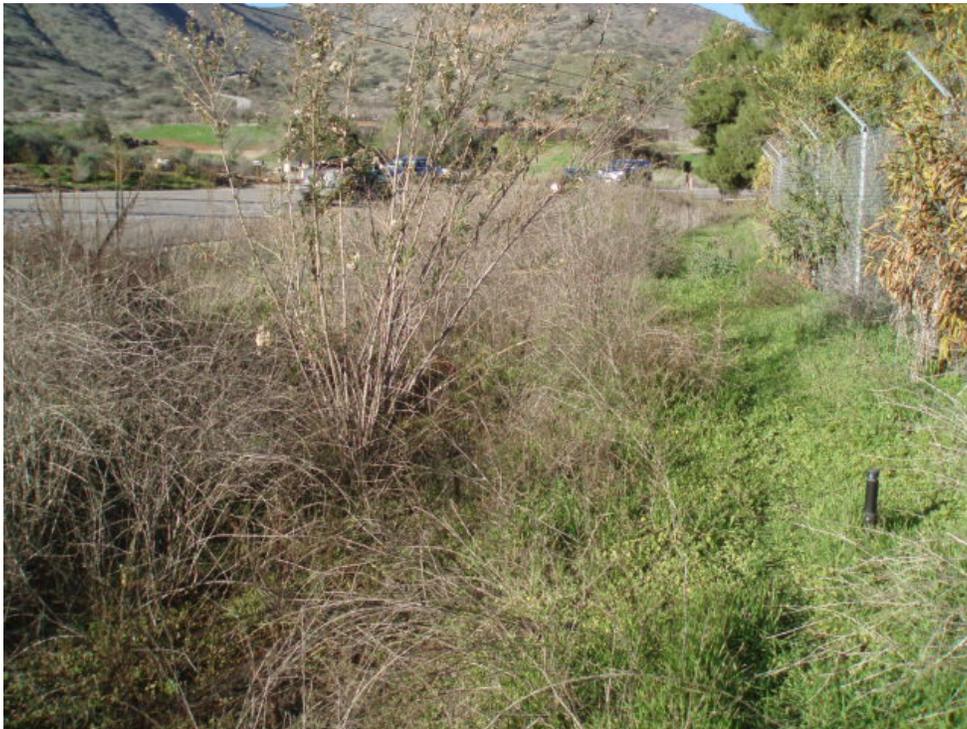
PS 4 – Drainage 1 south of SR 76 near terminus, facing northeast (upstream). Taken on 2/12/08.

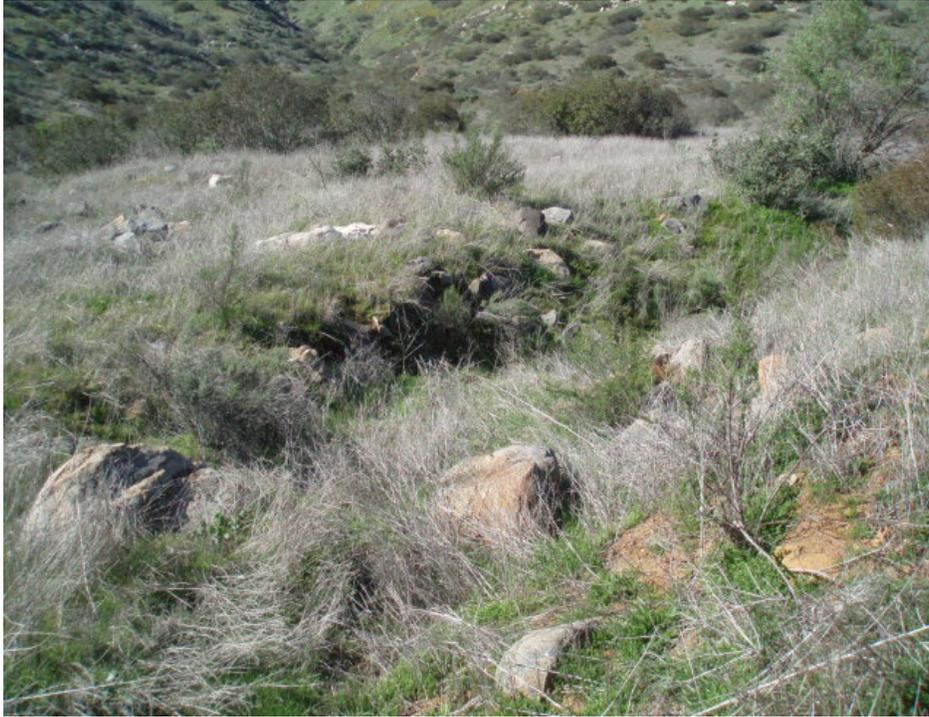
PS 5 – Tributary 1.1 upstream of Pala Del Norte Road, facing northwest. Taken on 2/7/08.

Data Point within tributary 1.1: Dominant vegetation consisted of wild mustard, storksbill filaree, common fiddleneck and scarlet pimpernel (*Anagallis arvensis*) (non-native, FAC) within coastal sage scrub habitat. Free water was noted in a pit at 6 inches deep and soil saturation was noted within 1.5 inches of the surface, but no hydric soils or hydrophytic

vegetation were found at this data point. Based on these observations, the drainage was not characterized as a wetland. The width of “waters of the U.S.” was measured at 2 feet 2 inches and “waters of the State” as 13 feet 5 inches. This tributary flows through a culvert beneath Pala Del Norte Road upstream of the confluence with Drainage 1.

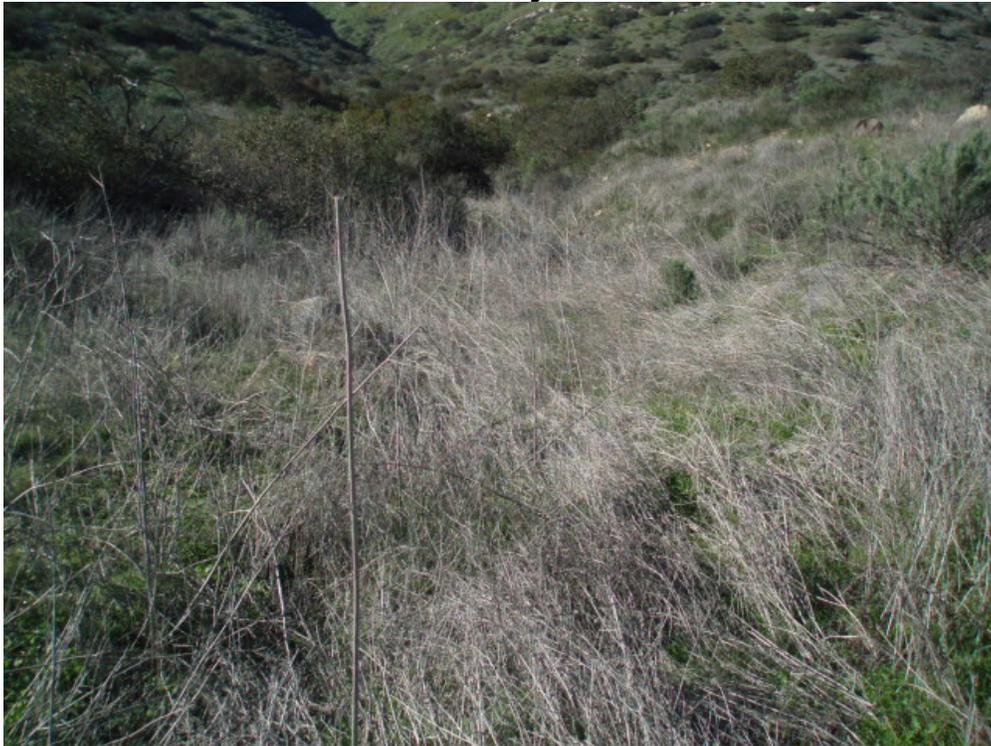
PS 6 – Tributary 1.2 upstream of Pala Del Norte Road, facing northwest. Taken on 2/7/08.

Data Point within tributary 1.2: Dominant vegetation consisted of non-hydrophytic vegetation including storksbill filaree and thistle (*Cirsium* sp., likely *C. vulgare*) (native, no wetland indicator status) within coastal sage scrub habitat. Surface inundation, sediment deposits, and saturated soils in the upper 12 inches (at 0 inches) were observed, but no hydric soils or hydrophytic vegetation were found at this data point. Based on these observations, the drainage was not characterized as a wetland. The width of “waters of the U.S.” was measured at 1 foot 9 inches and “waters of the State” as 2 feet 8 inches. This tributary flows through a culvert beneath Pala Del Norte Road upstream of the confluence with Drainage 1.

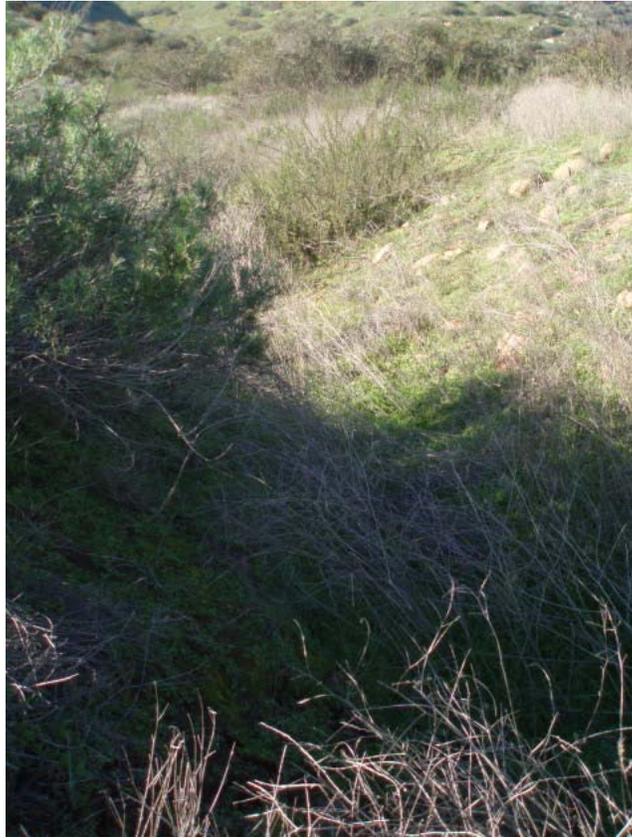
PS 7 – Tributary 1.3 upstream of Pala Del Norte Road, facing northwest. Taken on 2/7/08.

Data Point within tributary 1.3: Dominant vegetation consisted of non-hydrophytic vegetation including wild mustard and storksbill filaree within coastal sage scrub habitat. Saturated conditions were observed in the upper 12 inches of soil (within 2 inches), but no hydric soils or hydrophytic vegetation were found at this data point. Based on these observations, the drainage was not characterized as a wetland. The width of “waters of the U.S.” was measured at 2 feet 6 inches and “waters of the State” as 19 feet 5 inches. This tributary flows through a culvert beneath Pala Del Norte Road upstream of the confluence with Drainage 1. An additional topographic low point was also investigated approximately parallel to tributary 1.1 to the southwest. This low point was determined to lack signs of hydrology or a defined bed and bank, and therefore was not considered a jurisdictional water or wetland.

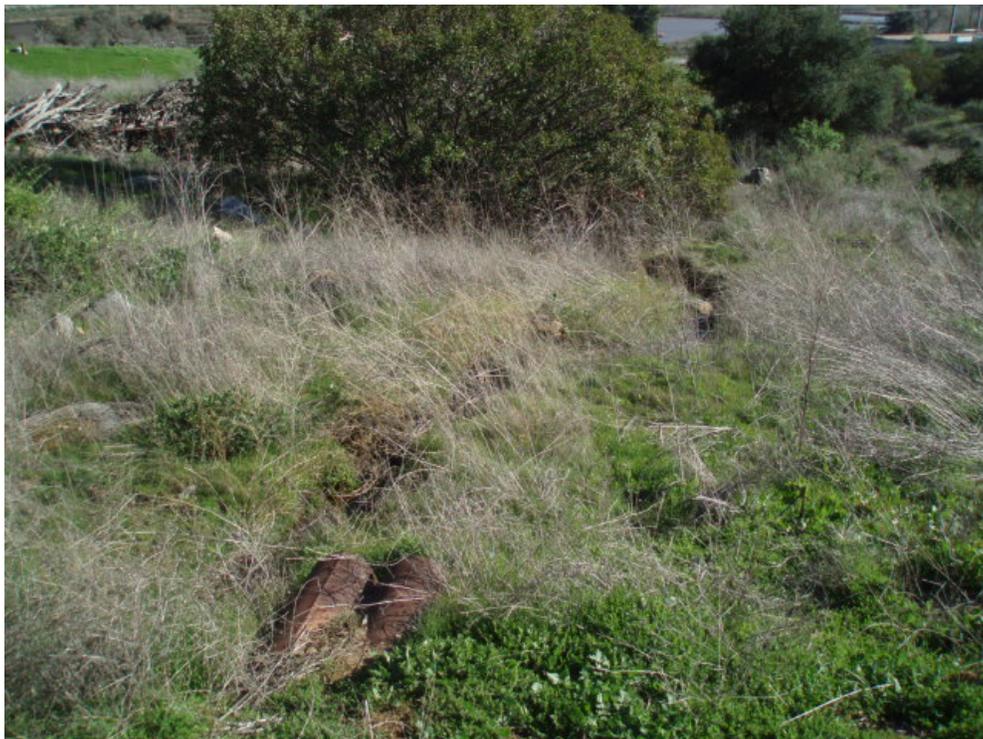
PS 8 – Tributary 1.3 downstream of Pala Del Norte Road (Drainage 1 in background), facing southwest. Taken on 2/7/08.

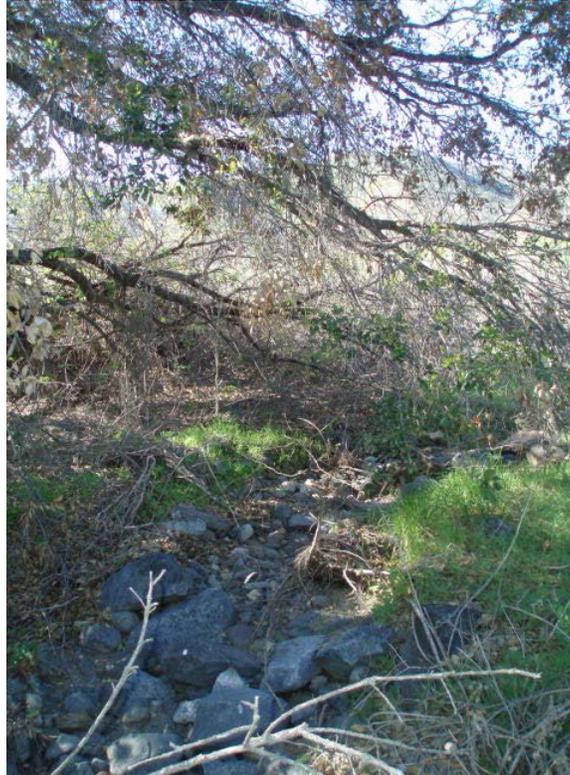
PS 9 – Drainage 2 upstream of SR 76, facing northwest (upstream). Taken on 2/12/08.

Data Point north of SR 76: The dominant species were coast live oak (native, no wetland indicator status), black sage (*Salvia mellifera*) (native, no wetland indicator status), pincushion (*Chaenactis* sp.) (native, no wetland indicator status) and wild cucumber (*Marah macrocarpus*) (native, no wetland indicator status). Drift lines and sediment deposits were observed, but no hydric soils or hydrophytic vegetation. Based on these observations, the drainage was not characterized as a wetland. The width of “waters of the U.S.” was measured at 1 foot 8 inches and “waters of the State” as 59 feet.

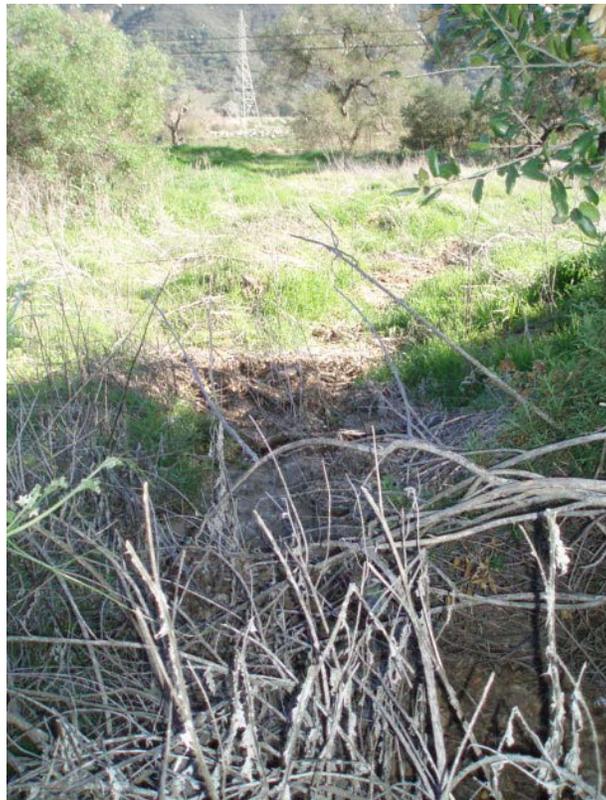
PS 10 – Drainage 2 upstream of SR 76, facing southeast (downstream). Taken on 2/12/08.

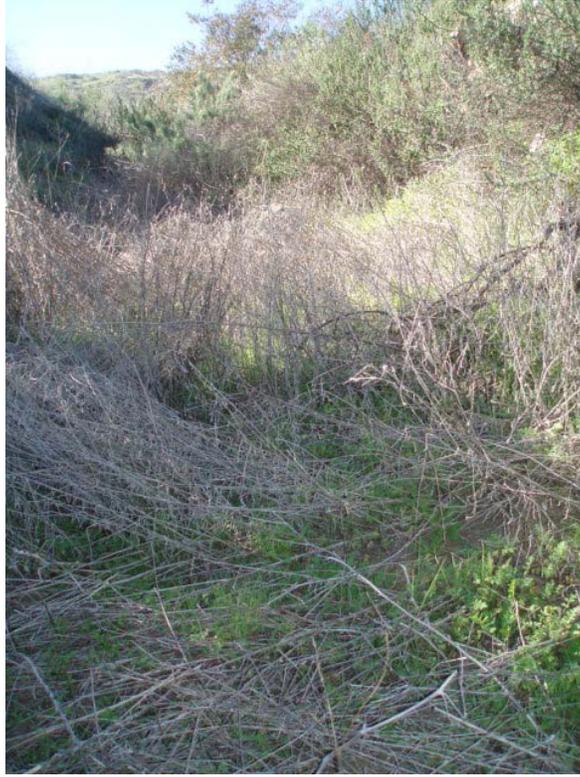
Tributary 3.1

PS 11 – Tributary 3.1, facing northwest (upstream). Taken on 2/12/08.

Data Point within tributary 3.1: The dominant vegetation was California sagebrush (*Artemisia californica*) and *Phacelia* sp. Shelving was noted at this area, but this was not clearly defined and no hydric soils or hydrophytic vegetation were observed at this data point. Based on these observations, the drainage was not characterized as a wetland. The width of “waters of the U.S.” was measured at 3 feet 8 inches and “waters of the State” as 12 feet 3 inches. This data point is representative of the downstream channel.

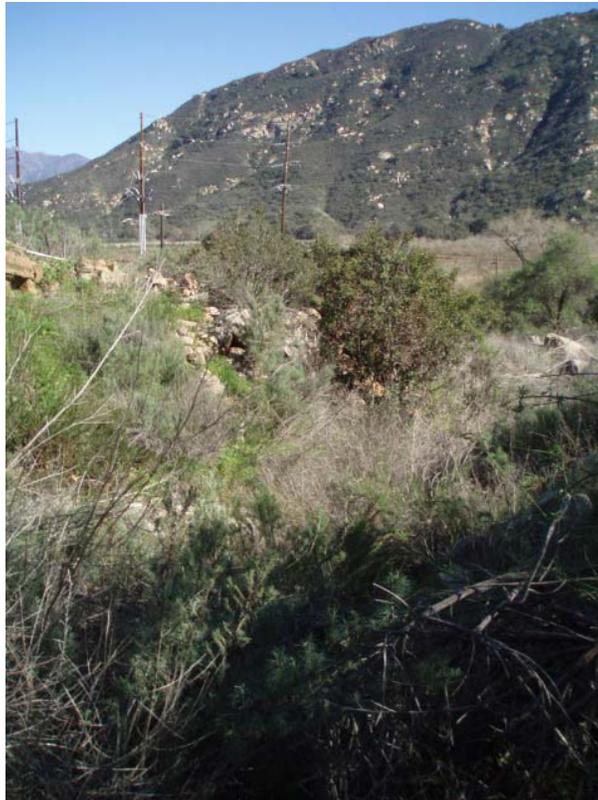
PS 12 – Tributary 3.1, facing southeast (downstream). Taken on 2/12/08.

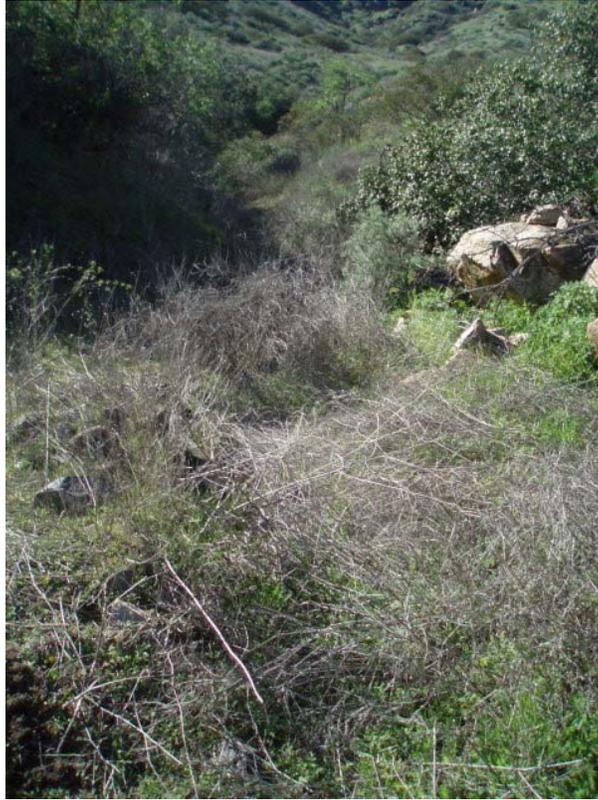
Tributary 3.2

PS 13 – Tributary 3.2, facing west (upstream). Taken on 2/12/08.

Data Point within tributary 3.2: This site was dominated by non-hydrophytic vegetation including California sagebrush (native, no wetland indicator status) and *Phacelia* sp. Shelving was noted at this area, but this was not clearly defined and no hydric soils or hydrophytic vegetation were observed at this data point. Based on these observations, the drainage was not characterized as a wetland. The width of “waters of the U.S.” was measured at 3 feet 7 inches and “waters of the State” as 16 feet 10 inches.

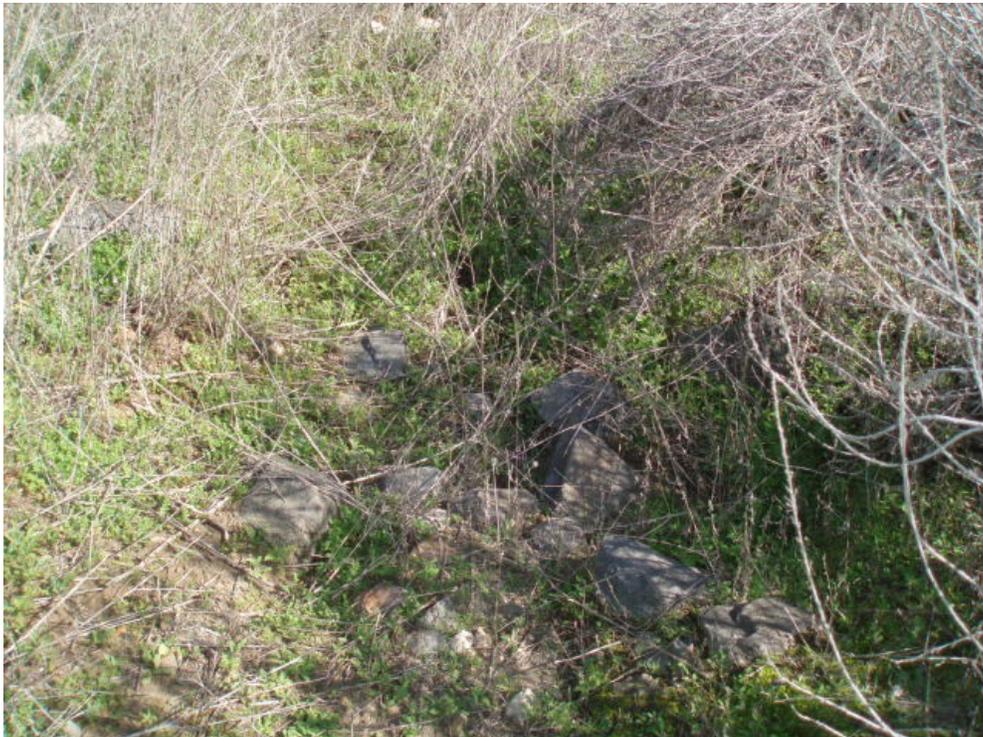
PS 14 – Tributary 3.2, facing southeast (downstream). Taken on 2/12/08.

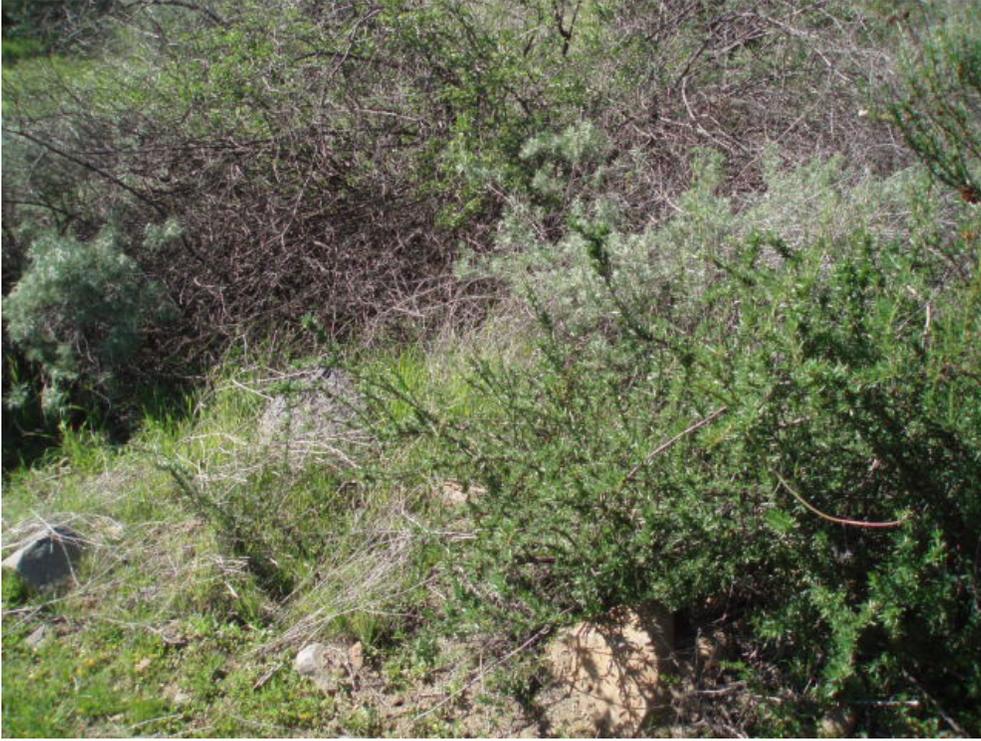
PS 15 – Drainage 4 upstream of dirt road, facing northwest (upstream). Taken on 2/12/08.

Data Point upstream: This data point was taken upstream of an unpaved road within a representative channelized reach of the drainage (Attachment A, Figure 6, Sheet 2). This area was dominated by non-hydrophytic vegetation including pincushion and wishbone bush (*Mirabilis californica*) (native, no wetland indicator status). Shelving was noted at this location, but no hydric soils or hydrophytic vegetation was found at this data point. Based on these observations, the drainage was not characterized as a wetland. The width of “waters of the U.S.” was measured at 1 foot 8 inches and “waters of the State” as 13 feet 5 inches.

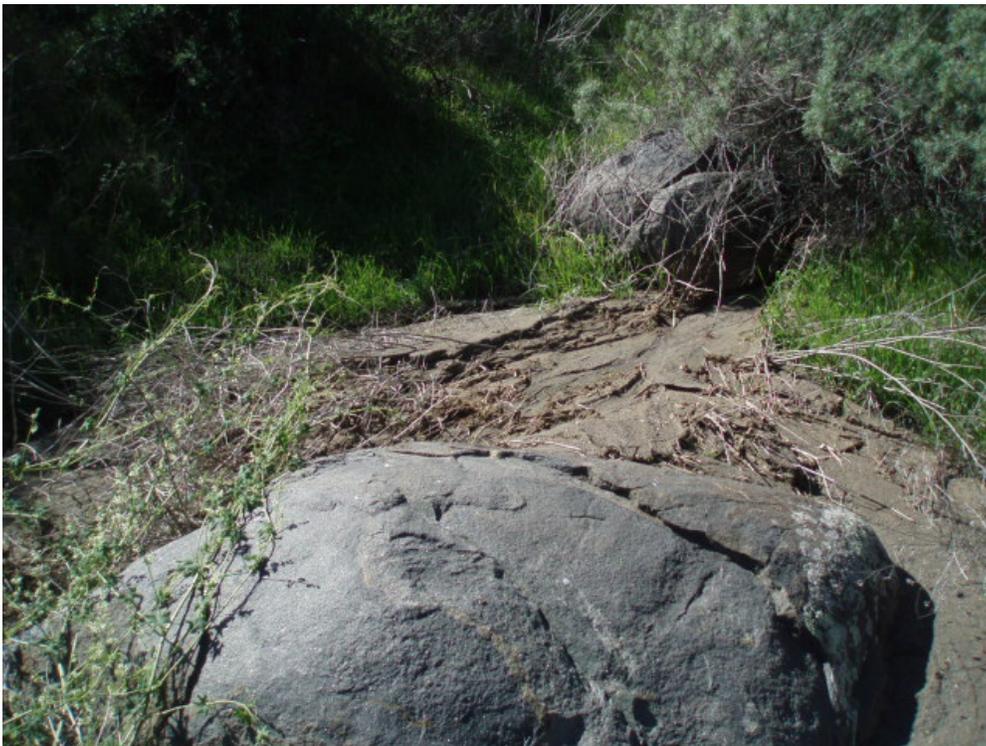
PS 16 – Drainage 4 at diffuse flow path portion (channelized portion in background), facing northwest (upstream). Taken on 2/12/08.

Data Point downstream: This data point was taken in a disturbed portion of the drainage just upstream of the unpaved road near SR 76 (a more representative upstream reach was not accessible due to steep topography and dense vegetation). The dominant vegetation was pincushion. Some debris collection was noted around the culvert, but no hydric soils or hydrophytic vegetation was present at this data point. Based on these observations, the drainage was not characterized as a wetland. The width of “waters of the U.S.” was measured at 1 foot 8 inches and “waters of the State” as 13 feet 6 inches.

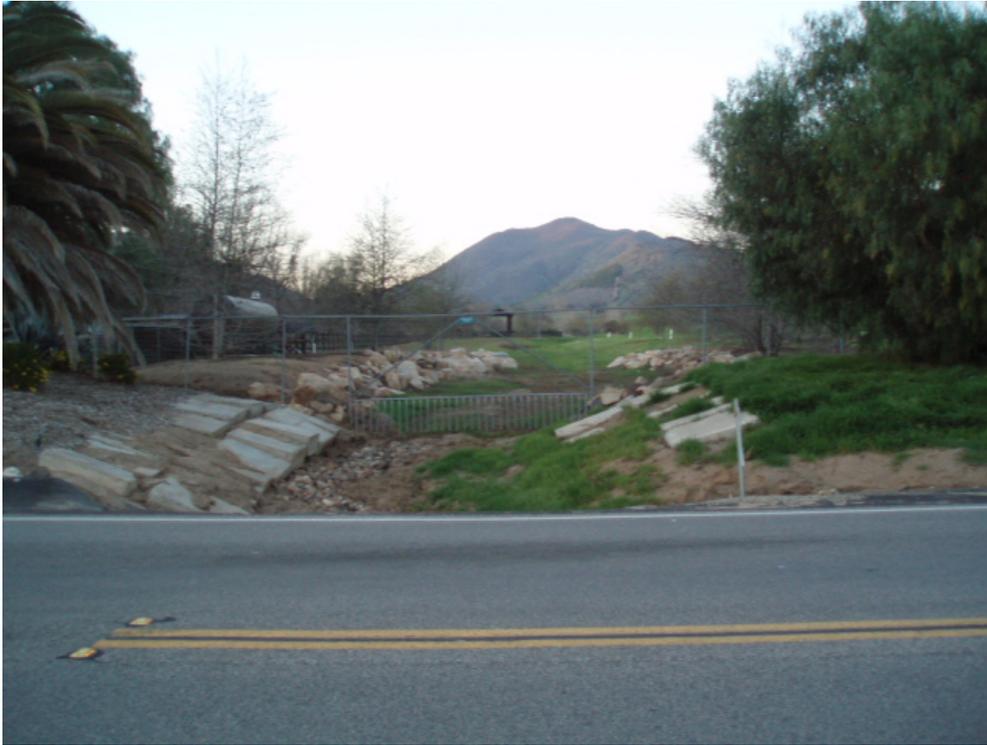
PS 17 – Drainage 5 north of SR 76, facing north (upstream). Taken on 2/12/08.

Drainage 5 was subsequently observed following the plant blooming period. Vegetation within and adjacent to the channel upstream of SR 76 between the fence and the road had recently been cut and was therefore sparse. However, based on a few remaining plants and the uncleared area north of the fence, the vegetation consists of grasses including barley (*Hordeum murinum*) (non-native, no wetland indicator status), bromes (*Bromus madritensis* and *Bromus diandrus*) (non-native, no wetland indicator status), and wild mustard. The channel downstream of SR 76 did not appear to have been recently cleared, but vegetation was sparse and consisted of the same species as observed upstream. The species observed lack a wetland indicator status and are not considered hydrophytic vegetation. Based on the absence of hydrophytic vegetation, the drainage is not considered likely to be a Corps jurisdictional wetland.

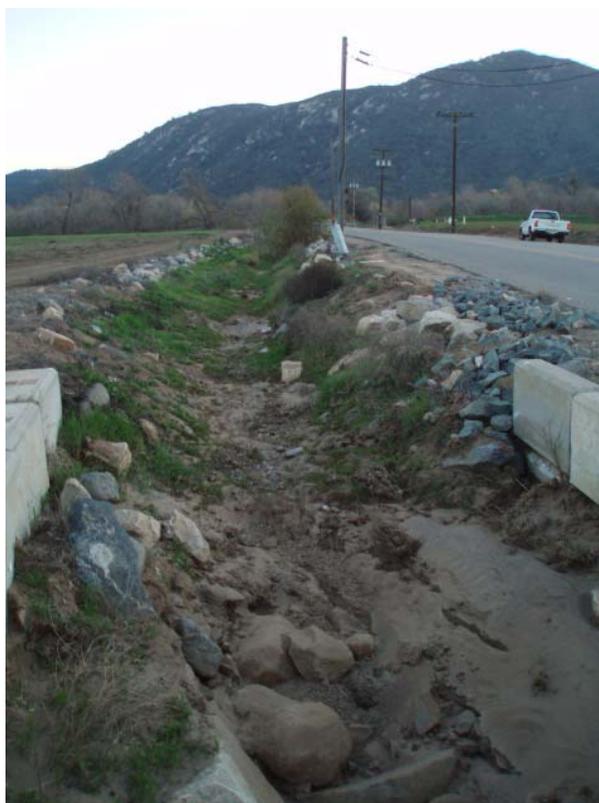
PS 18 – Drainage 5 south of SR 76 and parallel to Couser Canyon Road, facing south (downstream). Taken on 2/12/08.

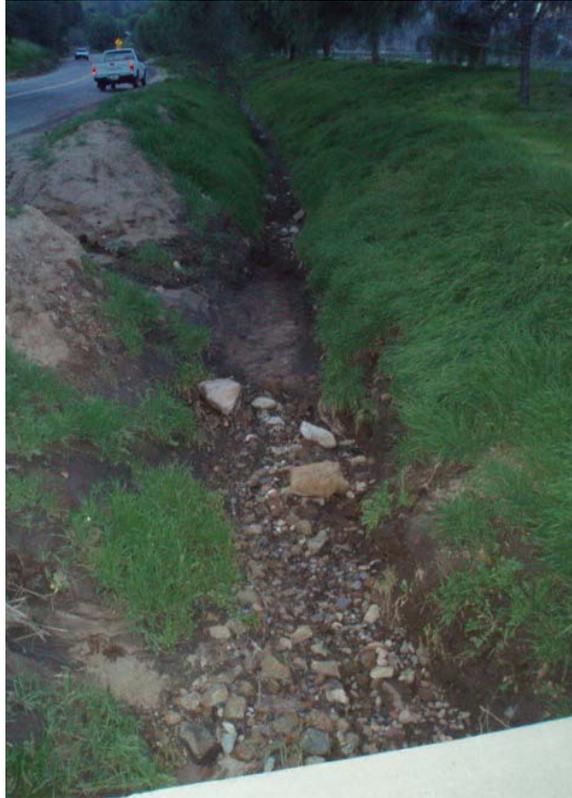
Drainage 6 (Rice Canyon Creek)

PS 19 – Drainage 6 north of SR 76 and parallel to Rice Canyon Road, facing north (upstream). Taken on 2/12/08.

Drainage 6 was subsequently observed following the plant blooming period. Vegetation within and adjacent to the channel upstream of SR 76 had recently been cut. However, based on the remaining and regenerating plants, the vegetation consists of grasses including barley and ripgut brome (*Bromus diandrus*), in addition to wild mustard. The channel downstream of SR 76 did not appear to have been recently cleared, but vegetation was sparse and included one saltcedar (*Tamarix ramosissima*) (non-native, FAC). Just outside the Survey Area the channel becomes vegetated with riparian forest species. The species observed upstream lack a wetland indicator status and are not considered hydrophytic vegetation. Based on the absence of hydrophytic vegetation, the drainage is not considered to be a Corps jurisdictional wetland north of SR 76. Although one plant with a wetland indicator status was observed downstream, based on the lack of vegetation and similarity with the immediate upstream area, the portion of the drainage

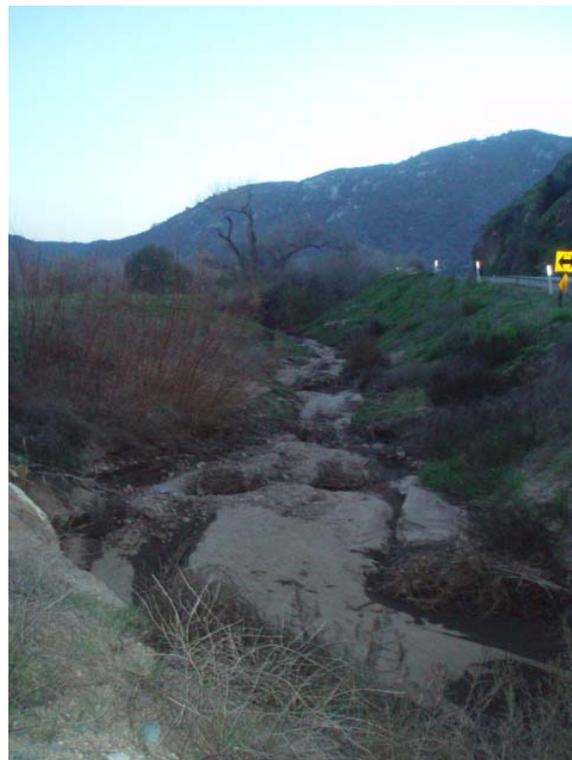
PS 20 – Drainage 6 south of SR 76, facing south (downstream). Taken on 2/12/08.

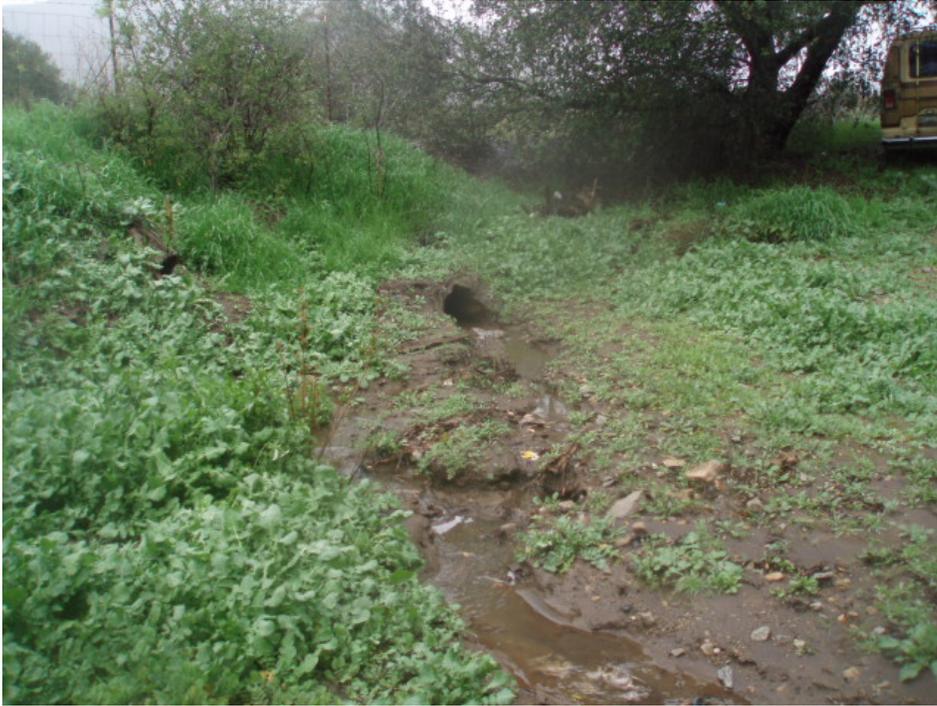
PS 21 – Tributary 6.1 at northeast corner of fresh water pickup station parcel east of Rice Canyon Road, facing southwest. Taken on 2/22/08.

An unnamed ephemeral tributary to Drainage 6/Rice Canyon Creek (Tributary 6.1) was observed just north of the proposed fresh water pickup station traversing in a northwest to southeast direction (Attachment A, Figure 6, Sheet 4). The drainage marginally traverses the northeast corner of the fresh water pickup station parcel, outside of the area planned for Project construction. The drainage flows through an area mapped as Disturbed (Holland classification 11300) with a few remnant oak trees and coastal sage scrub species, before crossing under Rice Canyon Road via a culvert and flowing through an area with three coast live oak trees along the banks that is also mapped as Disturbed. The tributary then flows across Agriculture (Holland classification 18000) before joining Open Coast Live Oak Woodland (Holland classification 71161) associated with Rice Canyon Creek. The drainage has a modified bed and bank with signs of an OHWM in the upstream reach that become less defined downstream due to established anthropogenic activities. This tributary is considered jurisdictional “waters of the U.S.” and “waters of the State.” The drainage is mapped on the USDA web soil survey map (Attachment A, Figure 5) as WmC and classified as well drained and not hydric. One data point was collected in the upstream portion of Tributary 6.1 within the Survey Area (Attachment A, Figure 6, Sheet 4) as follows:

Data Point within Tributary 6.1: This data point was taken upstream of a small stand of dense, inaccessible oaks and one Mexican elderberry (*Sambucus mexicana*) (native, FAC) located adjacent to Rice Canyon Road. The vegetation at the data point is characteristic of the disturbed habitat observed in the drainage within the Survey Area and includes wild mustard, *Phacelia* sp., and bromes, none of which have a wetland indicator status. Shelving, drift lines, and sediment deposits were noted at this location, but no hydric soils or hydrophytic vegetation were found at this data point. Based on these observations, the drainage was not characterized as a wetland. The width of “waters of the U.S.” was measured at 2 foot 8 inches and “waters of the State” as 16 feet.

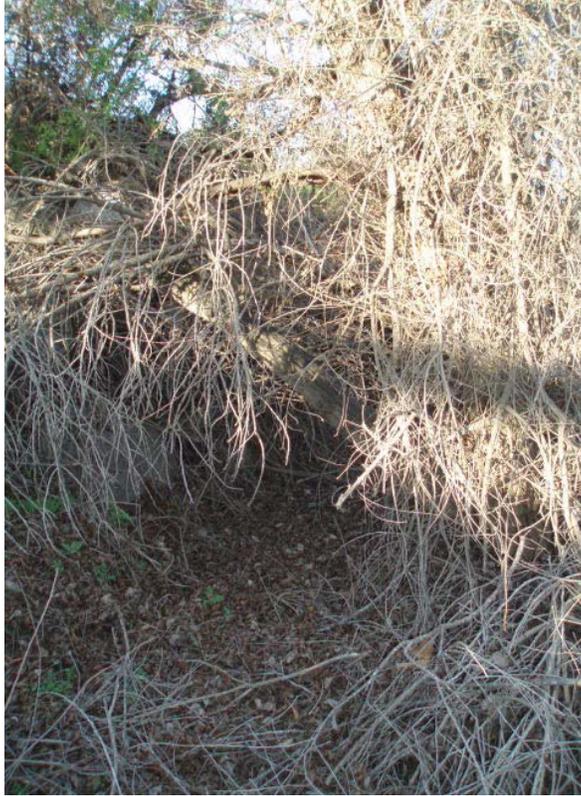
San Luis Rey River – Riparian Area

PS 22 – San Luis Rey River riparian area understory, facing west. Taken on 2/12/08.

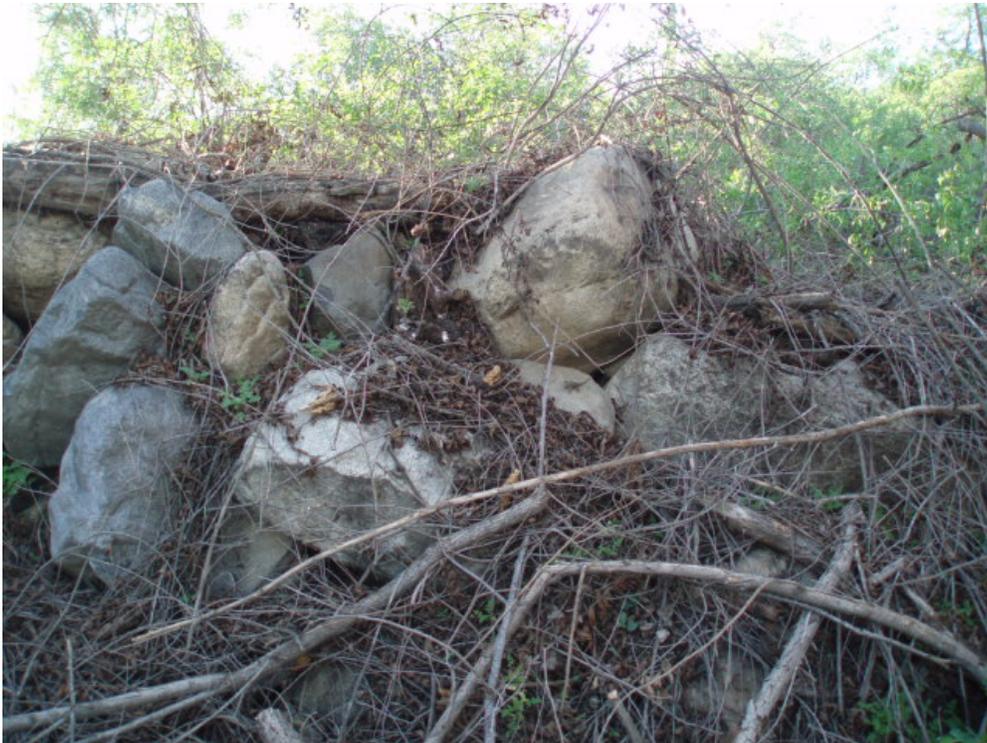
PS 23 – Berm between riparian area (background) and San Luis Rey River, facing north. Taken on 2/12/08.

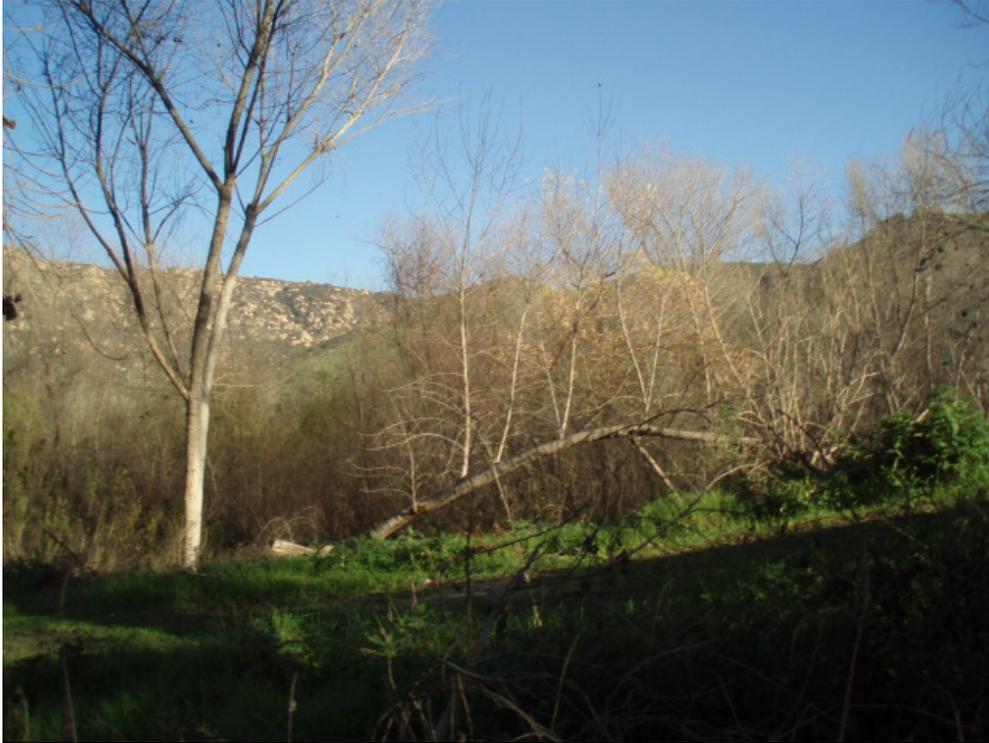
San Luis Rey River – Wetland Area

PS 24 – San Luis Rey River with wetland areas, facing south. Taken on 2/12/08.

Data Point in wetland area: This area was identified as a potential wetland area based on the presence of known wetland plants and an adjacent NWI-mapped wetland. Several locations within this area were observed from the road, but the steep slope of the road fill, dense vegetation, soft soils, and/or standing water resulted in limited access for data collection. One data point was collected at an accessible location. The dominant vegetation consisted of mulefat (*Baccharis salicifolia*) (native, FACW), broad-leafed cattail (*Typha latifolia*) (native, OBL) and sandbar willow (*Salix exigua*) (native, FACW). Since 100 percent of the species observed had a wetland indicator status above FAC-, the vegetation is considered hydrophytic. The area also displayed several wetland hydrology indicators including inundation, saturation in the upper 12 inches (at 0 inches), water marks, sediment deposits, and drift lines, in addition to gleyed hydric soils. This area is therefore considered a jurisdictional wetland. The exact boundary of the wetland could not be determined due to limited access, but based on field observations and the data point collected the wetland area was conservatively mapped to encompass the entire area identified by NWI mapping plus the entire area to the southeast edge of the road fill prism (Attachment A, Figure 6, Sheet 3). This entire area should be considered potential jurisdictional wetland unless additional evaluations show otherwise. The Project currently does not plan to disturb this feature, so no further delineation is needed for the Project as proposed.

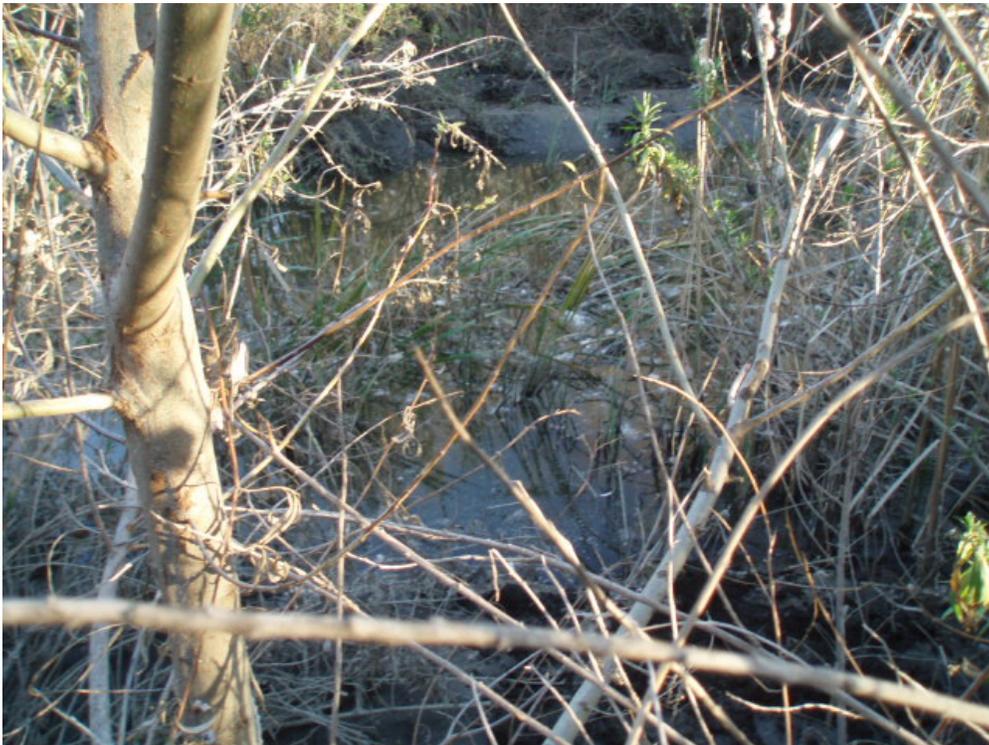
PS 25 – San Luis Rey River wetland, facing south. Taken on 2/12/08.
