Orange Grove Project Additional Historical & Cultural Resource Surveys

***Reconnaissance Level
Archaeological & Built Environment Survey Report
Freshwater & Reclaimed Water Pickup Stations
Yucca Road & Alturas Road, Fallbrook, California***

June 2008

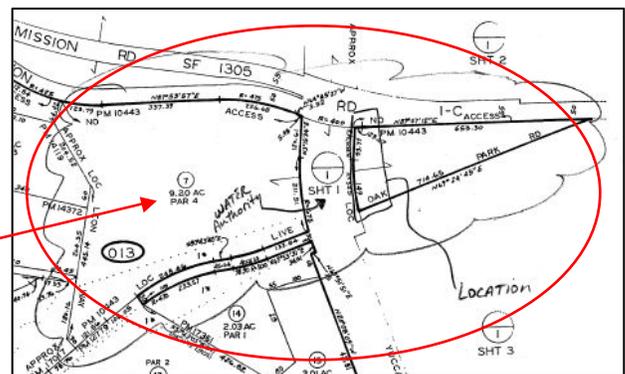
Figure 1:
San Diego County Assessor's Map of Parcel depicting survey boundary and proposed project site within the survey boundary.

A new freshwater pickup facility is proposed for installation at the Yucca Road Survey Area in association with the proposed Orange Grove Project. The water facility is proposed for construction on the westernmost portion of the east section of the survey area as depicted in Figure 1 on page one of this report.

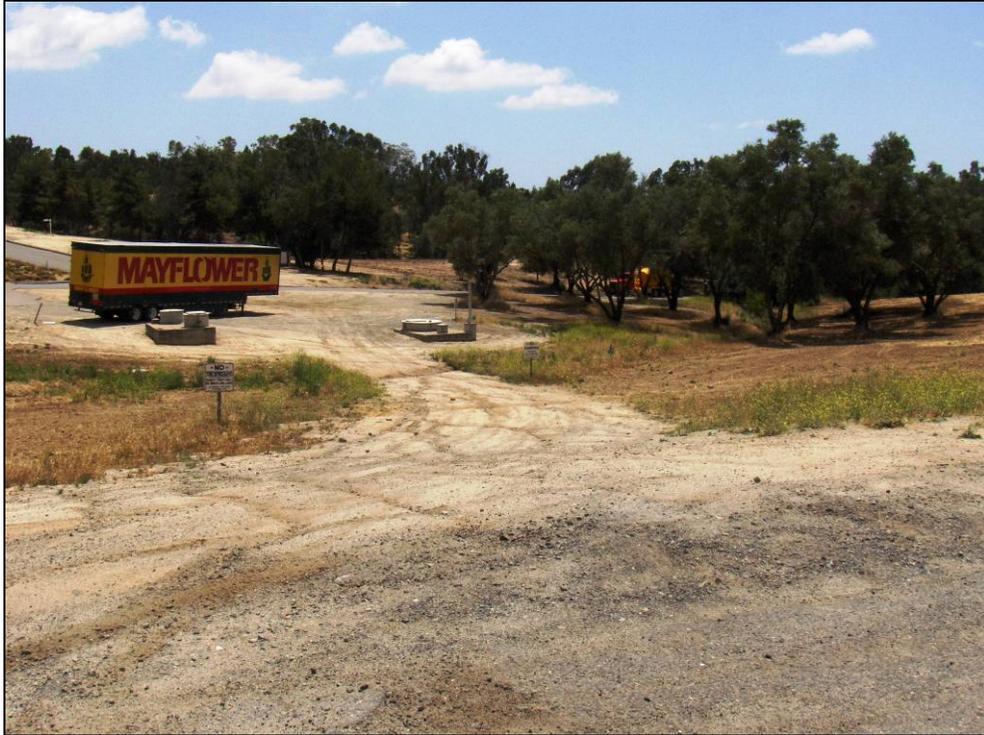
Photo 1:

Overview image of the Yucca Road Survey Area. View south toward Live Oak Park Road from north boundary of the survey area showing the unpaved extension (dirt road/path) of Yucca Road which bisects the survey area into two sections identified as east (left-side of image) and west (right-side of image).

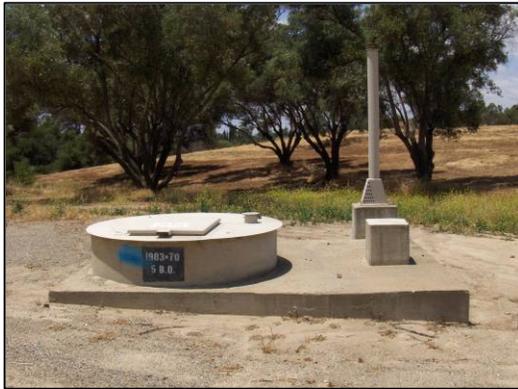
*Photo 2 (Left):
West MWD
platform.*

- Two non-historic structures owned by the San Diego County Metropolitan Water District (MWD) – these structures are board form concrete platforms measuring approximately 8 x 11 feet and projecting up from the sloped terrain between .5 to 3 feet. The two platforms are approximately 29 feet apart, separated by the unpaved extension of Yucca Road, with the East platform topped two cylindrical metal structures and the West platform topped by a single cylindrical metal structure. The MWD identifier “1983+78 4 B.O.” is stencil painted on all three cylindrical structures. The East Pad appears to fall with the footprint of the proposed water facility. Neither pad appears to be over 45 years of age; it is likely that both pads (and related cylindrical structures) were installed at the site in 1983.

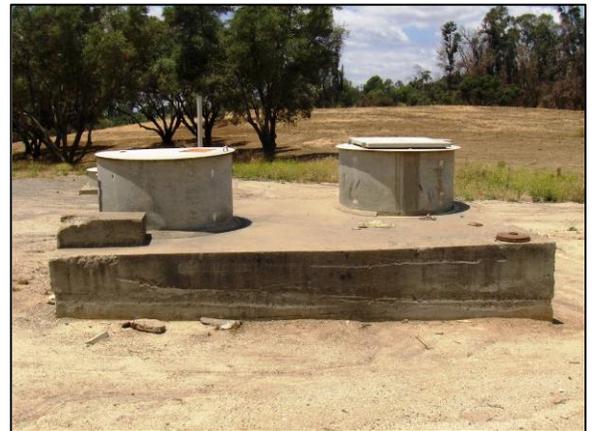
*Photo 3 (Right):
East MWD
platform.*

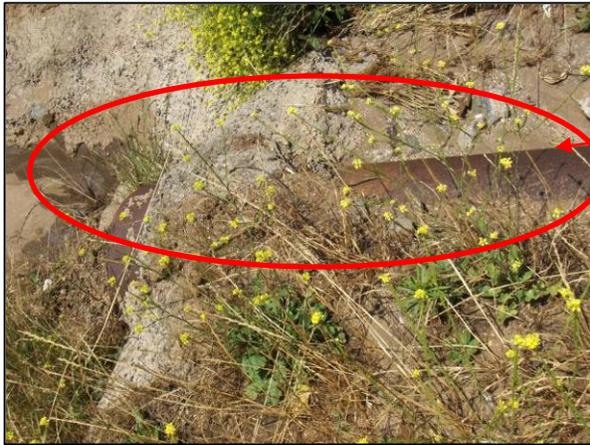
*Photo 4 (Left):
Exposed steel piping visible on western section of the
Yucca Road Survey Area.*

- A section of steel piping and associated concrete water drain with a steel grate. Located on the western section (west of the unimproved extension of Yucca Road) of the parcel, the visible piping is rusted and did not feature any identifiable lettering or markings. The pipe is owned and utilized by the MWD and is likely associated with the two nearby MWD platforms which appear to date to 1983.

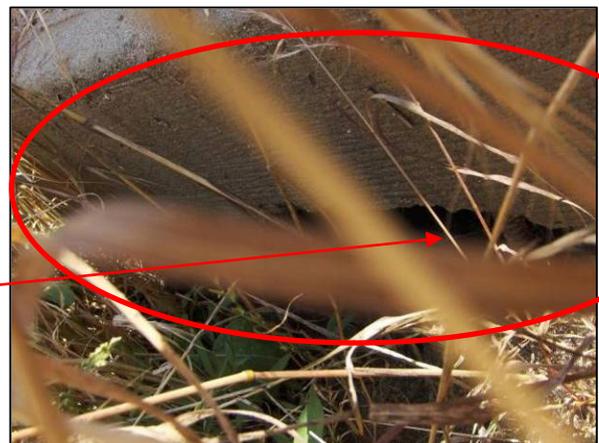
*Photo 5 (Right):
Concrete drainage outlet with steel grate associated with visible
steel piping.*

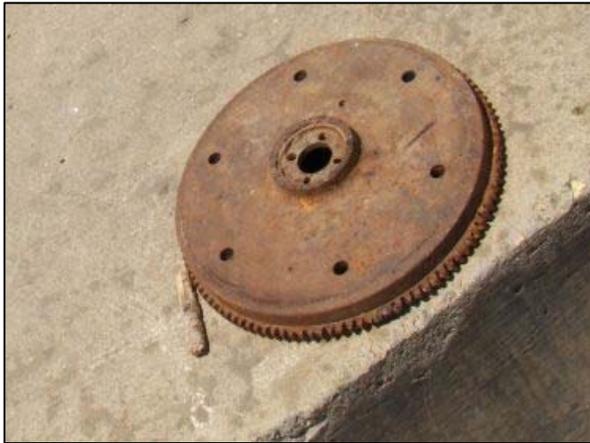
*Photo 6 (Left):
Machinery gear found on East MWD platform.*

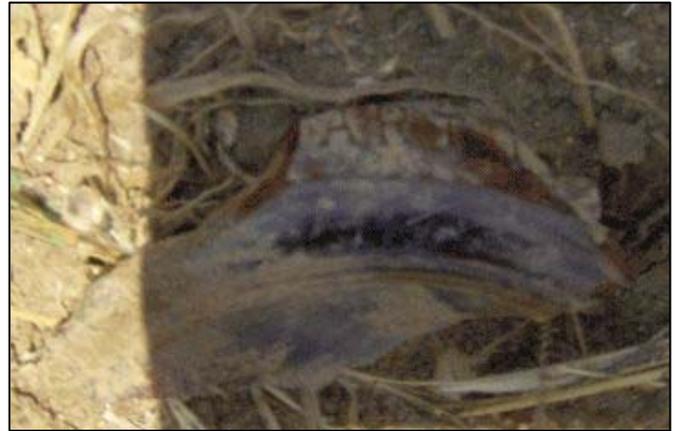
*Photo 7 (Right):
Quart jar base (brown glass) with raised inscription.*

- No archaeological sites were identified within the property boundaries, however two historic-period archaeological isolates were observed. The two historic-era artifacts observed within the survey boundaries were sited on the eastern portion of the parcel and are identified as:
 - 1) a rusted machine gear placed atop the East MWD platform, and
 - 2) a piece of brown colored glass which appears to be a portion of a common glass jar or bottle base. A section of the raised inscription was visible on the glass with the letters ‘ART’ indicating that the full inscription likely read ‘QUART’.

No pre-historic artifacts were observed on the property. The brown glass artifact was observed at ground surface level however it should be noted that the survey area ground soil was recently tilled. Recent ground disturbing activities likely changed the location, depth and context of the artifacts. It is also likely that the rusted machine gear observed on the East MWD platform was moved to its present location as part of tilling activities.

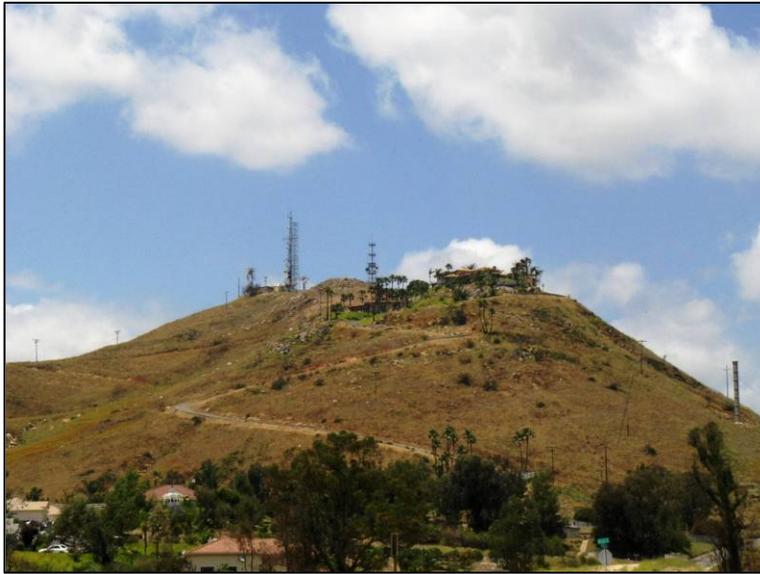
Photo 9 (Left): View northwesterly from the Yucca Road Survey Area.

Non-historic, contemporary period single-family dwellings sited within viewshed of the Yucca Road Survey Area. Dwellings are located north of Mission Road. A dwelling is sited atop the mountain illustrated in this photograph, as well as at the base adjacent to Mission Road. Also visible in the image are multiple satellite and cellular transmission towers and antennae. The tower associated with the Red Mountain Dam is also visible at the right side of the photograph (on the east slope). No historic-era buildings or structures appear to be sited within viewshed of the Yucca Road Survey Area.

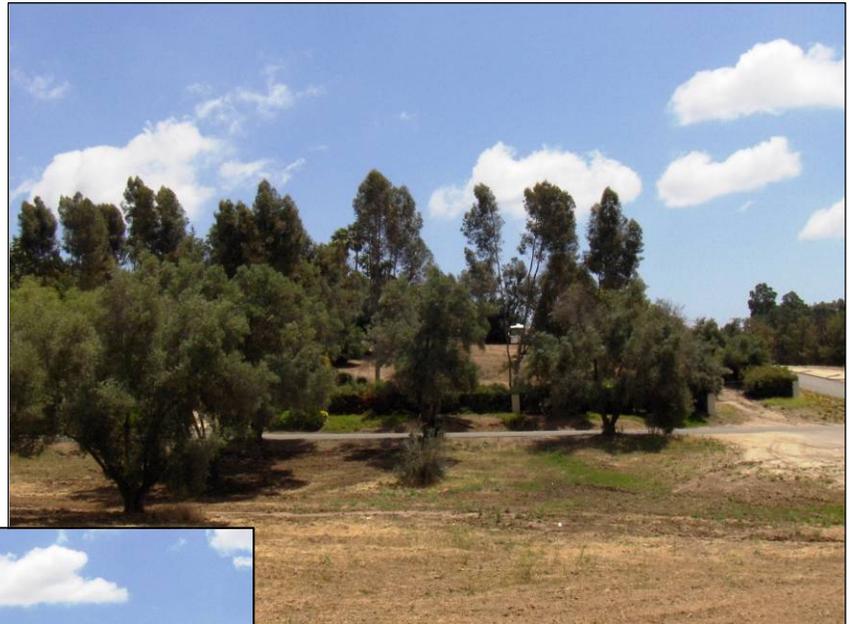
Photo 10 (Right): View south toward Live Oak Park Road from the north edge of the Yucca Road Survey Area boundary, showing a residential lot at the southeast corner of the intersection of Yucca Road and Live Oak Park Road. The property is enclosed with a gate and the dwelling built on the property is not visible from the public right-of-way. Discernible sections of the dwelling appear to be non-historic and of a contemporary style of architecture.

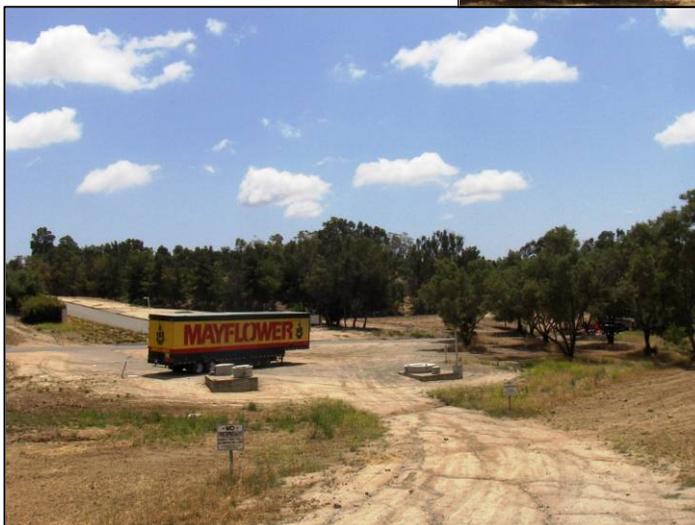
Photo 11 (Left): View south toward Live Oak Park Road from the northern edge of the survey area showing unimproved lot at the southwest corner of the intersection of Yucca Road and Live Oak Park Road. Development permit notices posted on the property disclose the lot is identified as 326 Yucca Road.

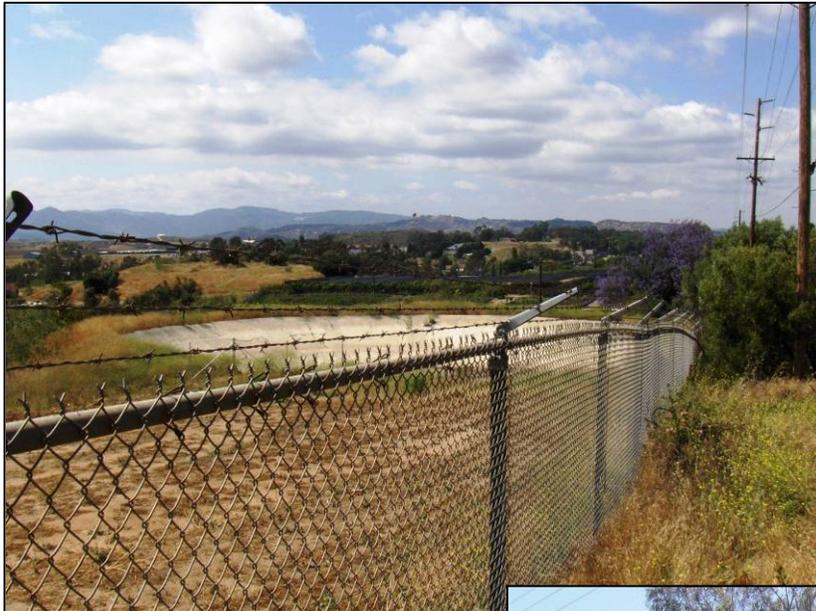
*Photo 12 (Left):
View southwesterly of the
concrete holding pond from
Alturas Road near the entrance
to the Good Earth Nursery
property at 1855 S. Alturas
Road.*

- A non-historic empty concrete holding pond with unknown ownership or use attributes that is sited immediately south of the Good Earth Nursery at 1855 S. Alturas Road within the survey boundaries,
- the non-historic 'Vermigro Resource, Recovery & Recycling Program' (address not identified) situated at a small nursery property immediately south of the empty concrete holding pond and west of the intersection of Cancun Drive and Alturas Road, and
- the non-historic 'Fallbrook Public Utilities District' building complex at 1425 S. Alturas Road, and sited at the south end of Alturas Road approximately 250 feet north of the intersection of Alturas Road and Ammunition Road.

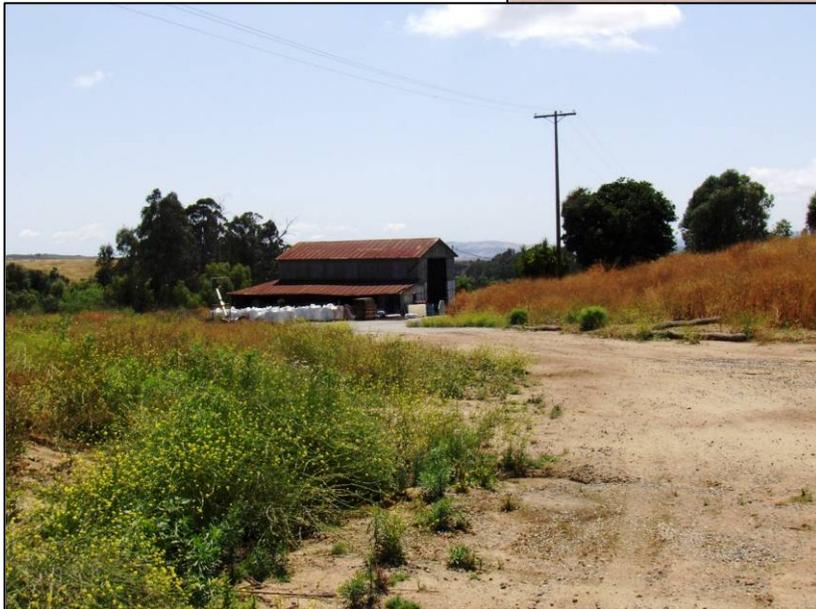
*Photo 14 (Left):
Metal-clad barn west of the
Vermigro nursery property and
accessible from the linear drive
running through the Vermigro
nursery property.*

- a barn or storage structure sited west of the 'Vermigro' nursery property accessible from a linear drive sited off the west side of Alturas Road north of Cancun Drive. The structure appears to be clad with corrugated aluminum panels for exterior walls and covered by a standing seam roof. The metal construction is rusted around the perimeter and the building is sited approximately 200 feet west of a locked entry gate to the property on which the structure is located, therefore making an accurate age determination challenging. The barn appears to be two stories in height and is surmounted at the ground level by a single-story volume covered by a standing seam shed roof which spans the east, south (rear), and west elevations. An open bay is centered at the front (north) elevation. The exact age of the barn is unknown, although it appears to be depicted on the 1949 USGS Bonsall Quadrangle Map which includes the entire Alturas Road Survey Area.

Little historical information was identified for the metal-clad barn as part of reconnaissance-level survey activities. The barn or another structure in the same location, or in close proximity, is depicted on the 1949 USGS Bonsall Quadrangle Map, and a structure is depicted on the USGS topographical survey map provided to Urbana to determine the survey area boundaries and the proposed project location. The metal-clad barn likely served a former agricultural use when the project area was planted with orchards. It does not appear to be historically significant and does not appear to maintain an association with the historic agricultural uses of the area, as the setting has been altered through the installation of the varied light industrial and residential uses that characterize the area today. The barn, preliminarily, does not appear to meet the definition of an historical resource.

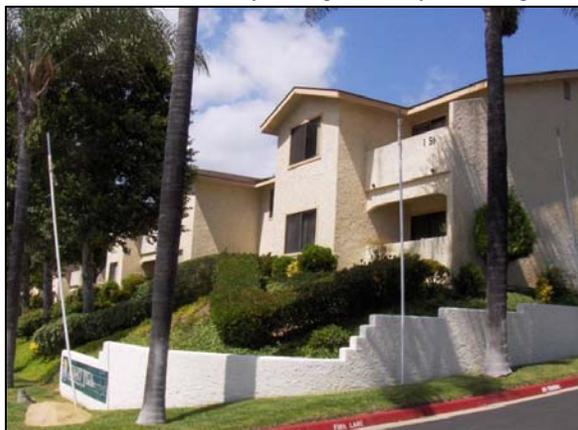
*Photo 17 (Left):
Sunset Terrace Apartments.*

several non-historic multi-family apartment complexes which also appear to date from the 1980s forward. These buildings are identified as Sunset Terrace Apartments at 1465 S. Alturas Road, Fallbrook, CA, and Palm Terrace Apartments at 1420 S. Alturas Road, Fallbrook, CA.

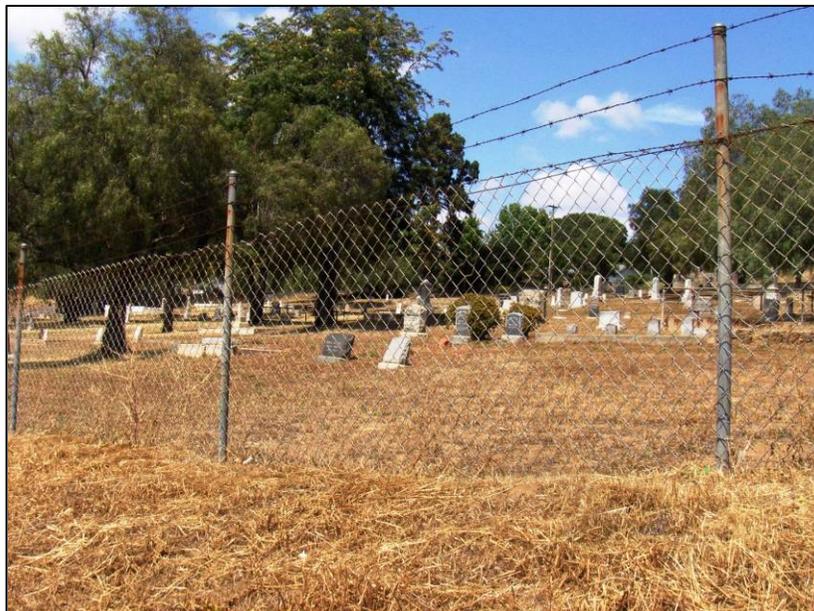
Photo 19 (Left):
Fallbrook Odd Fellows
Cemetery.

A historic-era cemetery is located on the east side of Alturas Road across from the Fallbrook Public Utilities District entry drive. The cemetery is identified as the 'Fallbrook Odd Fellows Cemetery' or the 'Fallbrook I.O.O.F. Cemetery' at 1300 S. Alturas Road. The plots and headstones

observed appear to be at least 45 years of age. Additional investigations on the cemetery at the San Diego Historical Society Research Archives disclosed the cemetery dates to the 1880s and is considered one of the earliest cemeteries in the Fallbrook area of San Diego County with several notable Fallbrook settlers interred there as well as a national Medal of Honor recipient.

Pending intensive level research, documentation and evaluation, the Odd Fellows Cemetery may be considered significant and eligible for inclusion on the California Register of Historical Resource or the National Register of Historic Places, and therefore may meet the definition of an historical resource under the guidelines of the California Environmental Quality Act. However, the cemetery property is situated outside of the survey boundaries, and although within viewshed, installation of the proposed water facility would not result in a material impact to the property or any individual headstones or related landscape features at the cemetery.

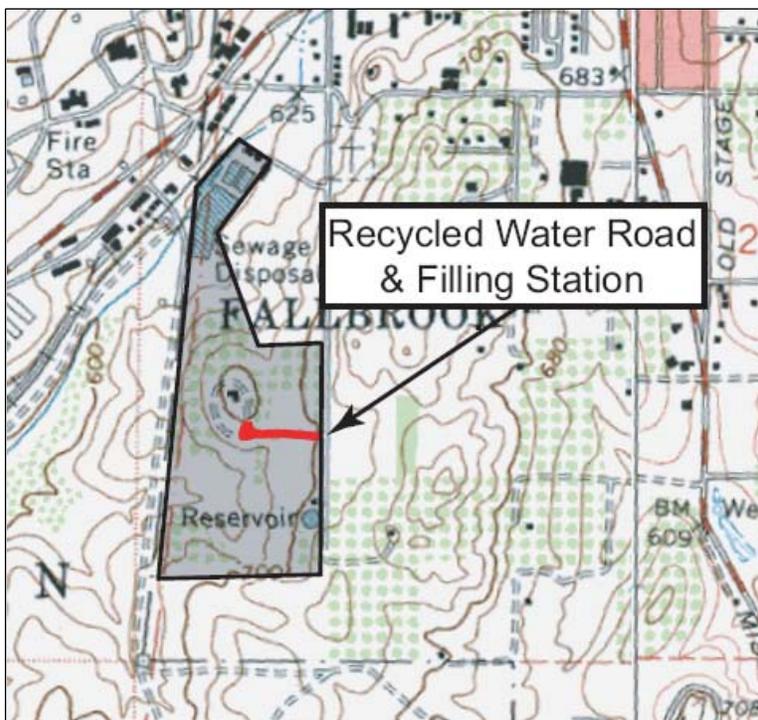
Figure 2:
Alturas Road Survey Area and location
of the proposed water facility
associated with the Orange Grove
Project.

A reclaimed water facility is proposed for installation at the Alturas Road Survey Area to serve the Orange Grove Project. The water pickup facility is proposed for installation along or near the linear drive which provides access to the Vermigro nursery property and the metal-clad barn. The proposed water facility location is depicted by a red line in Figure 2 on the following page.

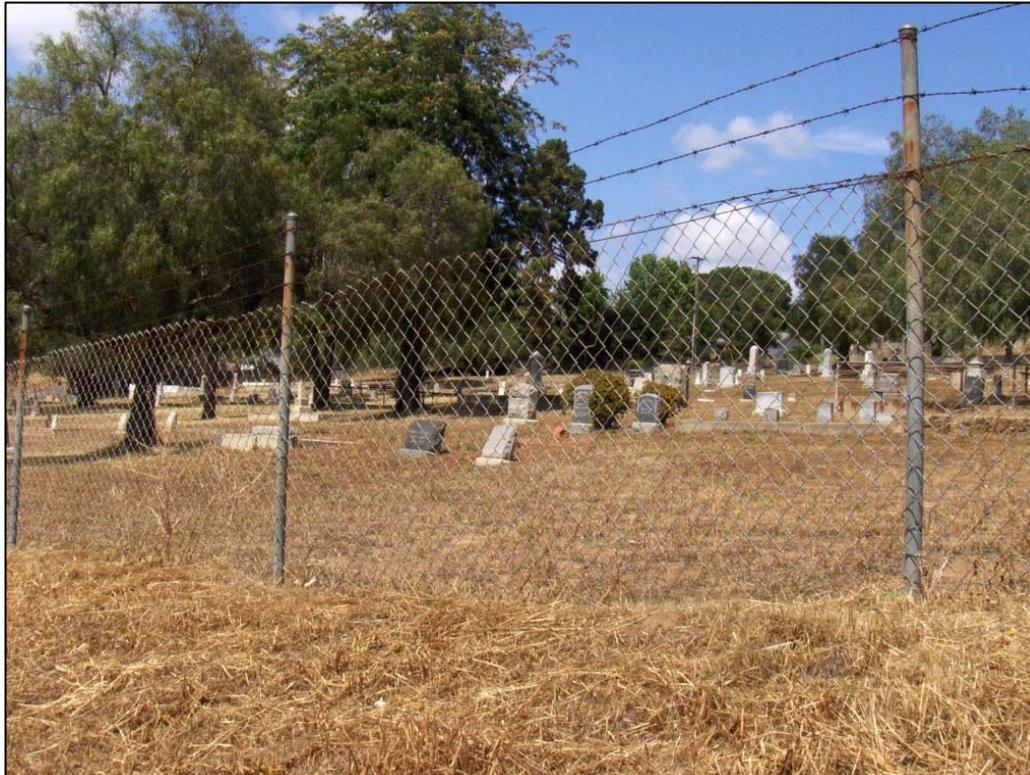
Sited at the corner of S. Alturas Road and W. Clemens Lane, the Independent Order of Odd Fellows Cemetery is considered one of the earliest cemeteries in the Fallbrook area of San Diego County with several notable Fallbrook settlers interred there as well as a national Medal of Honor recipient. The cemetery is approximately four acres comprising 236 burial plots in 16 sections with mature trees, shrubbery and dried grass throughout. Most grave markers are upright concrete or stone slabs of various shapes, sizes and heights with varying patterns of inscription. White picket fencing is set around some graves and trees. A chain link fence topped with 3 rows of barbed wire surrounds the property. The property does not appear to be well maintained.

P5b. Description of Photo:
(View, date, accession #)
Northeasterly view of cemetery
from S. Alturas Road.
Photo date: May 27, 2008

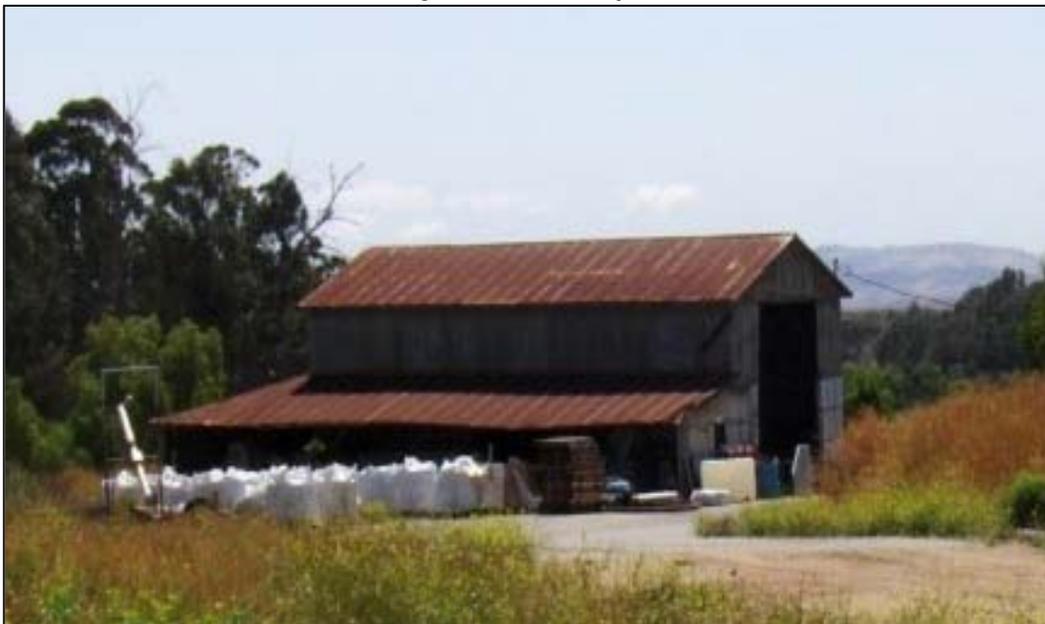
This two-story metal-clad barn is sited west of the Vermigro nursery property and is accessible from an unpaved, unnamed drive off of the west side of S. Alturas Road immediately north of Cancun Drive. The metal-clad structure is covered by a standing seam roof and is surmounted at the ground level by a single-story shed roof volume which spans the east, south (rear), and west elevations, and is covered with additional standing seam material. An open bay is centered at the front (north) elevation. Aerial photographs from 1929 disclose the presence of a structure on the subject property or in close proximity to the site on which the barn is located, indicating the barn may date to the 1920s. A similarly sited structure also appears on the 1949 Bonsall USGS Quadrangle Map. The barn was not directly accessible as part of field survey efforts and was observed and photographed from a distance of approximately 200 feet. The metal material appears to be rusted around the perimeter. Overall the structure appears to be in fair-to-poor condition. The barn likely served a former agricultural use when the project area was planted with orchards. Current use is unknown, however, the structure appears to be sited on land associated with the Fallbrook Public Utilities Waste Water Treatment Plant and the Vermigro Nursery.

(View, date, accession #)
Southwesterly view of North (front) & East (left-side) elevation.
