DRAFT REPORT PHASE I ENVIRONMENTAL SITE ASSESSMENT

**Quail Brush Project Site
APN 366-081-42
San Diego, California
San Diego County**

August 2011

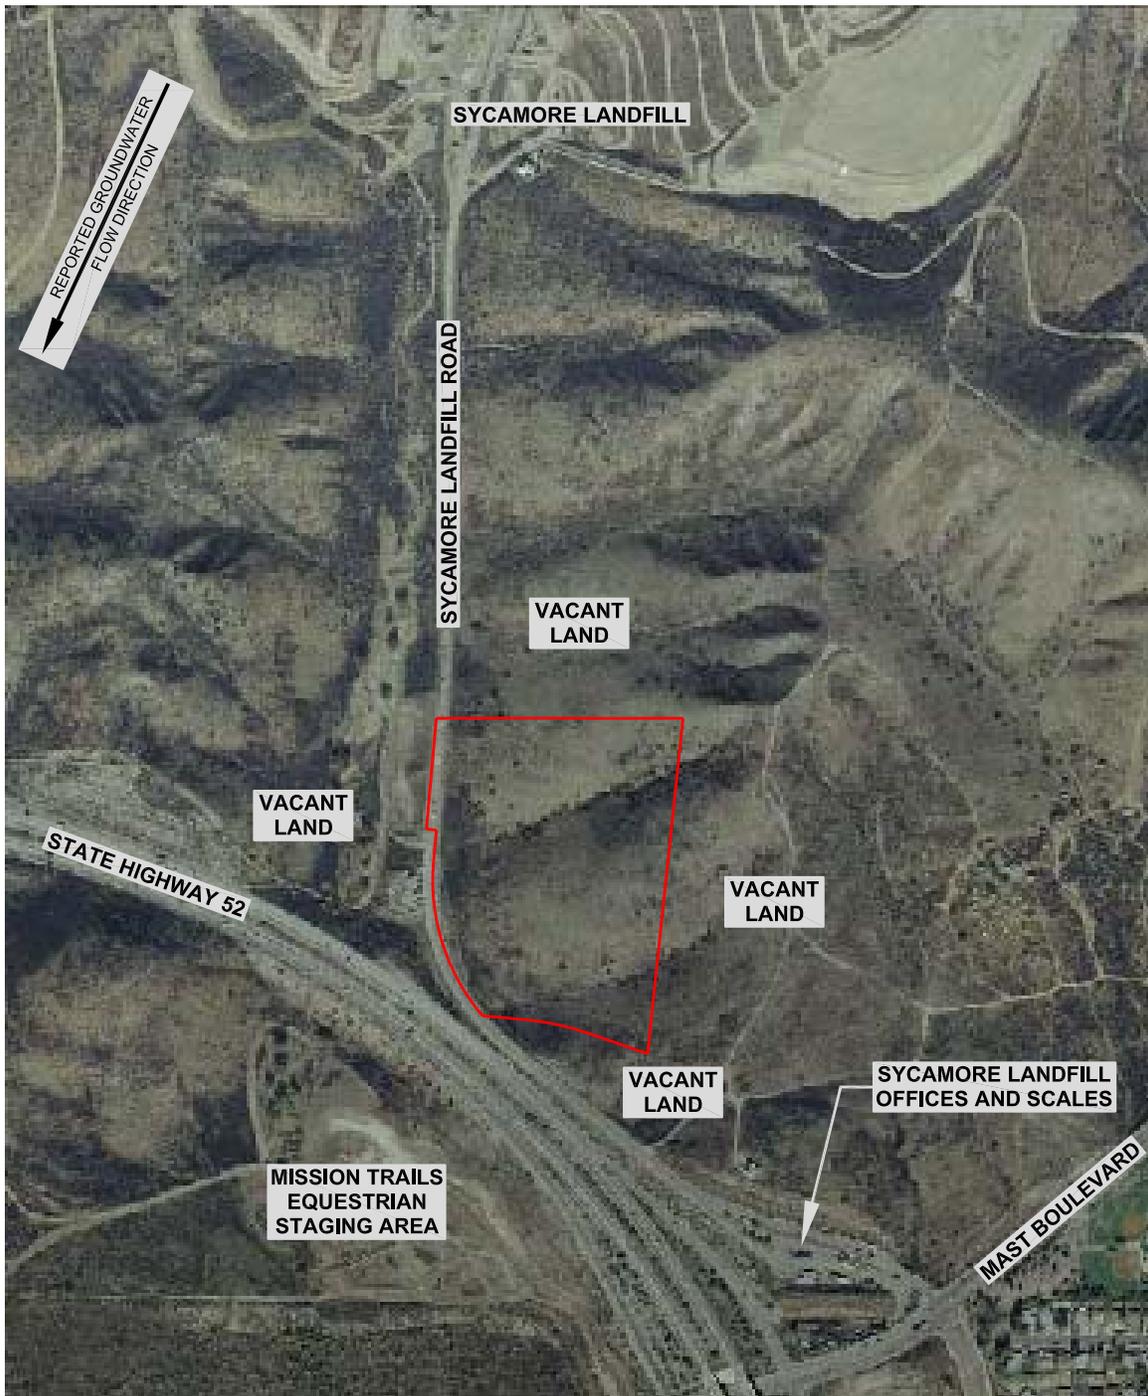
At the time of the inspection, the Property was vacant land. No structures were observed on the Property. Approximately 400 feet of Sycamore Landfill Road (approximately 25 feet wide) crosses the Property along the western boundary at the northwest part of the Property. Some dirt trails and tamped down grassland trails were observed at a few locations on the Property. A small concrete v-shaped ditch, barbed-wire fence, two storm water catch basins, and a pipe labeled "reclaimed water" were observed along the western side of the Property, adjacent and east of Sycamore Landfill Road.
