Subject: Rice Solar Energy Project (09-AFC-10)
Supplementary Information Items #7-11, Additional Information
Regarding the Archaeological Features at Rice Army Airfield

Rice Solar Energy Project

CEC Docket #09-AFC-10

Attachment SII9-1
Rice Army Airfield Feature Forms

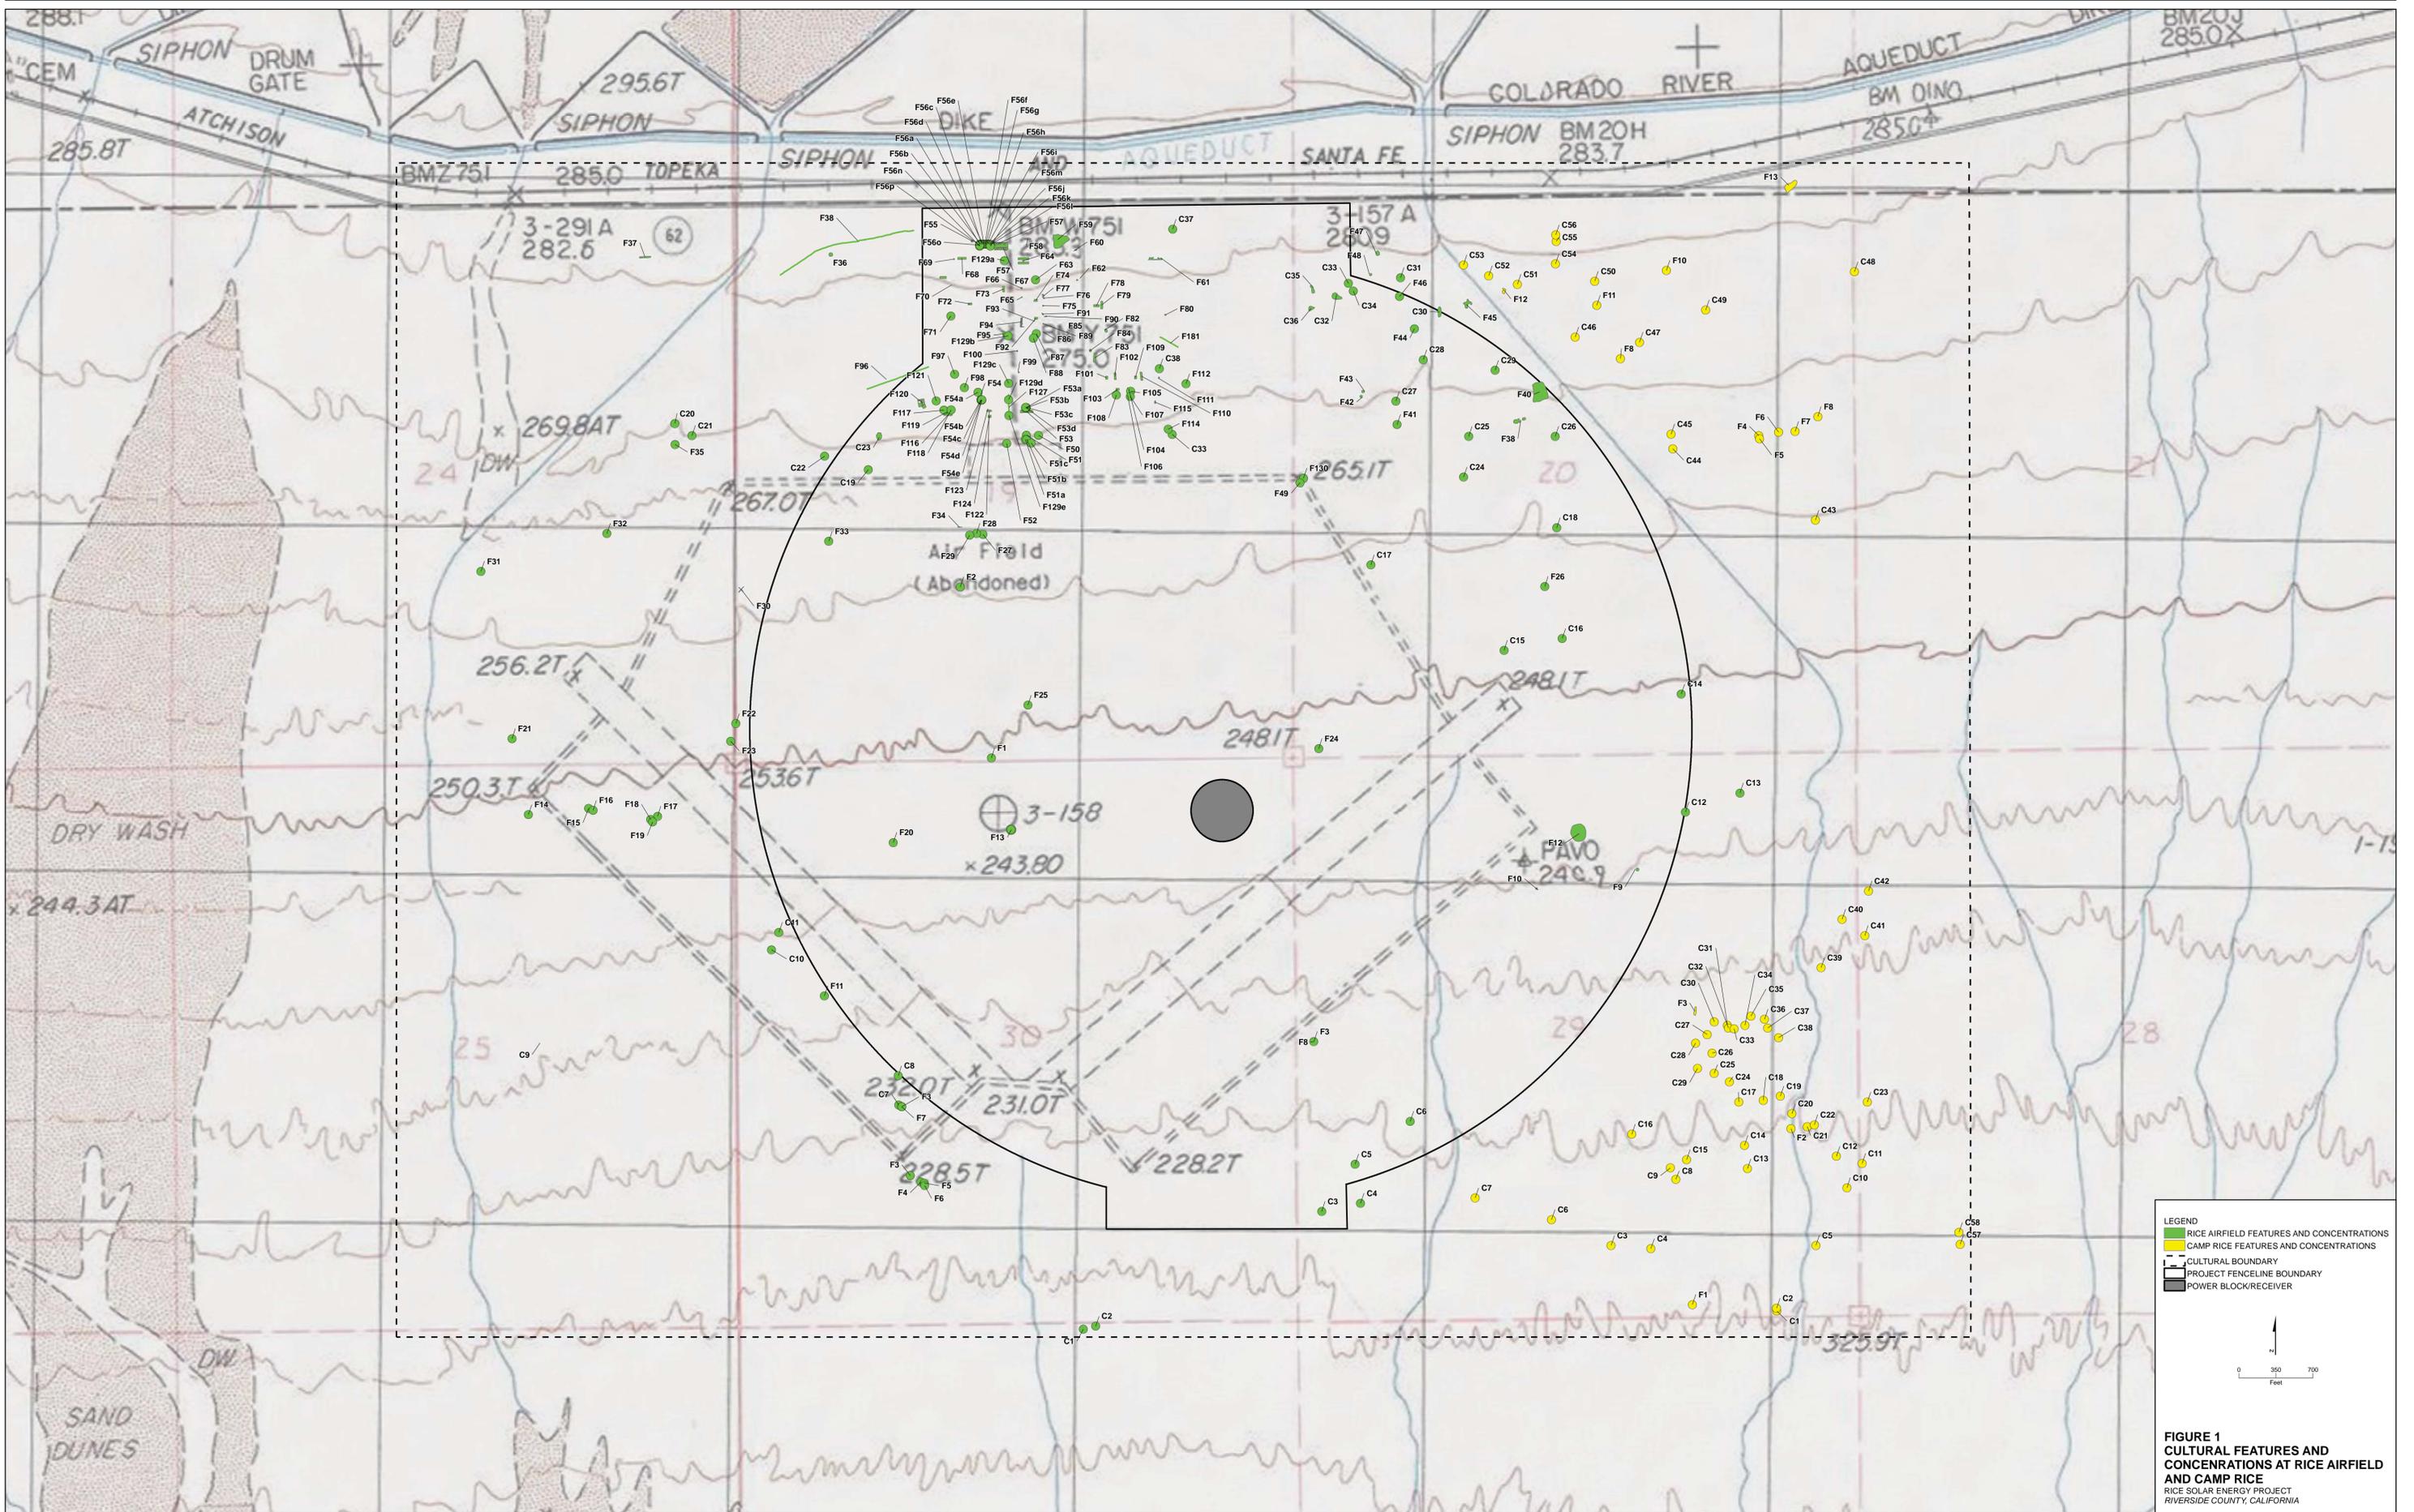
FIGURE 1
CULTURAL FEATURES AND
CONCENTRATIONS AT RICE AIRFIELD
AND CAMP RICE
 RICE SOLAR ENERGY PROJECT
 RIVERSIDE COUNTY, CALIFORNIA

Information: Every feature was recorded using a Trimble GeoXT GPS unit. All features were mapped as GIS polygons or lines, rather than as points, including concrete foundations, rock-lined pits, trenches, and rock piles. In many cases the features are so small that a point shows up on a map better than a polygon to show relationships between features, especially for features smaller than 5 x 5 meters. Figure 1, attached, shows the locations of all of the Rice Army Airfield features and artifact concentrations.

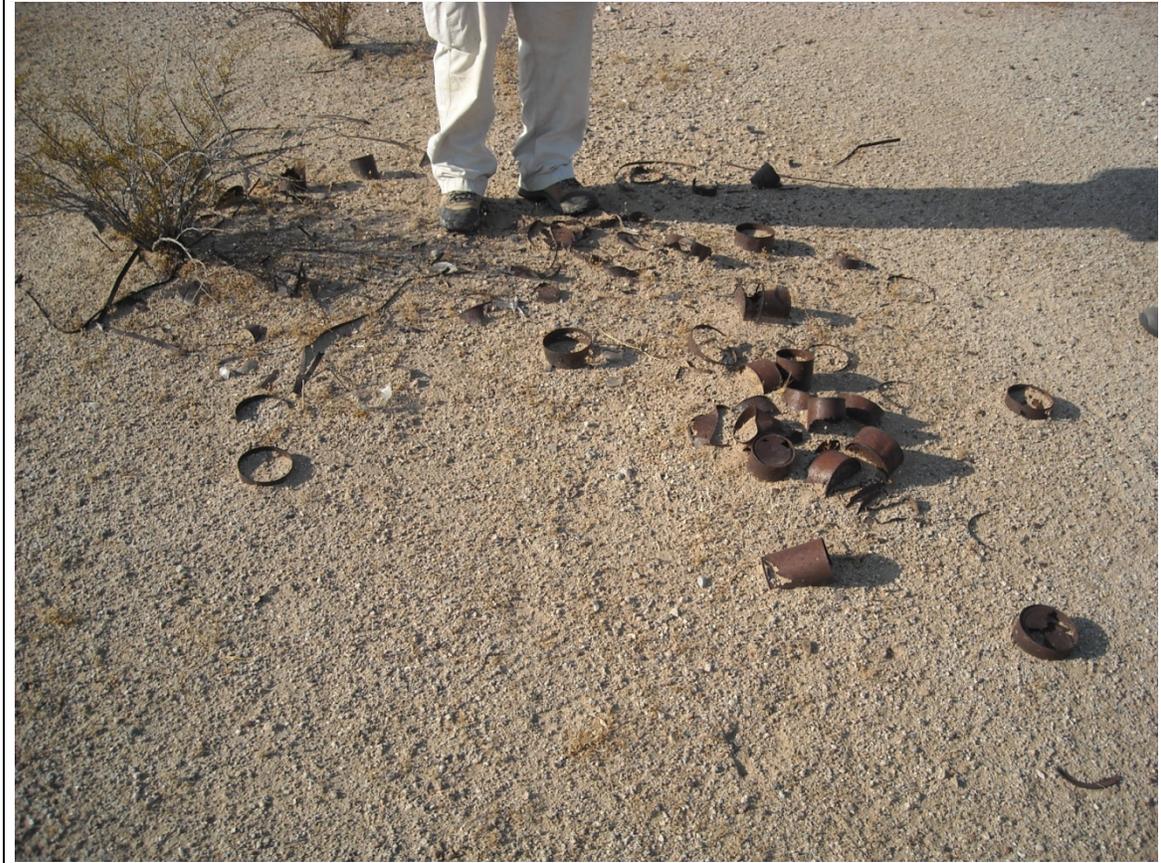
C-1 (Concentration 1)

Photo description: Overview of C-1, view to the south. Photo #0478.

Description of Artifact Concentration: This concentration is a single-episode dump of approximately 40 cans or can lids with some associated metal strapping. No other class of artifacts was noted. The cans are all Army c-ration cans, which held foods (solids and liquids) of various types. The cans were manufactured using modern techniques with crimped double-end seams and locked-side seams. The cans are all found within an area covering no more than 8 feet in diameter. This concentration is located south of the airfield and away from any features.

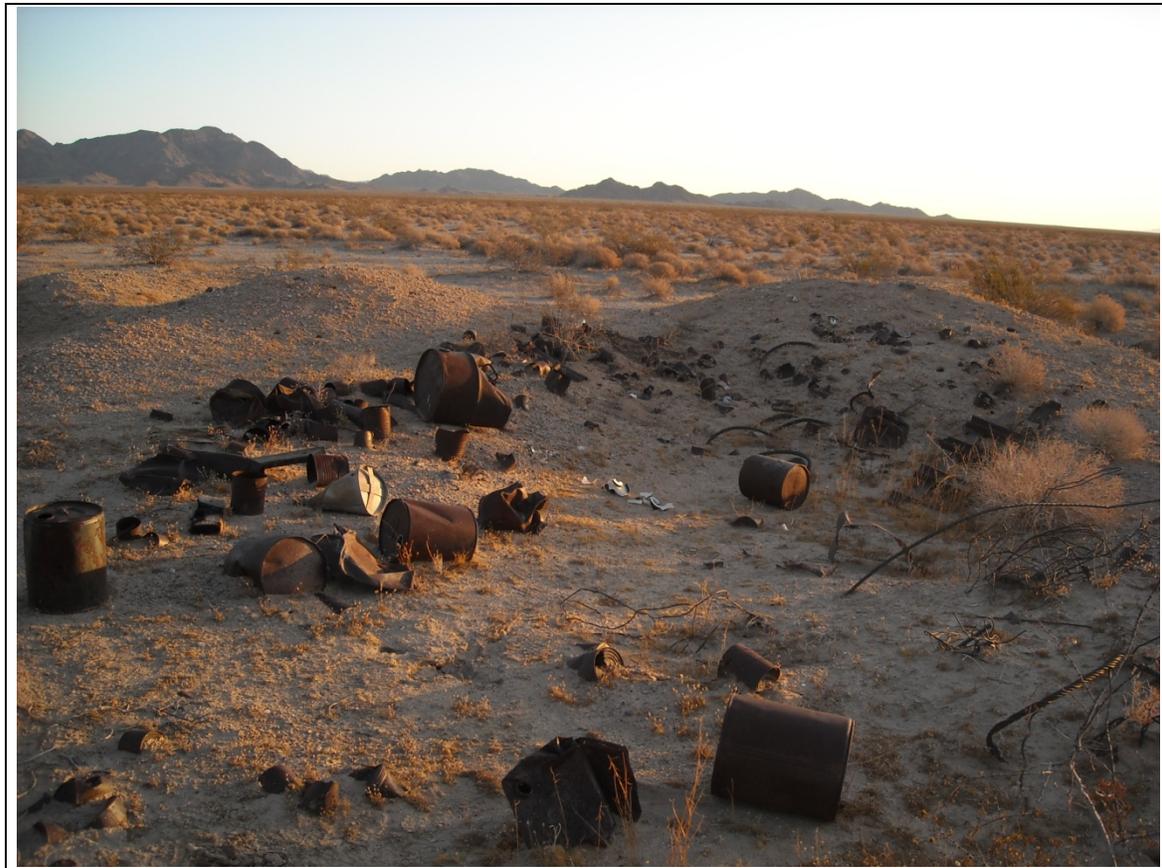
C-11 (Concentration 11)

Photo description: Overview of C-11, view to the northeast. Photo #0551.

Description of Artifact Concentration: This concentration contains a large number of historic debris contained within a 5-meter diameter area. It appears to be in a possible large, shallow pit due to several low mounds of dirt nearby. It is unclear if the mounds of dirt are historic or if they represent looters pits looking for abandoned Army materials. Artifacts found within the pit include 10 round 5-gallon fuel cans, 2 square 5-gallon fuel cans, 2 55-gallon drums, 14 one-gallon paint cans, numerous #10 food cans, coffee cans, Army c-ration cans and beverage cans. The debris also includes sections of stove pipe, a galvanized bucket, a military ammunition box lid, ceramic insulator fragments, clear glass bottle and jar fragments, and 1/2" steel cable. The debris also includes aluminum pull top beer cans. This concentration is located beside the western runway, between the runway and the taxiway.

Potential for Sub-Surface Artifacts/Features: The cans in this concentration are partially buried under a sheet of sand and sediments. There remains the potential for further buried cultural materials, but it is unlikely the number or types of buried materials would differ substantially from that noted on the surface.

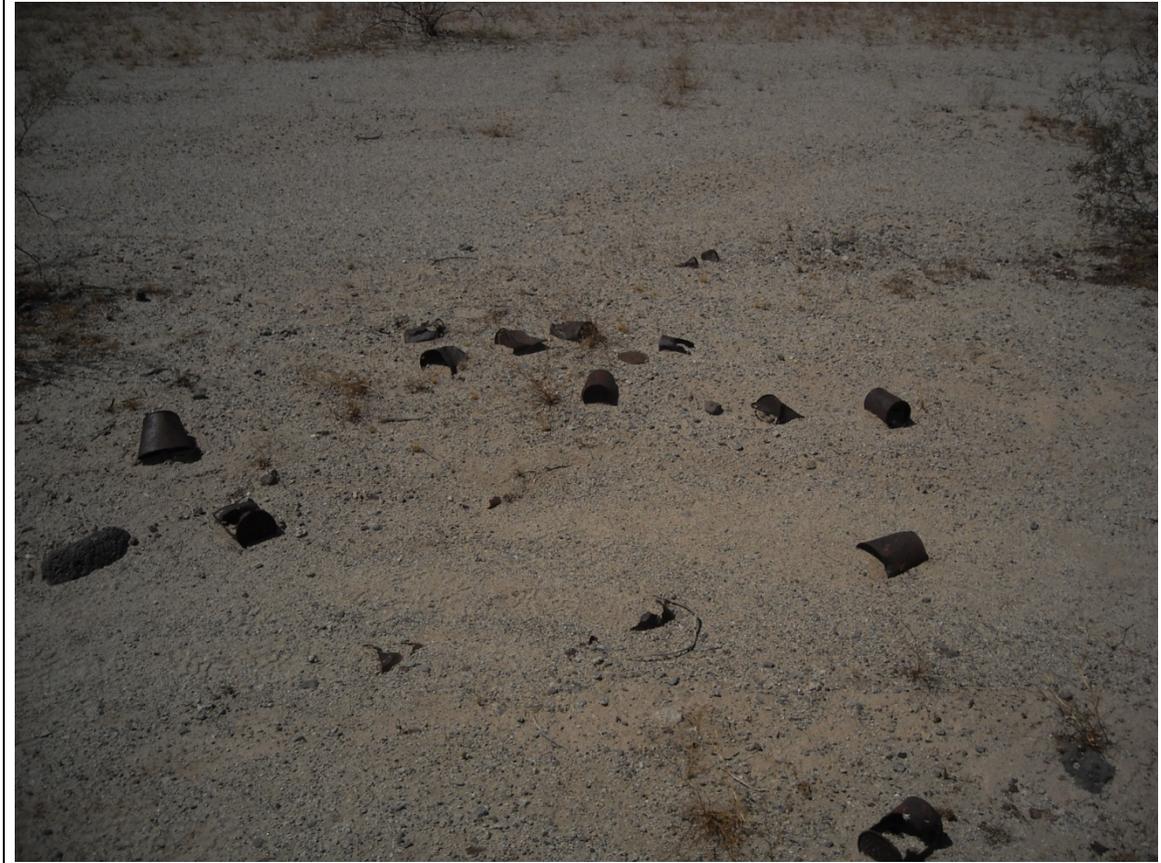
C-21 (Concentration 21)

Photo description: Overview of C-21, view to the west. Photo #0615.

Description of Artifact Concentration: This concentration is located in an area of braided washes on the west side of the Airfield. The concentration is partially buried from erosional processes. The concentration contains approximately 20 cans and some clear glass jar fragments in a 20' diameter area. The cans include hole-in-top, matchstick filler soldered condensed milk cans, Army c-ration food cans, an external friction can lid. The clear glass includes jar fragments and a bottle finish.

Potential for Sub-Surface Artifacts/Features: The cans in this concentration are partially buried under a sheet of sand and sediments. There remains the potential for further buried cultural materials, but it is unlikely the number or types of buried materials would differ substantially from that noted on the surface.

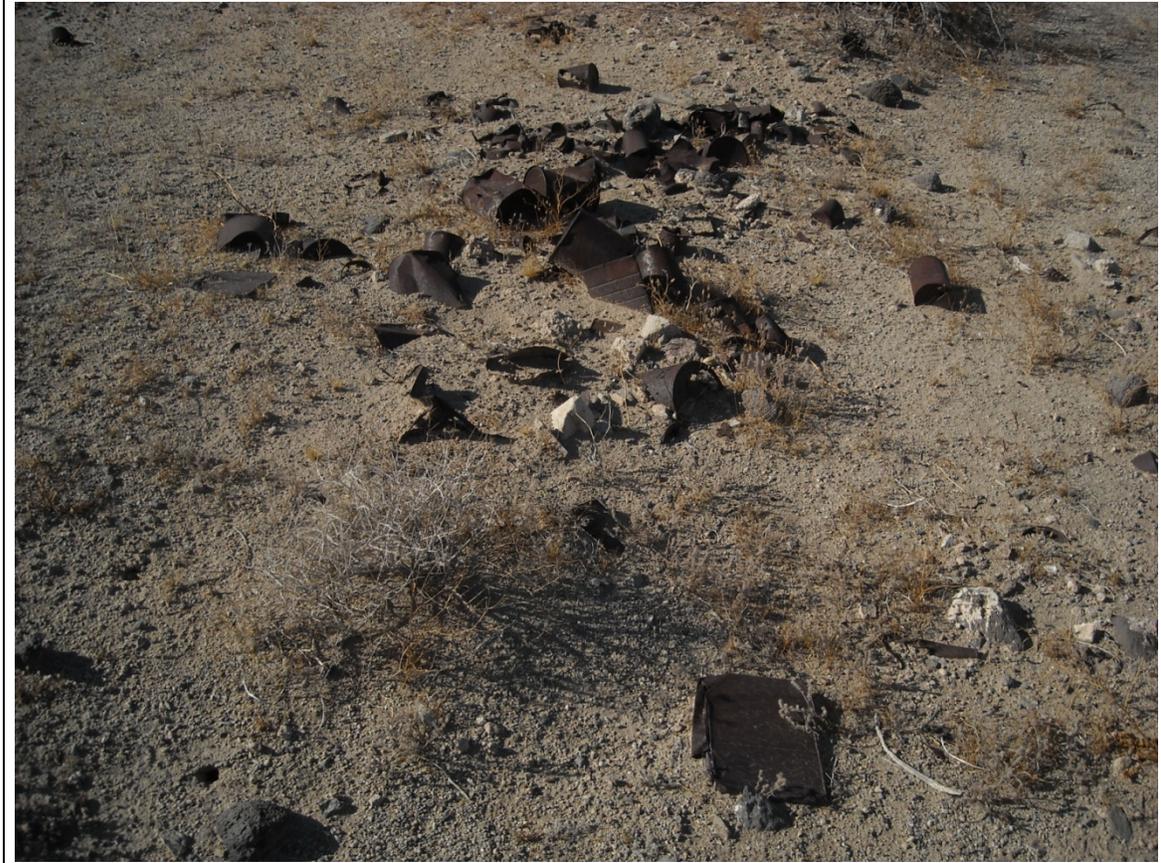
C-31 (Concentration 31)

Photo description: Overview of C-31, view to the southwest. Photo #0663.

Description of Artifact Concentration: This concentration is located in an area of braided washes on the east side of the Airfield, between the Airfield and Camp Rice in an area where the flood flow has broken through the protective barrier. The concentration is partially buried from erosional processes. The concentration contains approximately 80 cans and some clear glass fragments in a 15' diameter area. The artifacts include 4 hole-in-top, matchstick filler soldered condensed milk cans, 30 Army c-ration food cans, 12 #10 food cans, 2 coffee cans, external friction can lids, numerous rusted and crushed cans that could not be identified, and clear glass jar fragments.

Potential for Sub-Surface Artifacts/Features: The cans in this concentration are partially buried under a sheet of sand and sediments. The remains have the potential for further buried cultural materials, but it is unlikely the number or types of buried materials would differ substantially from that noted on the surface.

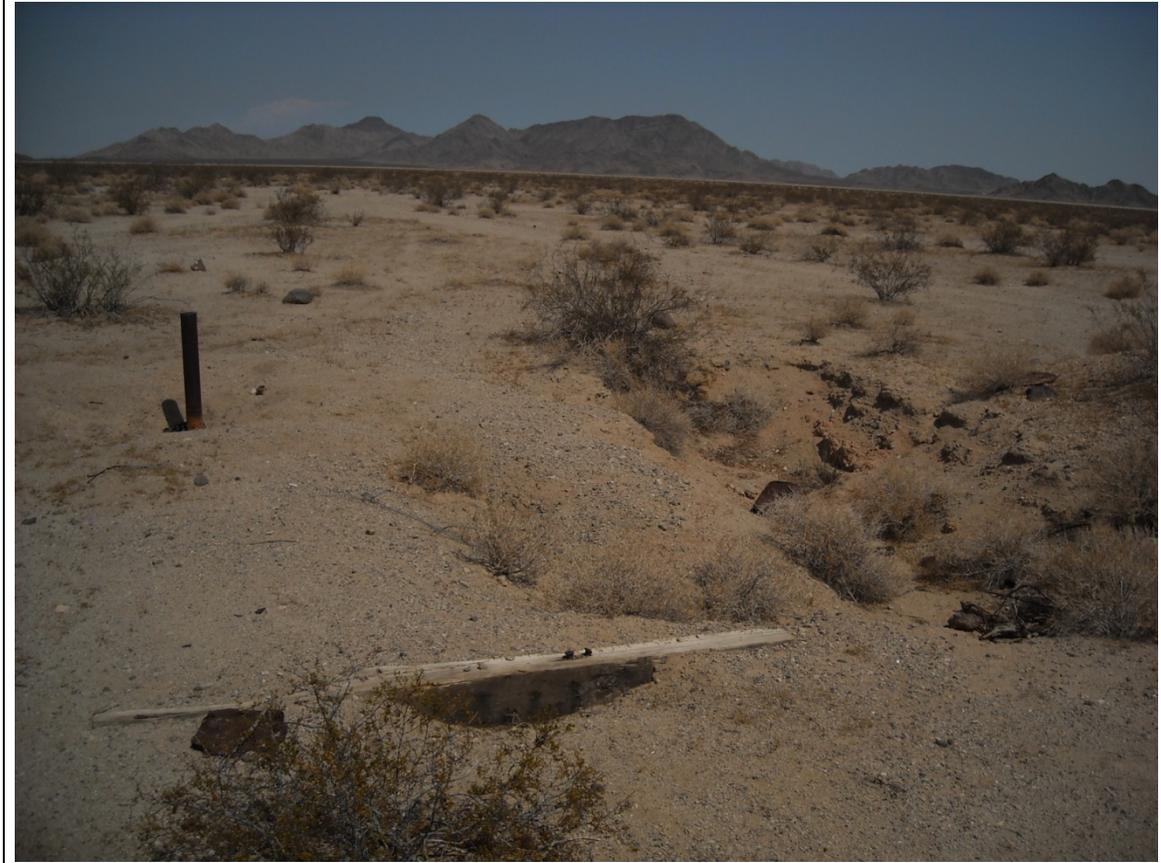
F-1 (Feature 1)

Photo description: View north of feature. Abutment is in foreground. Photo #0484.

Description of Feature: This feature consists of a capped well casing, an adjacent 6"x12" buried wooden abutment, and an excavated area and backdirt pile. The excavation took place in the modern era, likely by looters looking for buried WWII Army artifacts. Associated artifacts include modern cans and glass, with undateable steel cable, steel bands, and lumber fragments. It is unclear whether or not this well casing and abutment date to WWII, there is not enough datable artifacts to clearly date or associate this with the Rice Army Airfield.

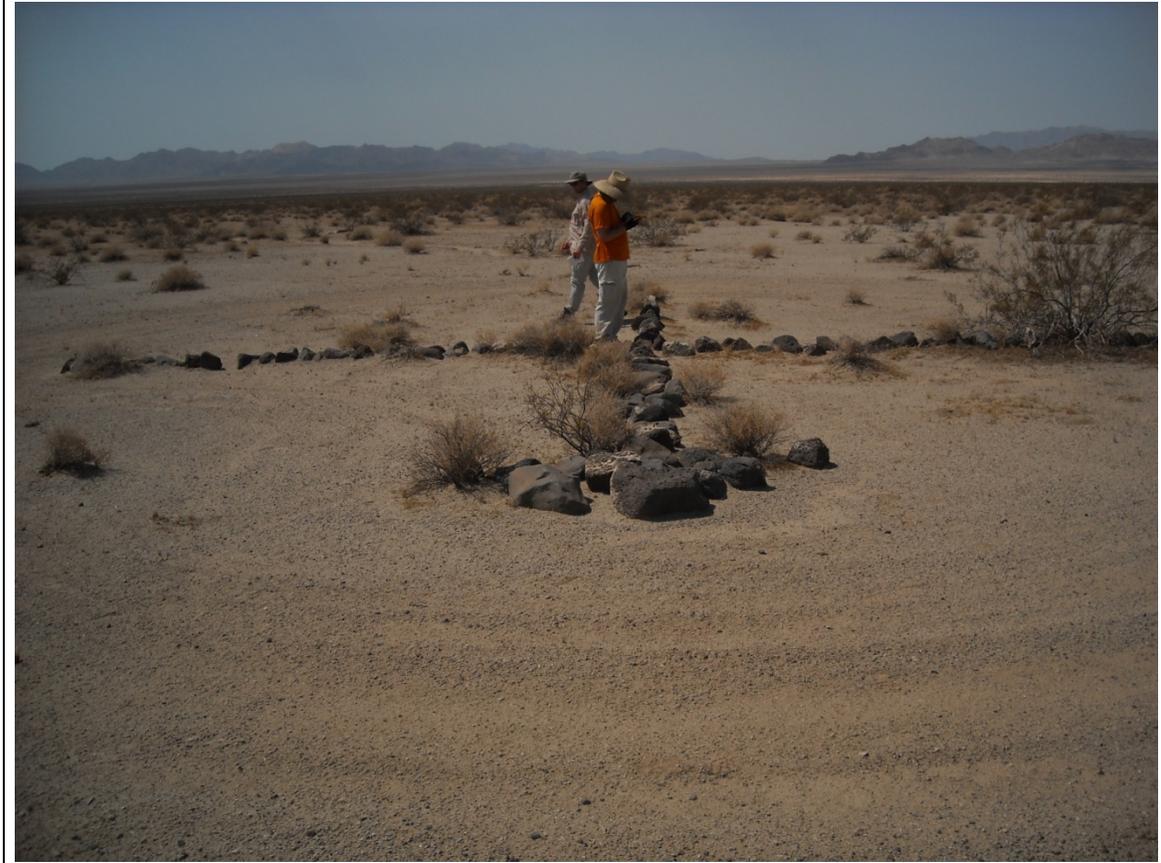
F-2 (Feature 2)

Photo description: View southwest of feature. Potential arrow is in foreground. Photo #0485.

Description of Feature: This feature consists of a large stone “X” that likely served as an aerial marker to indicate the runway is closed and not available for aircraft landing. It measures 12 meters across, made from single course of locally obtained basalt rocks. NE end has an arrow point. The feature is oriented NE/SW and NW/SE and is not located on one of the two major runways but on one of the smaller east/west taxiways. A single-hinged lid tobacco tin (Prince Albert) was found in the area. It is likely this was constructed well after WWII and would be associated with the 1950s private operation of the airfield since this was the last known use of the airfield. A similar stone feature is located on the western end of the same taxiway (F30).

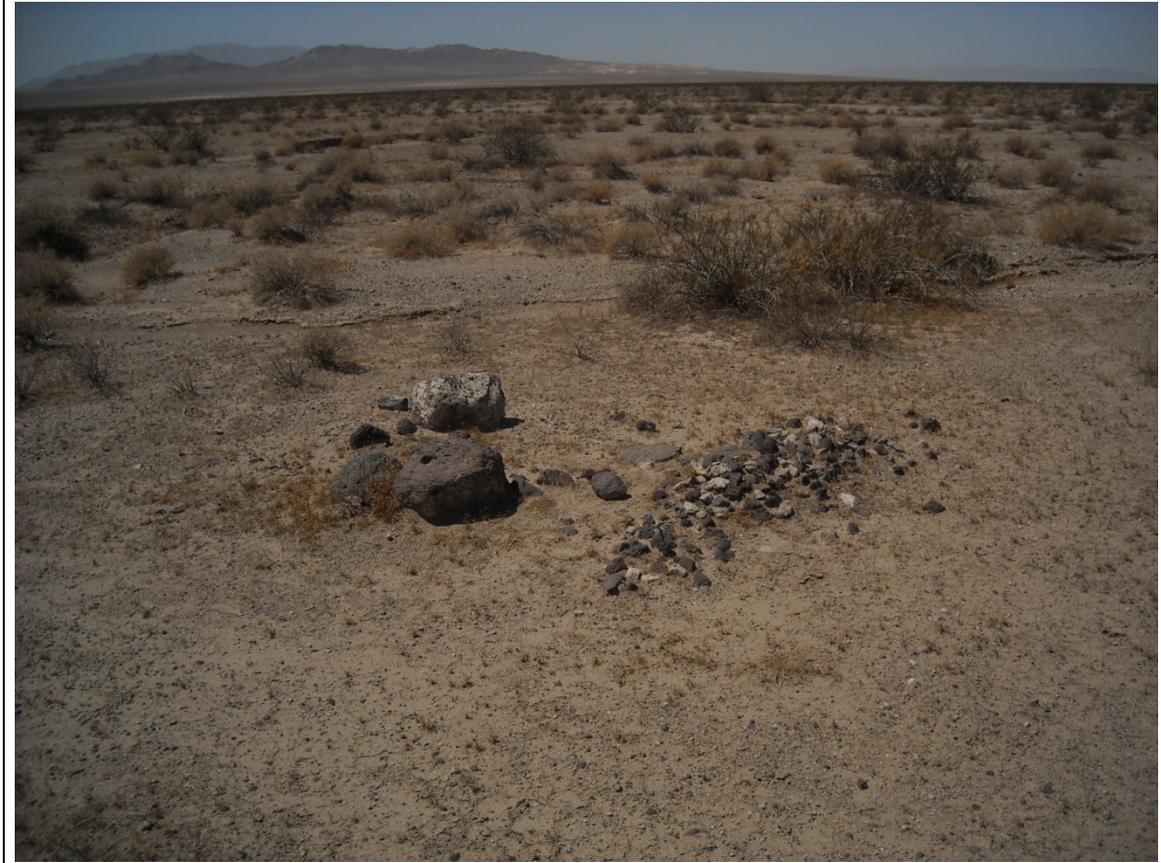
F-3 (Feature 3)

Photo description: View west of Feature 3, small mound of stones. Photo 0493.

Description of Feature: This feature consists of a small pile of baseball sized rocks measuring 60 cm x 210 cm. There are a few larger rocks in proximity, but this pile of rocks is clearly man-made. The only artifact found in association was a Coca-Cola bottle. The function of these rock piles is unknown, but the rocks this size are not naturally occurring in this area. The rocks must have been carried in from naturally occurring basalt fields to the west (within 0.25 mile). The feature is located just south of the western taxiway, but not directly associated with any of the runways, taxiways, or parking aprons.

Associations: This rock pile is similar to several others found in the general vicinity. Features F4, F5, and F6 are located approximately 125 feet to the east.

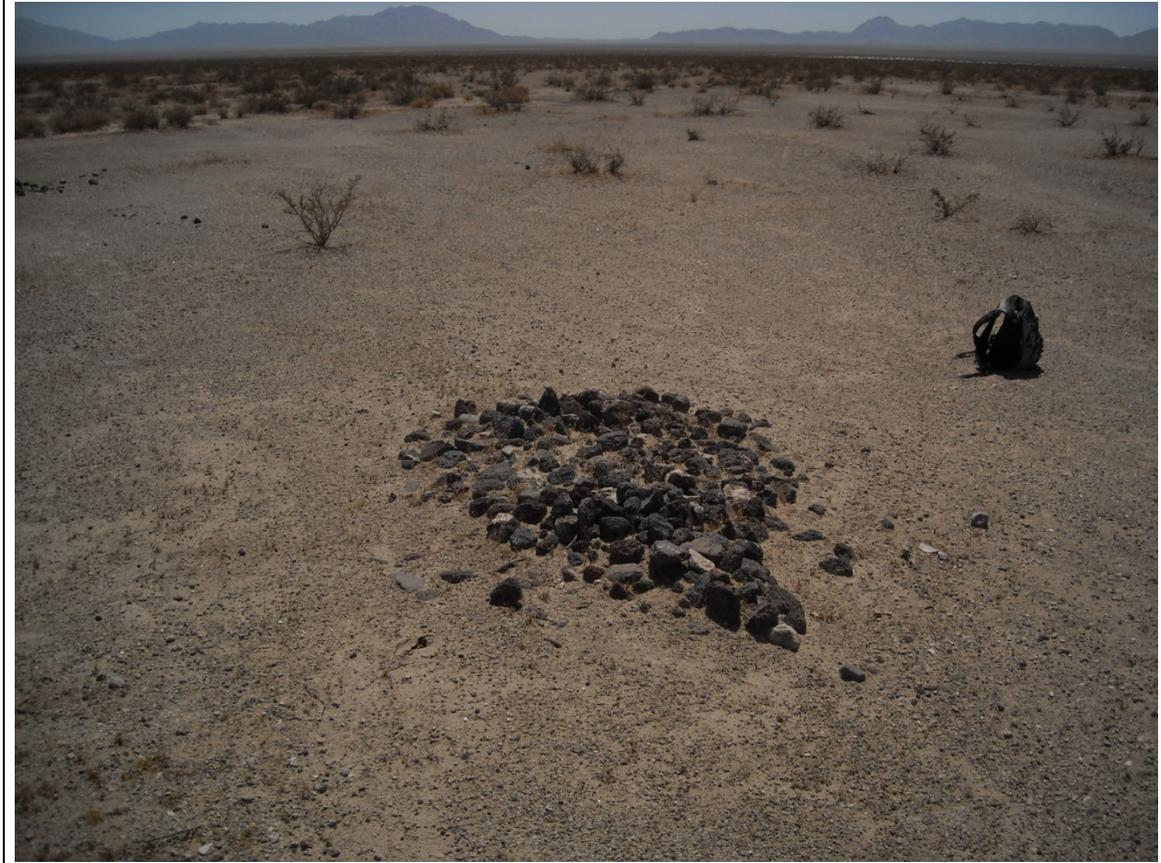
F-4 (Feature 4)

Photo description: View south of Feature 4, small mound of stones. Photo #0494.

Description of Feature: This feature consists of a small teardrop shaped rock pile of baseball-sized rocks measuring 2 m x 3.5 m. The function of these rock piles is unknown, but the rocks this size are not naturally occurring in this area. The rocks must have been carried in from naturally occurring basalt fields to the west (within 0.25 mile). The feature is located just south of the western taxiway, but not directly associated with any of the runways, taxiways, or parking aprons.

Associations: This rock pile is similar to several others found in the general vicinity. Feature F3 is located approximately 125 feet to the west and F5 and F6 are within 45 feet.

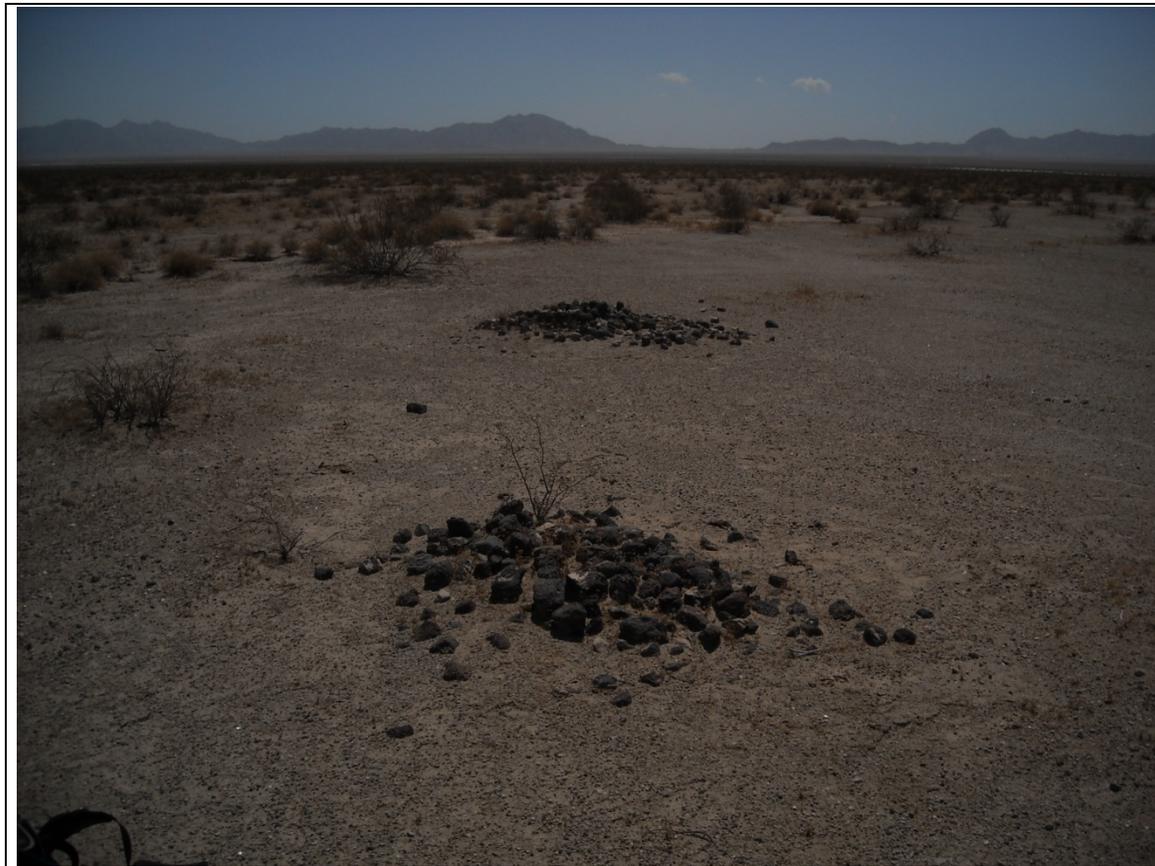
F-5 (Feature 5) and F-6 (Feature 6)

Photo description: View south of Features 5 and 6, small mounds of stones. Photo #0495.

Description of Feature: These two feature are located in such close proximity (25 feet apart) and are so similar that they are both discussed on this one form. F5 consists of a small rock pile of baseball-sized rocks measuring 2 m x 1.5 m. F-6 consists of a small rock pile of baseball-sized rocks measuring 2.5 m x 1.6 m. Both are approximately 40 cm high. The function of these rock piles is unknown, but rocks of this size are not naturally occurring in this location. The rocks must have been carried in from naturally occurring basalt fields to the west (within 0.25 mile). These features are located just south of the western taxiway, but not directly associated with any of the runways, taxiways, or parking aprons.

Associations: These rock piles are similar to several others found in the general vicinity. Feature F3 is located approximately 125 feet to the west and F4 is within 45 feet.

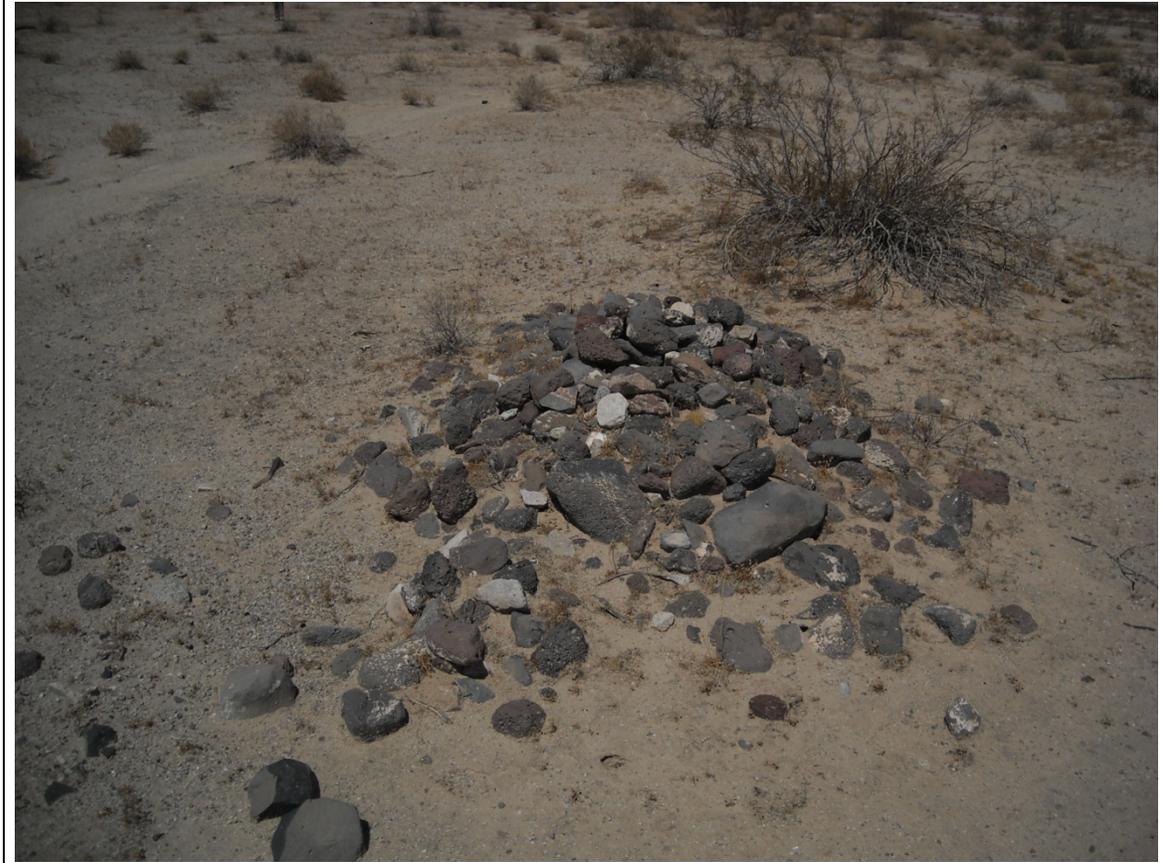
F-7 (Feature 7)

Photo description: View north of Feature 7, small mound of stones. Photo 0527.

Description of Feature: This feature consists of a small rock pile of baseball- to softball-sized rocks measuring 2 m x 3 m x .45 m high. The function of these rock piles is unknown, but rocks of this size are not naturally occurring in this location. The rocks must have been carried in from naturally occurring basalt fields to the west (within 0.25 mile). The feature is located just north of the southern end of the western taxiway between the taxiway and the runway, but not directly associated with any of the runways, taxiways, or parking aprons.

Associations: This rock pile is similar to several others found in the general vicinity. Features F3, F4, F5 and F6 are within 700 feet to the south. A burned debris dump (C-36) is located 40 feet to the west, but there is no clear association between this feature and the burned debris as there are no artifacts around this feature.

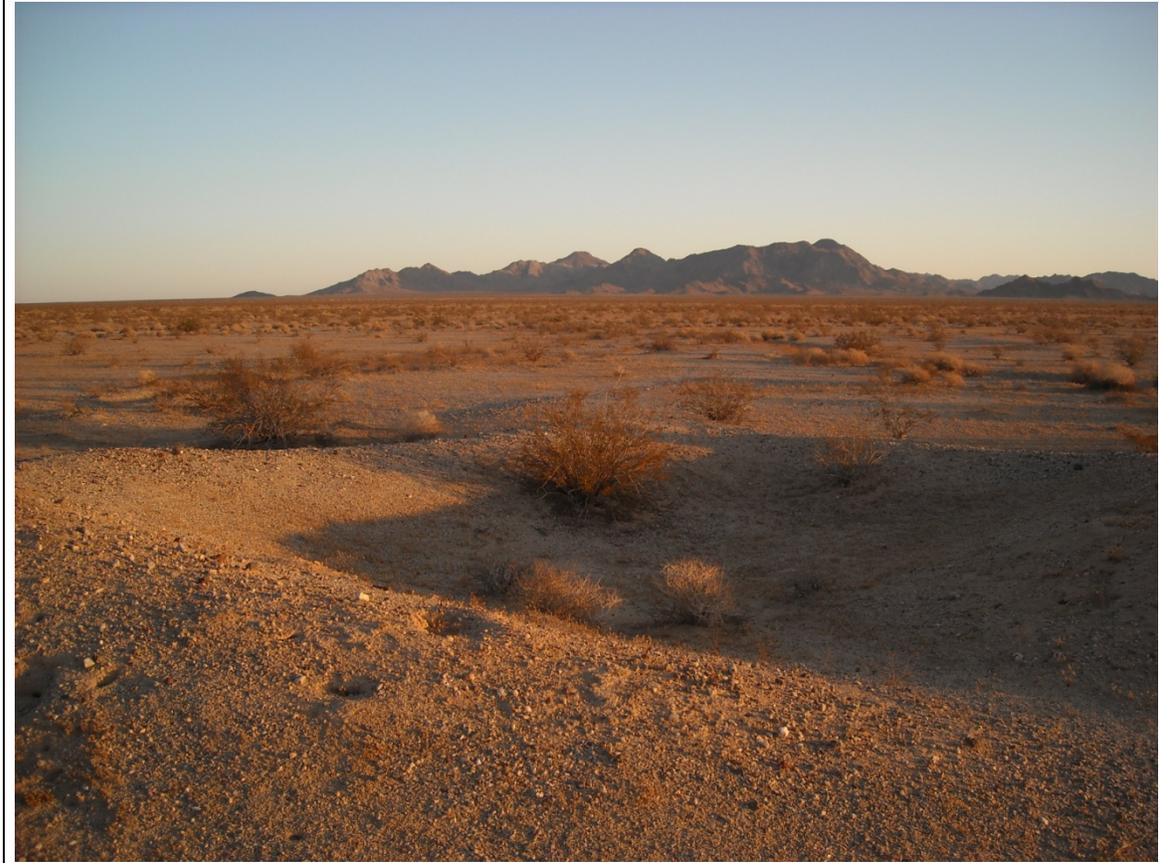
F-8 (Feature 8)

Photo description: View to the north of Feature 8, emplacement. Photo #0530.

Description of Feature: This feature is defined as an emplacement measuring 12 meters x 14 meters with earthen embankments about 40 cm high. There is an opening or an entrance to the SE corner. Overall, the emplacement is approximately 1 meter deep. This emplacement is located within the parking aprons of the eastern runway/taxiway. There were no artifacts found in association with this feature.

Potential for Sub-Surface Artifacts/Features: There is a low probability of buried subsurface material in this emplacement. There were no surface artifacts found in the area, and while there is a possibility of finding small artifacts that may have been dropped and buried in the earthen floor of the feature, there is little potential for finding any features or artifacts that would substantially increase our knowledge of the airfield.

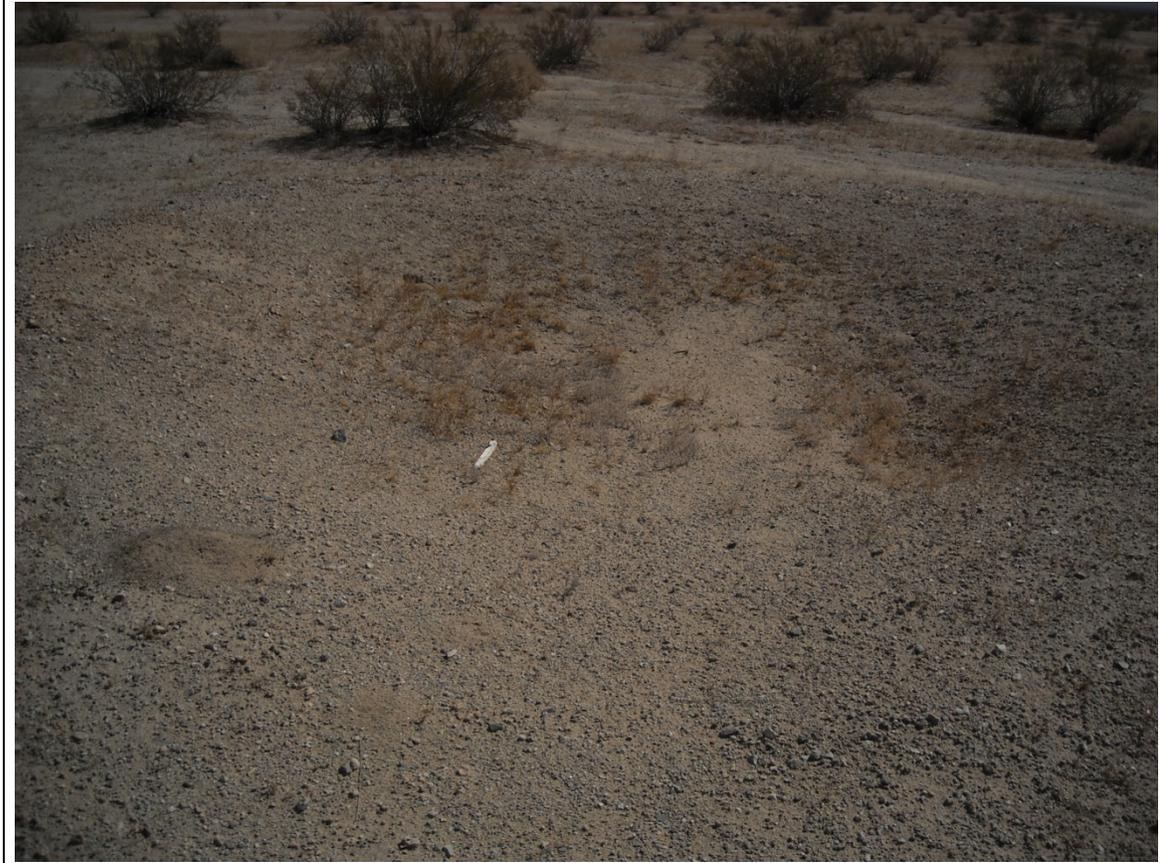
F-9 (Feature 9)

Photo description: View to the east of Feature 9, emplacement. Photo #0546.

Description of Feature: This feature is an earthen pit or an emplacement measuring 8 meters x 8 meters with earthen berms approximately 30 cm high. There is an entrance break in the berms to the west. Overall pit is approximately 1 meter deep, but through infill and erosion, the sides are much shallower and the walls are smaller than they were. The feature is located east of the northern end of the eastern runway. There are no artifacts or artifact concentrations in association with this feature.

Potential for Sub-Surface Artifacts/Features: There is a low probability of buried subsurface material in this emplacement. There were no surface artifacts found in the area, and while there is a possibility of finding small artifacts that may have been dropped and buried in the earthen floor of the feature, there is little potential for finding any features or artifacts that would substantially increase our knowledge of the airfield.

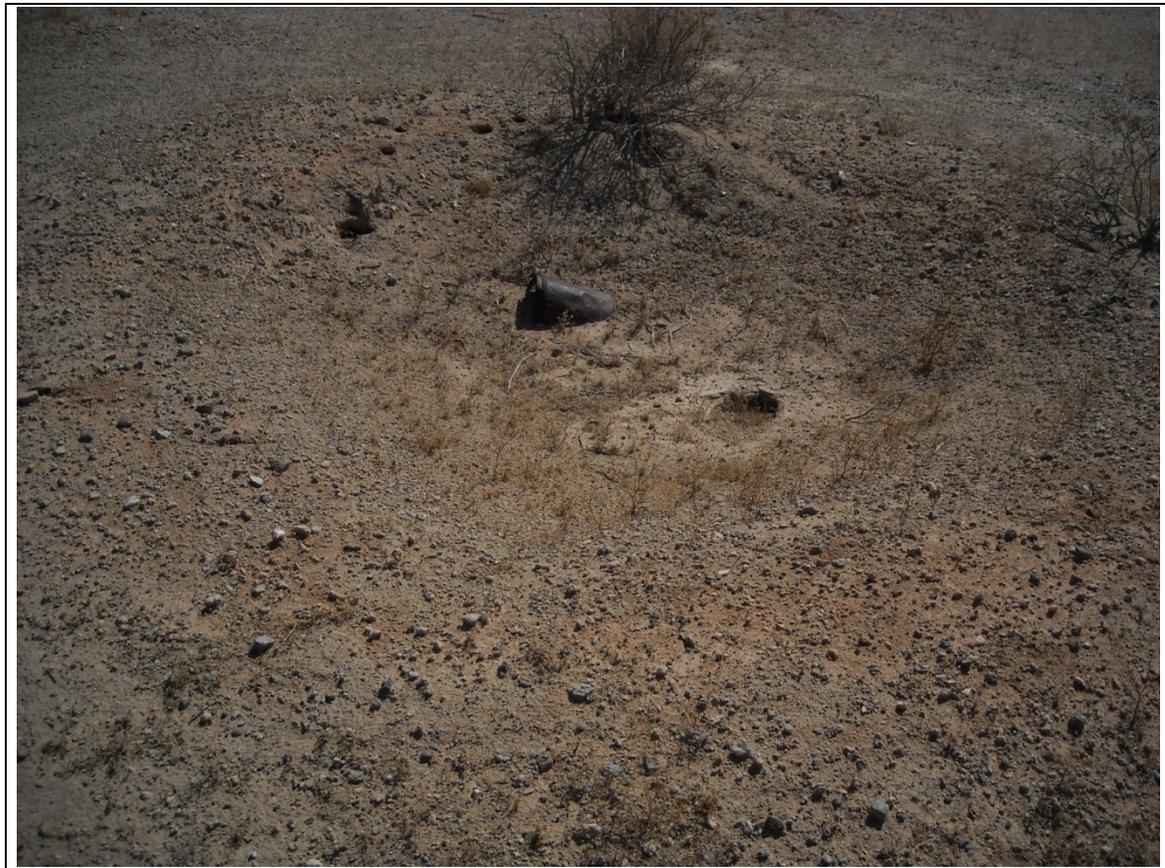
F-10 (Feature 10)

Photo description: View east of Feature 10, pit with associated cans. Photo #0547.

Description of Feature: This feature is a small earthen pit measuring 5 x 5 meters and approximately 60 cm deep. Inside the pit is a 5-gallon paint bucket, and outside is a 1-gallon fuel can and a section of a fuel hose.

Date of Feature: The artifacts found around the feature are not by themselves diagnostic. However, these same fuel and paint cans have been found at other locations across the site in direct association with diagnostic materials that would date the cans to 1942 – 1944, the period of Army occupation of the airfield.

Potential for Sub-Surface Artifacts/Features: There is moderate potential for uncovering buried cultural material within this pit. The partially buried 5-gallon bucket within the pit indicate the active erosion filling in the pit. While the potential for buried deposits remains, the types of the deposits are likely to be similar to other deposits found around the site which consist of mainly WWII-era food ration cans and industrial type deposits expected in an airfield.

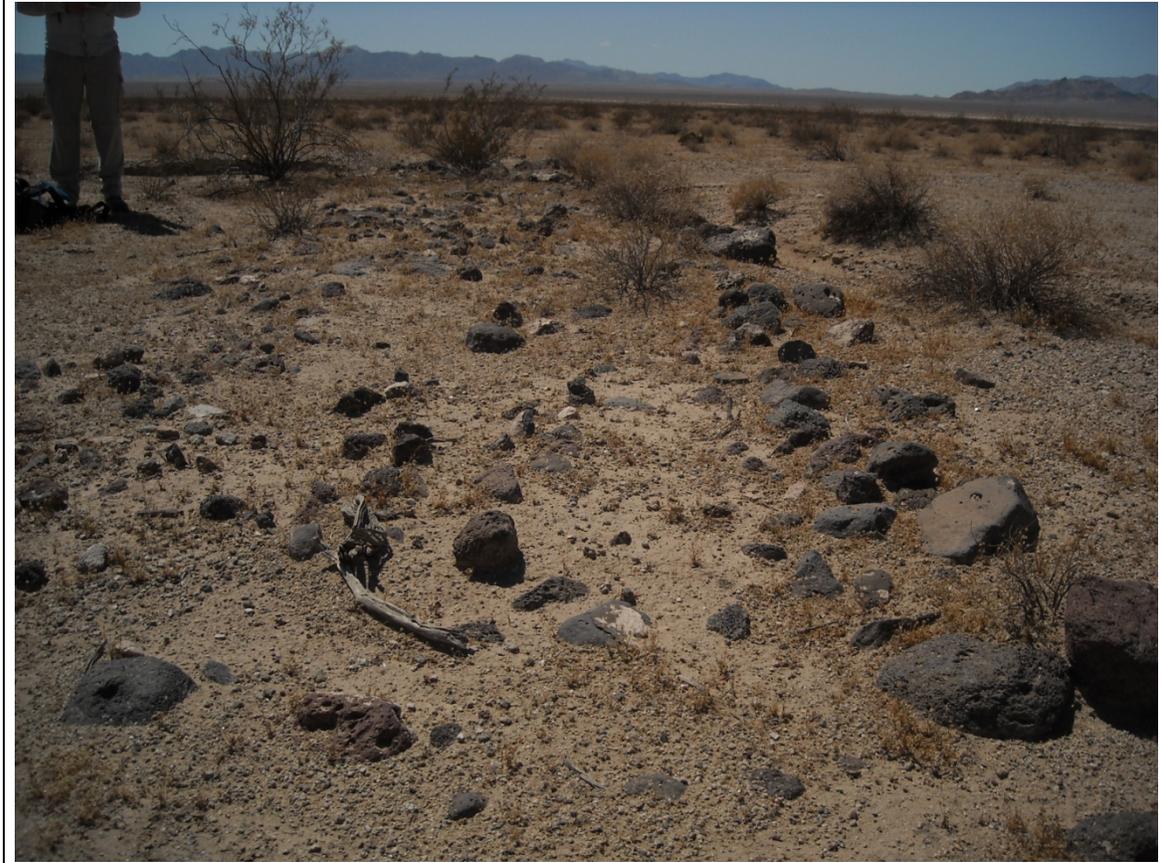
F-11 (Feature 11)

Photo description: Overview of Feature 11, view to the southwest. Photo #0549.

Description of Feature: This feature is a rock feature measuring 2.2 meters wide by 14 meters long. It is made of locally available basalt rocks aligned one course deep. It is located between the western runway and the taxiway. The function of this feature is unknown.

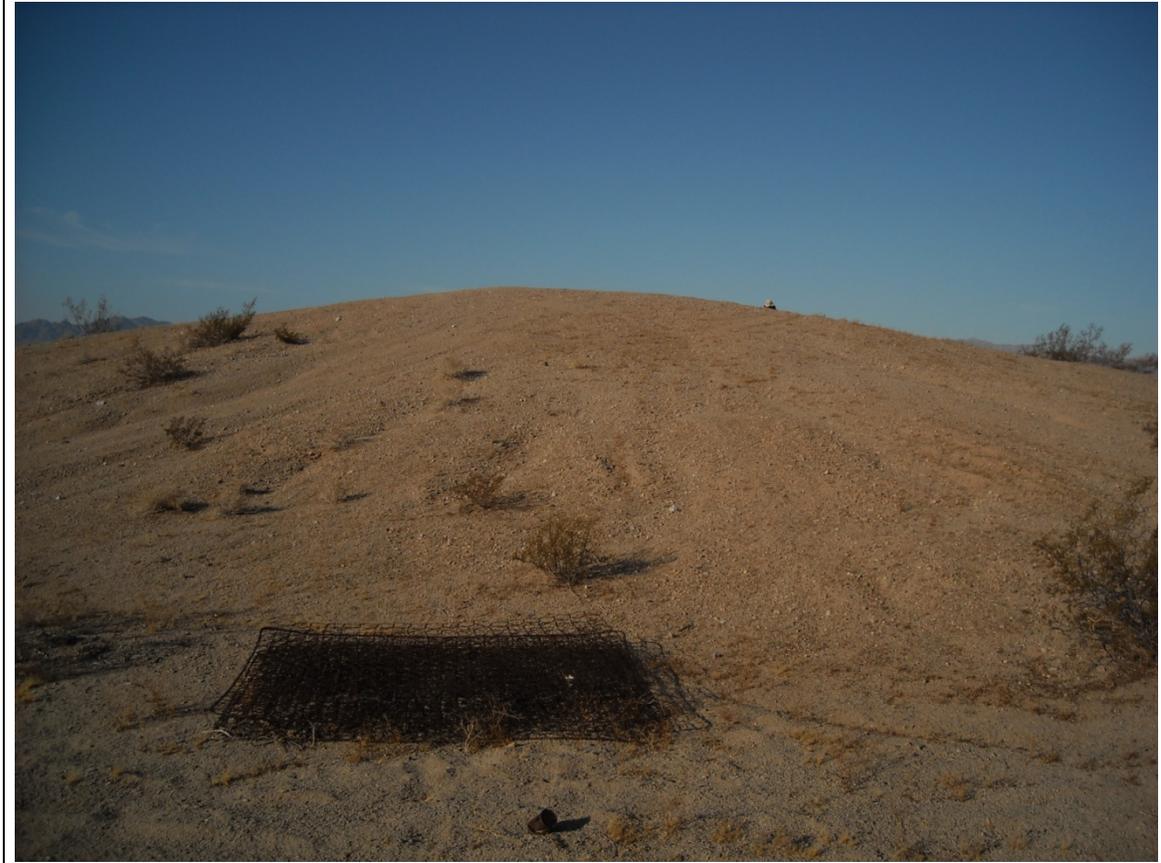
F-12 (Feature 12)

Photo description: Overview of Feature 12, view to the southeast. Photo #0553

Description of Feature: This feature is a large mound of dirt located off of the eastern taxiway. It is accessed off of the taxiway that leads to the northernmost parking apron on the eastern side of the airfield. The dirt mound is 6 meters high. It has been partially excavated in several locations, in two locations it appears that cuts have been made with heavy equipment. ATV trails cross over the mound in several locations. The mound is surrounded by modern debris and no historical debris or direct associations with other historical features.
