Subject: Rice Solar Energy Project (09-AFC-10)
Supplementary Information Items #7-11, Additional Information
Regarding the Archaeological Features at Rice Army Airfield

Rice Solar Energy Project

CEC Docket #09-AFC-10

Attachment SII9-1
Rice Army Airfield Feature Forms

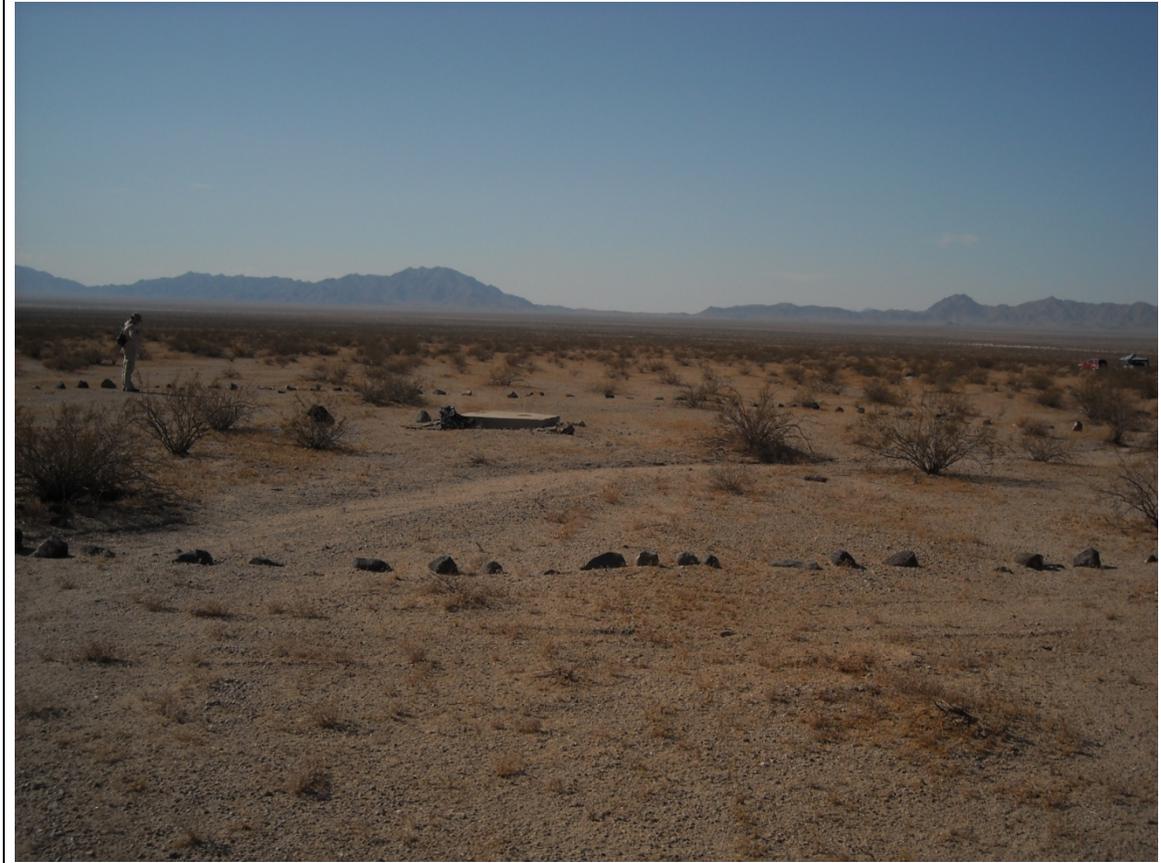
F-13 (Feature 13)

Photo description: Overview of Feature 13, view to the north. Photo #0557

Description of Feature: This feature consists of a small concrete slab measuring 59" x 59" with four anchor bolts 10" high. The concrete slab is surrounded by a 30 meter diameter ring of basalt rocks making a large stone circle around the concrete. The feature is located very near the center of the airfield. The concrete likely supported an airfield feature, possibly a windsock or a flagpole. There are a few artifacts in the area including a few c-ration cans, some glass fragments, and some small segments of 1" x 6" lumber.

Date of Feature: The feature itself is not diagnostic, but the cans found in association indicate a date of 1942-1944.

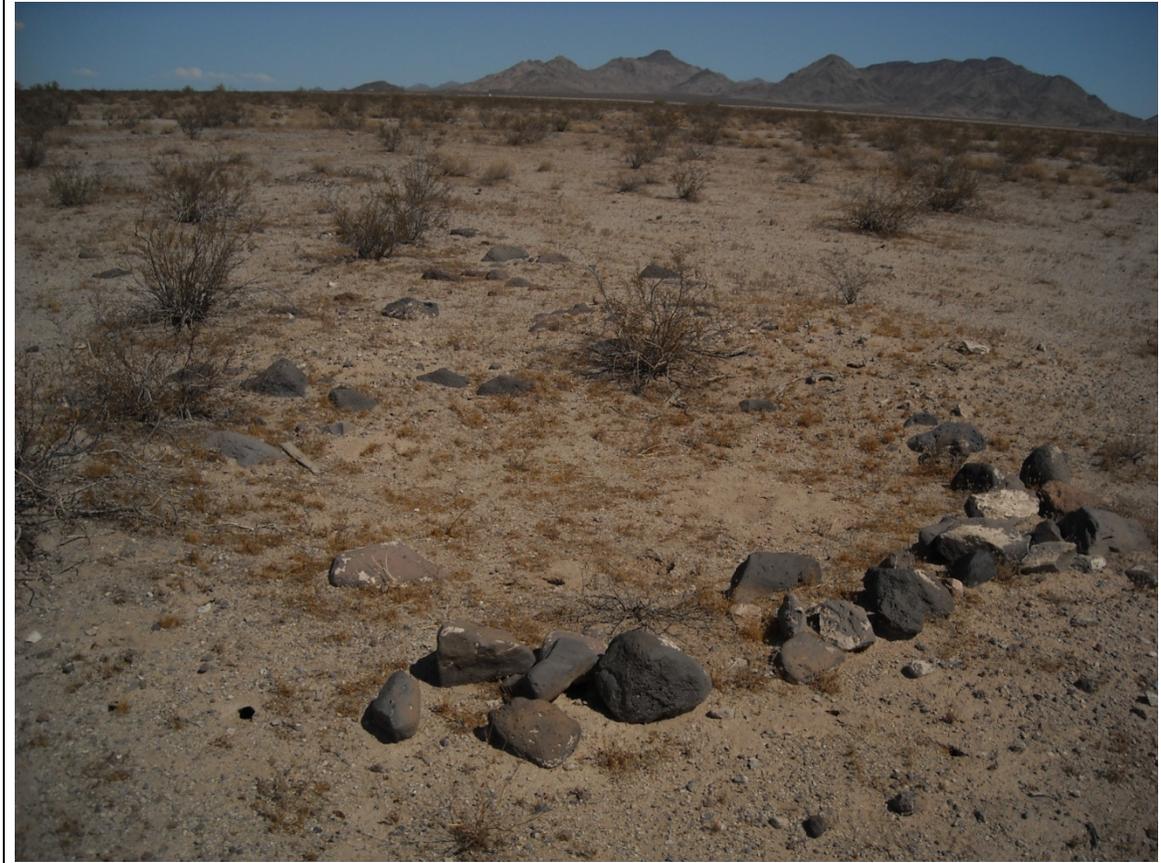
F-14 (Feature 14)

Photo description: Overview of Feature 14, view to the north. Photo #0558

Description of Feature: This feature is a pit measuring 5 m x 5 m with rocks lining the exterior surface of the pit. The pit is only 30 cm deep, and given the color and vegetation change in the soils, it may have originally been a little deeper. The pit is located near the northern parking aprons on the west side of the airfield. The area appears to have been used in multiple dumping episodes, likely from clearing the runways of rock. Associated artifacts include amber glass bottle fragments and a D-cell battery

Potential for Sub-Surface Artifacts/Features: There is a moderate potential for buried cultural materials in this feature. The pit has clearly had some infill from erosion. The potential for buried cultural materials that is substantially different from the materials gathered in other areas of the site is very low. The materials observed across the site remain remarkably homogeneous in date and variety.

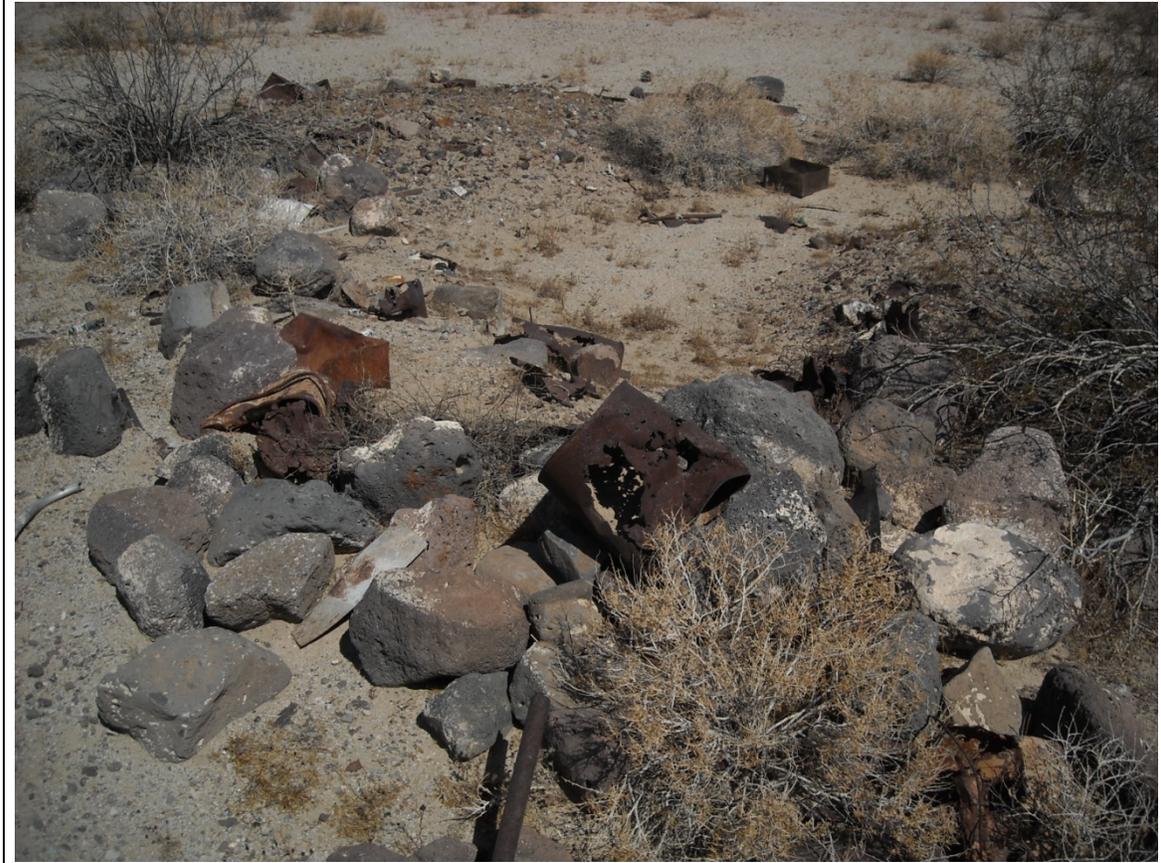
F-15 (Feature 15)

Photo description: Overview of Feature 15, view to the north. Photo #0559.

Description of Feature: This feature is an 8-meter-diameter debris dump pile/pit. The pit and banks are filled with burned debris including fragments of metal, glass, and cans. Also noted were batteries, fuses, aluminum aircraft parts, hinges, and an antenna. The pit is located between the western taxiway and runway, near the northern end.

Date of Feature: From the few identifiable cans noted, the debris likely dates to 1942 – 1944.

Potential for Sub-Surface Artifacts/Features: There is a high potential for buried cultural deposits in this feature. The buried deposits would likely be very similar in composition and age as the fragments noted on the surface. It is unknown how deep this pit may be, but the presence of obviously burned materials on the surface suggest the buried deposits would also be burned.

Associations: The pit is associated with the runways and the taxiway on the west side of the airfield, and it is located within 50 feet of Feature 16, another possible burned debris dump.

Interpretations: This feature was clearly a pit where refuse was dumped and then burned. The amount of burned metal and cans on the surface indicate that a decent amount of material was burned here. This pit was likely associated with the WWII Army occupation of the airfield.

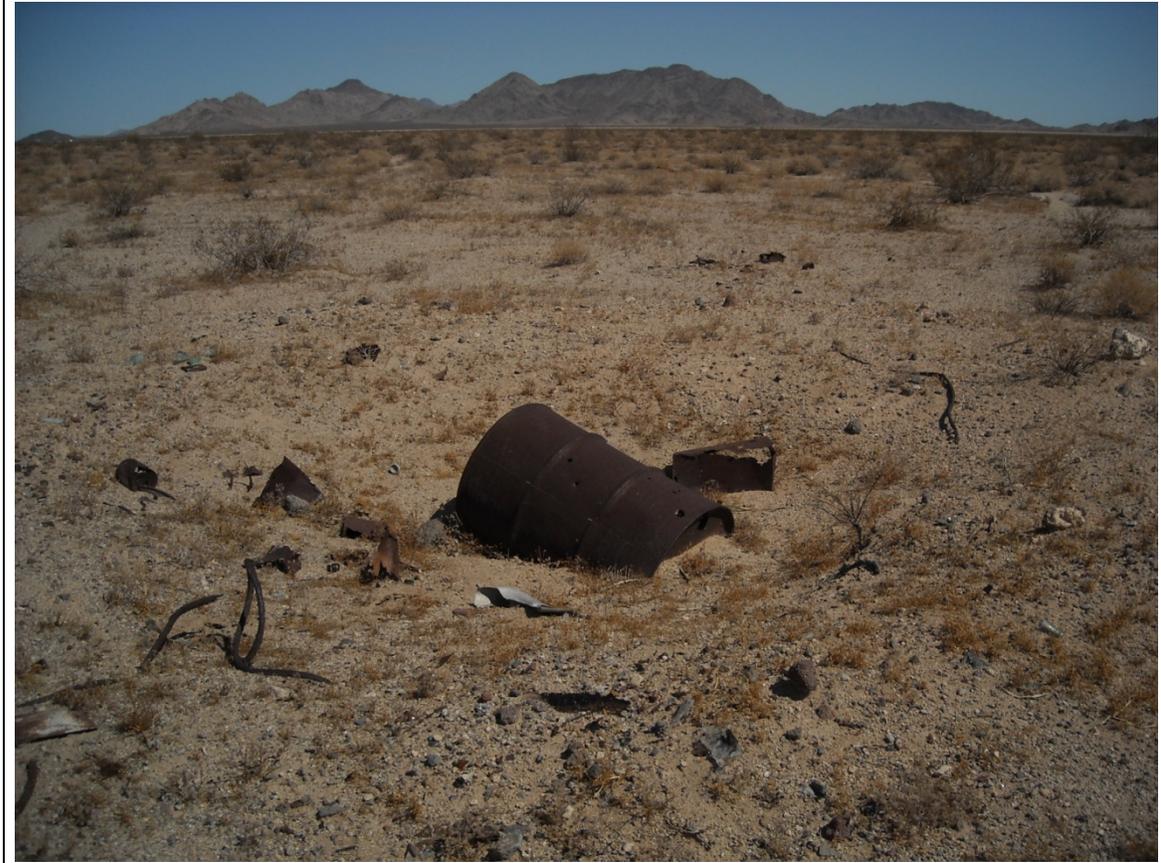
F-16 (Feature 16)

Photo description: Overview of Feature 16, view to the north. Photo #0560.

Description of Feature: This feature is shallow pit with a 55 gallon-drum partially buried near the center. There is burned debris located around the edges along with steel cables and a Coca-Cola bottle. The pit is located between the western taxiway and runway, near the northern end.

Date of Feature: From the few identifiable cans noted, the debris likely dates to 1942–1944.

Potential for Sub-Surface Artifacts/Features: There is a high potential for buried cultural deposits in this feature. The buried deposits would likely be very similar in composition and age as the fragments noted on the surface. It is unknown how deep this pit may be, but the presence of obviously burned materials on the surface suggests that any buried deposits would also be burned.

Associations: The pit is associated with the runways and the taxiway on the west side of the airfield, and it is located within 50 feet of Feature 15, another possible burned debris dump.

Interpretations: This feature was clearly a pit where refuse was dumped and then burned. The amount of burned metal and cans on the surface indicate that a decent amount of material was burned here. This pit was likely associated with the WWII Army occupation of the airfield.

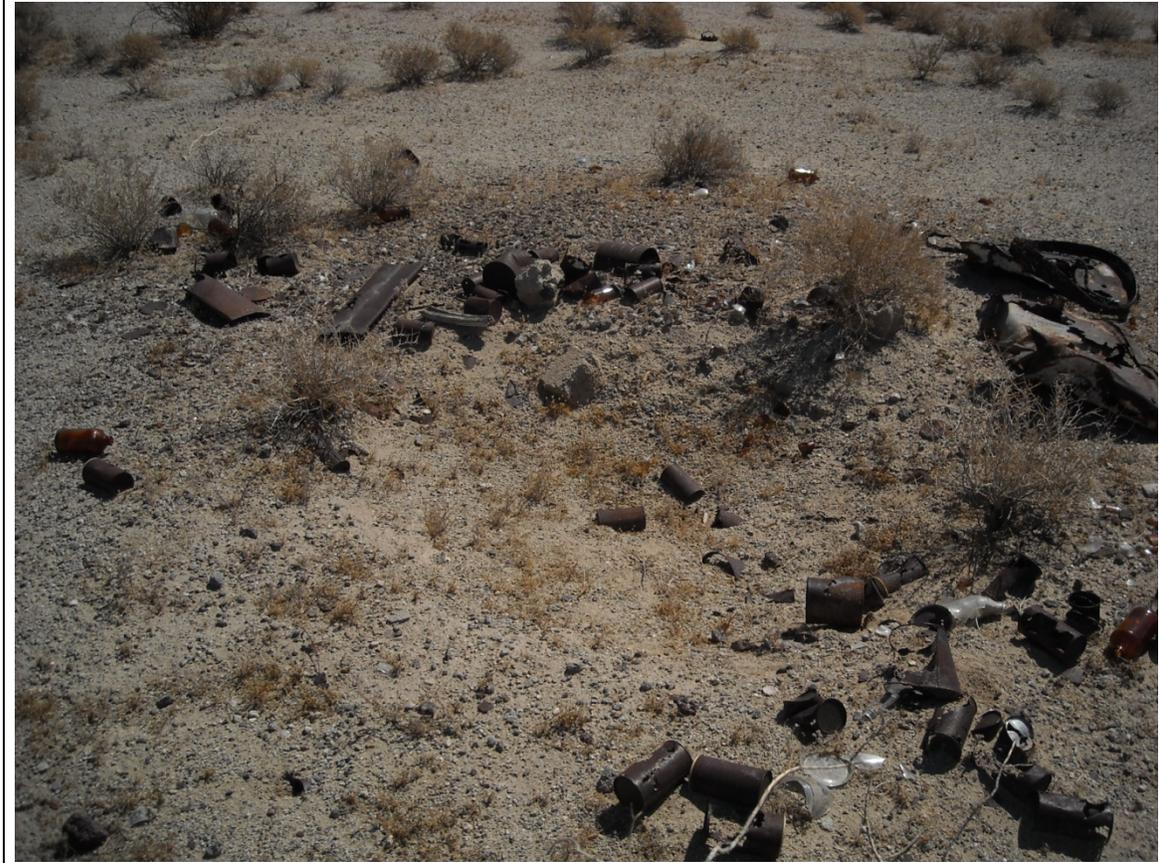
F-17 (Feature 17)

Photo description: Overview of Feature 17, view to the west. Photo #0564

Description of Feature: This feature is an earthen pit filled with burned debris. This pit is located just off of the western edge of the western runway. Artifacts noted in the pit include hole-in-top cans measuring 2 15/16" x 3 14/16", glass jars, miscellaneous metal fragments, and modern aluminum cans. The hole-in-top cans were manufactured between 1917 and 1929 according to the can measurements. The pit measures 1.5 m x 1.5 m and 30 cm deep.

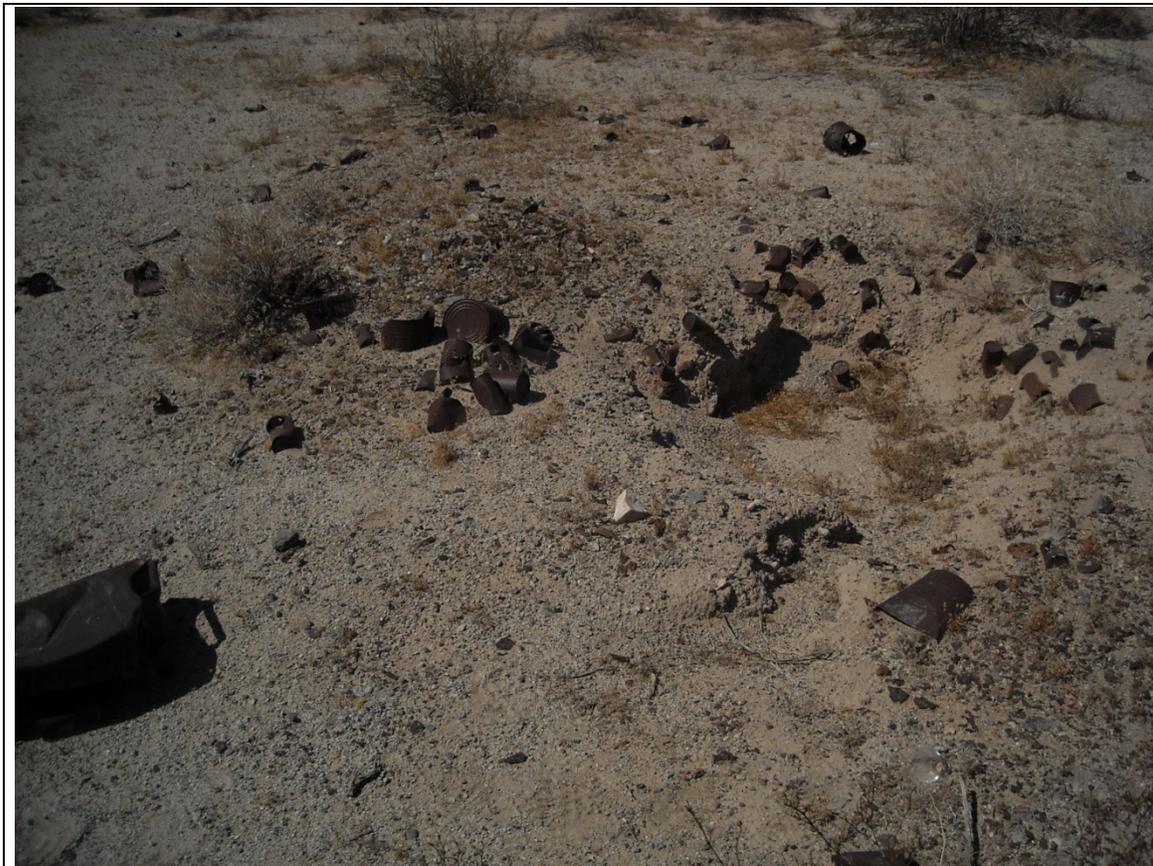
F-18 (Feature 18)

Photo description: Overview of Feature 18, view to the east. Photo #0563.

Description of Feature: This feature is an earthen pit filled with burned debris. This pit is located just off of the western edge of the western runway. Artifacts noted in the pit include glass jars and bottles, miscellaneous metal fragments, and at least one c-cell battery. The pit measures 1.5 m x 1.5 m and nearly 1 m deep due to recent excavations that disturbed the deposits.

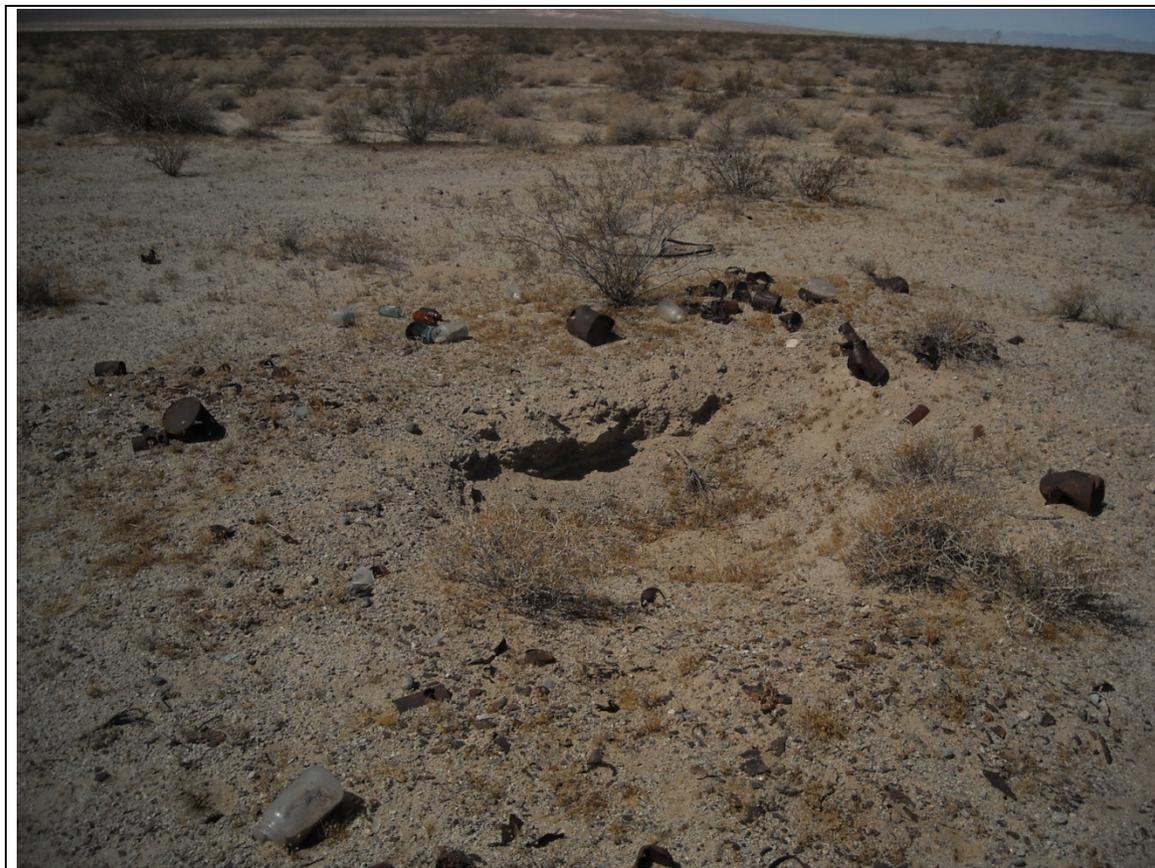
F-19 (Feature 19)

Photo description: Overview of Feature 19, view to the east. Photo #0562.

Description of Feature: This feature is an earthen pit filled with burned debris. This pit is located just off of the western edge of the western runway. Artifacts noted in the pit include glass jars and bottles, miscellaneous metal fragments, and battery fragments. The pit measures 2.0 m x 1.5 m and nearly 1.0 m deep due to recent excavations that disturbed the deposits.

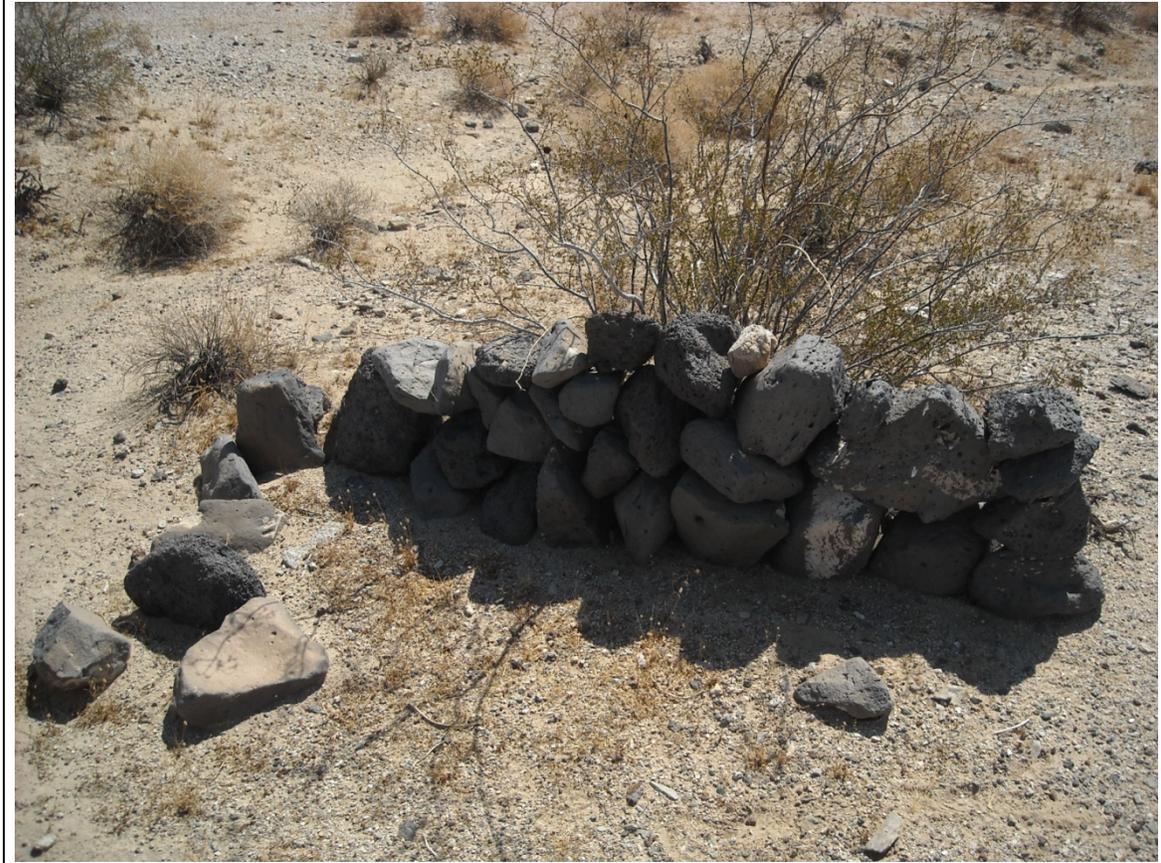
F-20 (Feature 20)

Photo description: Overview of Feature 20, view to the west. Photo #0565.

Description of Feature: This feature is a stone alignment, or even a low wall measuring 2.4 m long 60 cm high, and 30 cm wide. It is made with a single course of stacked basalt rocks. It is located in between the two runways and is not associated with any other feature or artifact.

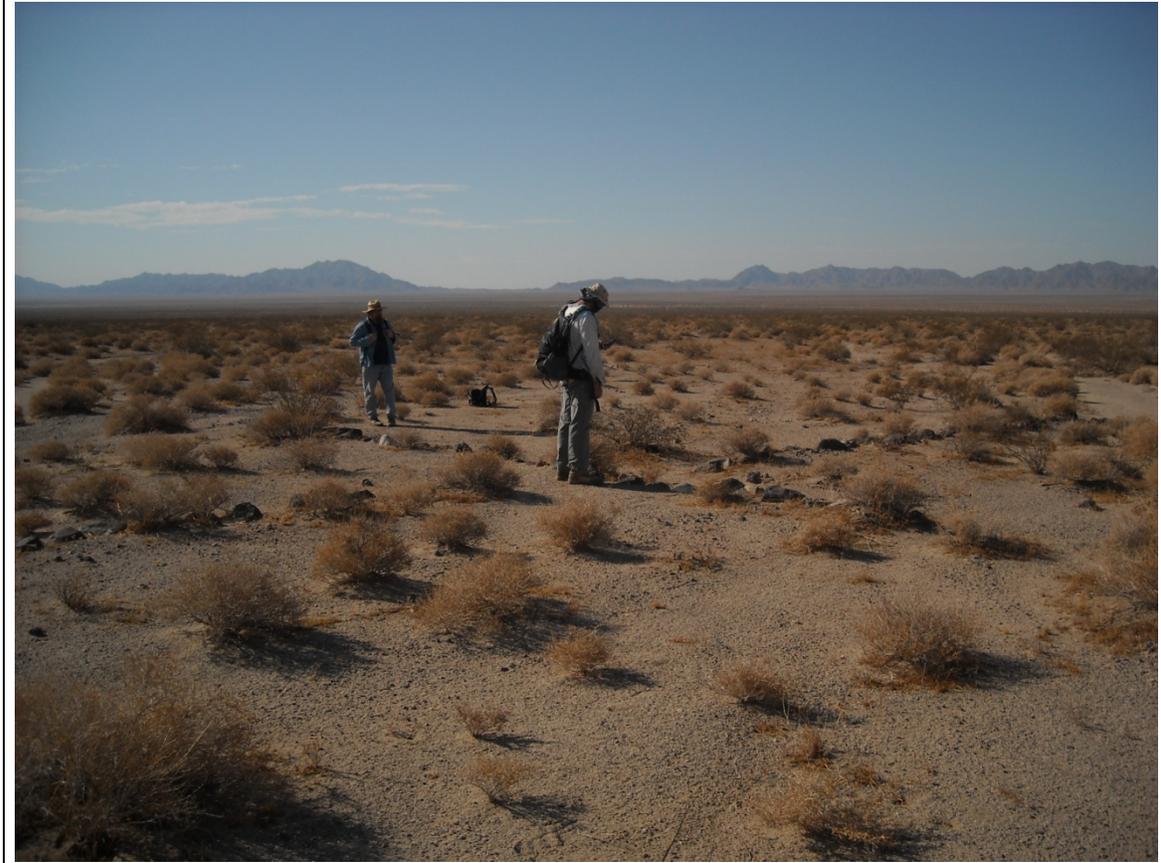
F-30 (Feature 30)

Photo description: Overview of Feature 30, view to the south. Photo #603.

Description of Feature: This feature consists of a large stone “X” that likely served as an aerial marker to indicate the runway is closed and not available for aircraft landing. It measures 24 meters across, made from single course of locally obtained basalt rocks. NE end has an arrow point. The feature is oriented NE/SW and NW/SE and is not located on one of the two major runways but on one of the smaller east/west taxiways. It is likely this was constructed well after WWII and would be associated with the 1950s private operation of the airfield since this was the last known use of the airfield. A similar stone feature is located on the same taxiway (F2).

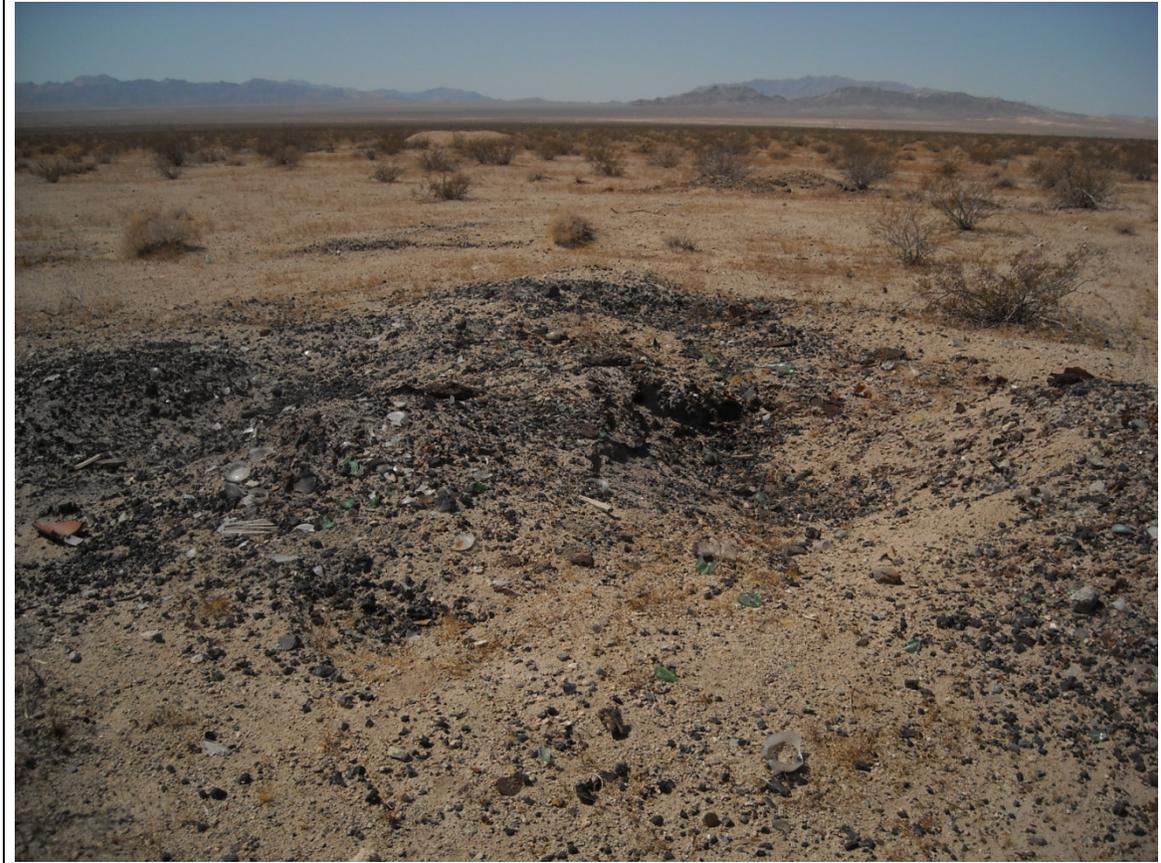
F-40 (Feature 40)

Photo description: Overview of Feature 40, view to the west. Photo #639.

Description of Feature: This feature consists of an area containing at least 10 individual dump areas in a 40 m x 40 m area. Each of the individual dump areas contains burned debris and charcoal and the deposits are thrown up on the edges as if the area has been looted recently. Identifiable artifacts include burned fragments of metal, melted glass bottles and bottle fragments, lumber and wood fragments, and c-ration cans. The feature is located between the Rice Army Airfield and Camp Rice and is bisected by a road that connects the two former Army installations.

Interpretations: This area was very likely a dump area. It is impossible to say which installation contributed to the dump, or if both Camp Rice and the Rice Army Airfield used this area as a dump. But the size of the feature and the extensive burning of the debris indicate the consistent use of this area to both dump regular refuse and burn the deposits. The area has also been heavily looted as evidenced by the numerous recently dug pits located throughout the feature.

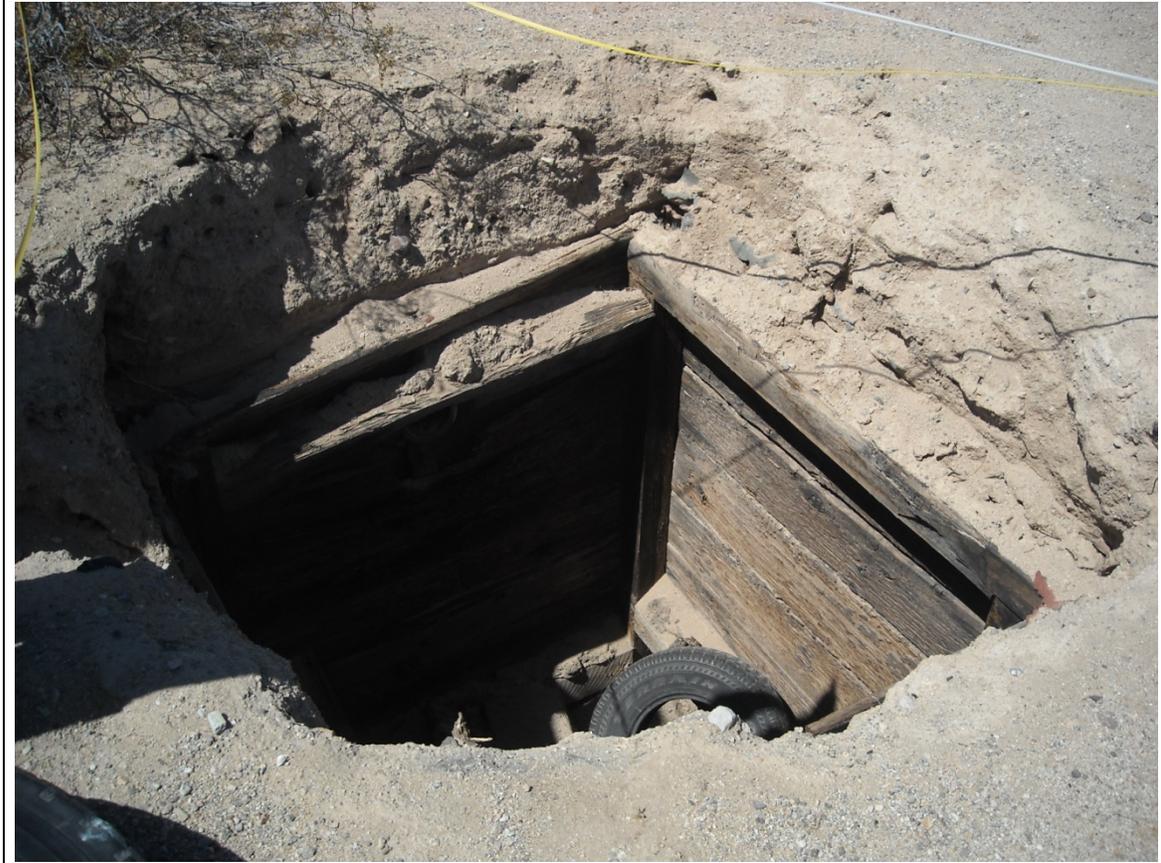
F-50 (Feature 50)

Photo description: Overview of Feature 50, view to the northwest. Photo #684.

Description of Feature: This feature is a wood-lined septic pit. The pit measures 8' x 8' square and is approximately 15' deep. The pit is lined with 6" x 6" posts supporting 2" x 12" planks. Near the top is a 6" diameter pipe entering from both the east and the west. Asphalt shingle sheeting material can be seen near the top on some of the wood, possibly from a cover that once covered the pit. The woodwork is 2" below the modern ground surface, and the pit contains various modern debris including cans and a tire.

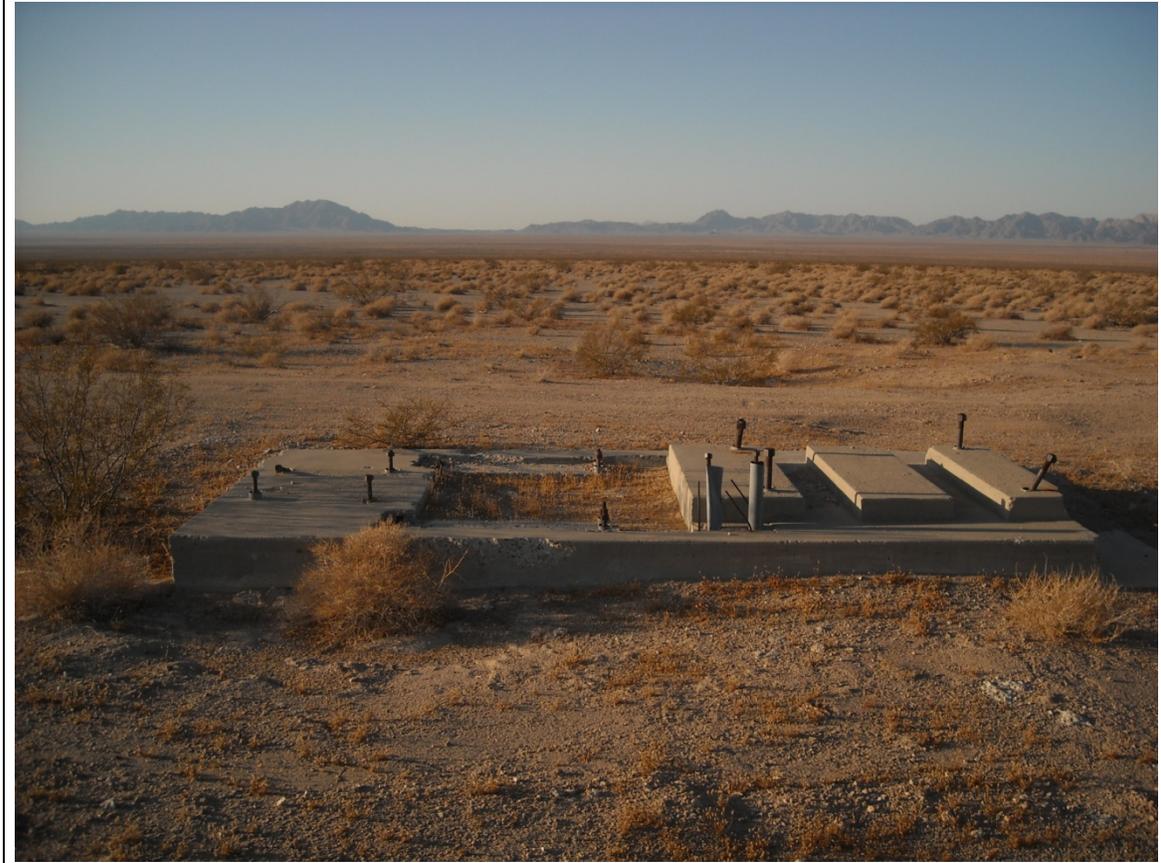
F-60 (Feature 60)

Photo description: Overview of Feature 60, view to the south. Photo #0711.

Description of Feature: This feature is a concrete foundation located just a few inches above ground level measuring 8' x 15' 10". The concrete contains numerous large bolts and nuts along with conduit. This was very likely the foundation for the generator that provided power to the airfield.

Potential for Sub-Surface Artifacts/Features: There is very little chance this foundation or the area around it contains buried deposits. There are no surface artifacts in this area and this was part of the industrial, heavy equipment portion of the base.

Associations: This foundation is located in the northeast portion of the camp/administration area of the Rice Army Airfield. It is most closely associated with the charcoal dump to the NW (F59). There are no other features or artifact scatters in this immediate area.

Interpretations: This foundation was very likely the generator foundation that supplied power to the base. It is located away from the rest of the buildings at the NE corner of the administrative area of the base, likely to have it close enough to be accessible, but away from the day to day operations.

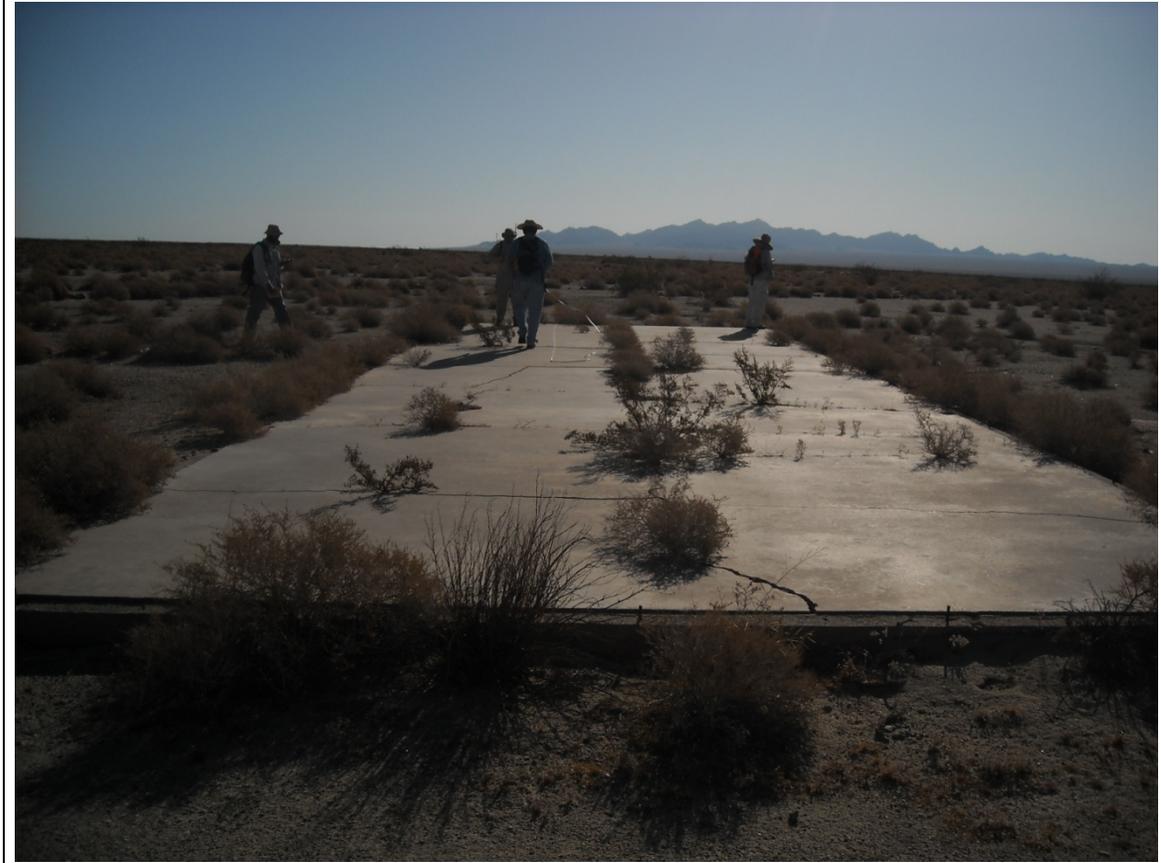
F-70 (Feature 70)

Photo description: Overview of Feature 70, view to the east. Photo #0729.

Description of Feature: This feature is a concrete foundation located near the northwest corner of the administration area. The slab is built just a few inches above ground level and measures 20' x 60' x 3". The concrete foundation was poured in two steps. First a border our outside foundation wall was poured approximately 4" thick and set with numerous large anchor bolts. Then the rest of the floor was poured. The anchor bolts were attached to the building that once sat on this foundation.

Potential for Sub-Surface Artifacts/Features: There is very little chance this foundation or the area around it contains buried deposits. There are no surface artifacts in this area.

Associations: This foundation is located in the northwest portion of the administration area of the Rice Army Airfield. It is most closely associated with a 'loop' road that runs diagonally from the NW corner SE to connect back into the main road. There are no other features or artifact scatters in this immediate area, although other building foundations are in the general area.

Interpretations: This foundation once supported a building that was later torn down.

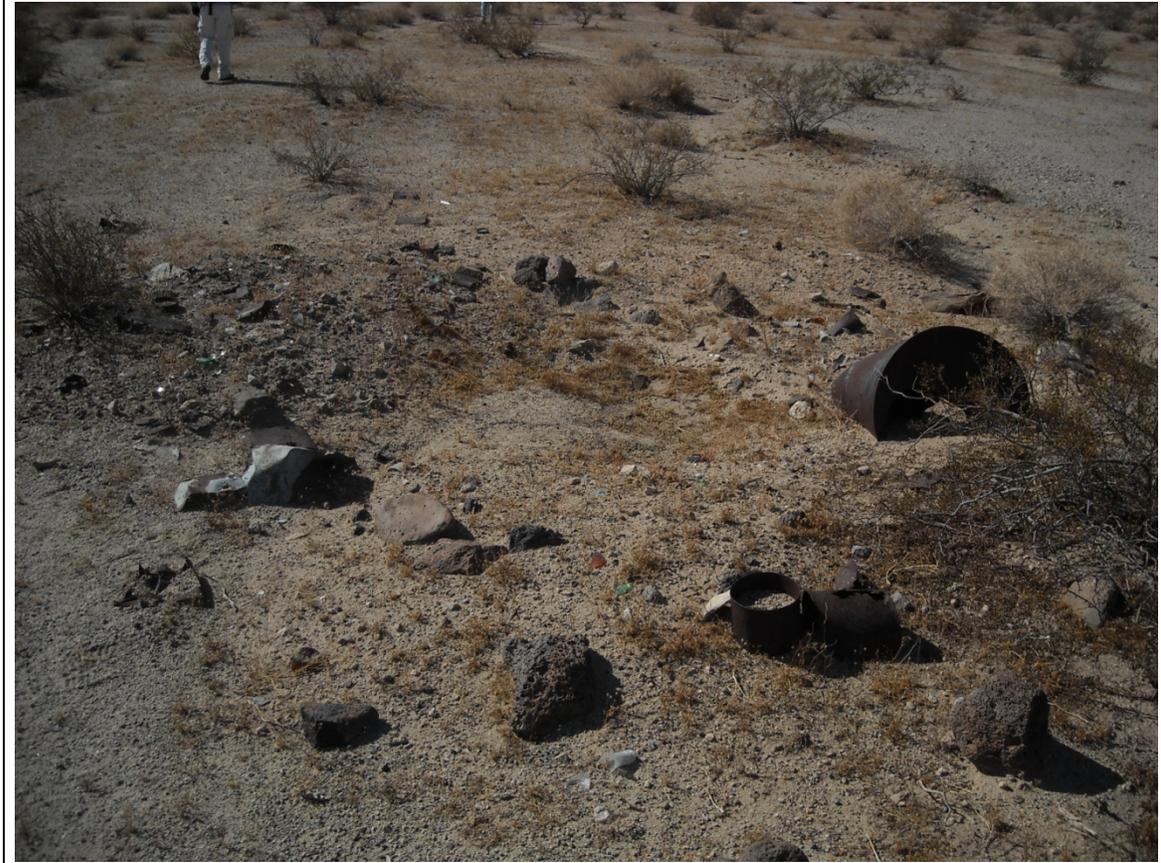
F-80 (Feature 80)

Photo description: Overview of Feature 80, view to the south. Photo #0740.

Description of Feature: This feature is a pit containing a debris scatter. This pit is either rock lined, or the rocks the surround the border of the pit were excavated from within the pit. The pit measures approximately 3 meters in diameter. The debris scatter contains burned trash remains including miscellaneous metal fragments, #10 tin cans, Army c-ration cans, a 55-gallon drum, and numerous fragments of green, amber, and clear glass, many of which were melted. The pit is located in the northeastern portion of the Rice Army Airfield.

Potential for Sub-Surface Artifacts/Features: There is a high probability that this pit contains further cultural material. However, the burned nature of the debris on the surface indicates this was a trash pit that was frequently burned, so any buried cultural resources would be heavily burned and possibly disturbed from looting.

Interpretations: This feature is a trash pit that was used to burn refuse.

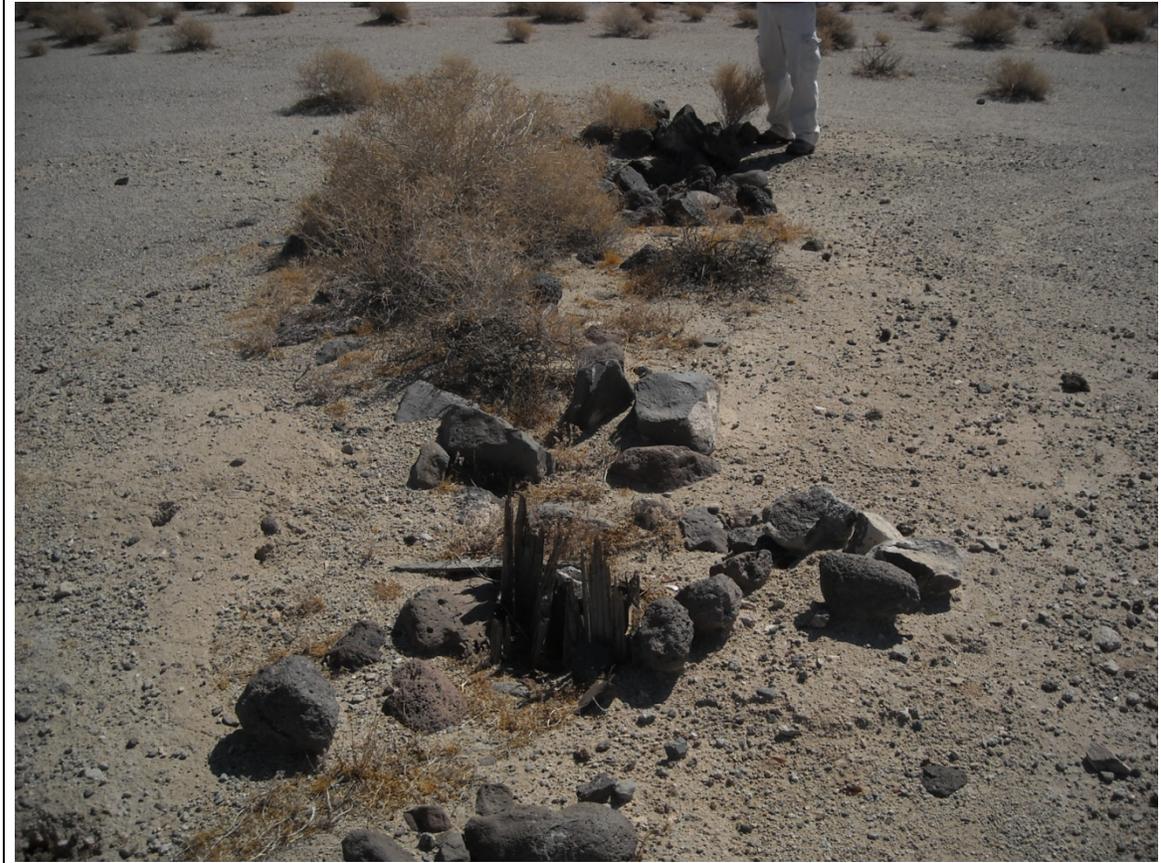
F-90 (Feature 90)

Photo description: Overview of Feature 90, view to the east. Photo #0750.

Description of Feature: This feature is a rock alignment, possibly part of a trench. On the western end there is a column made from 1" x 10" lumber to make a 10" square column or box sticking up vertically from the alignment. The alignment measures 1.5 meters wide and is 5 meters long. The alignment is located in the northeastern quarter of the Rice Army Airfield camp/administrative area, near the remains of a north/south road.

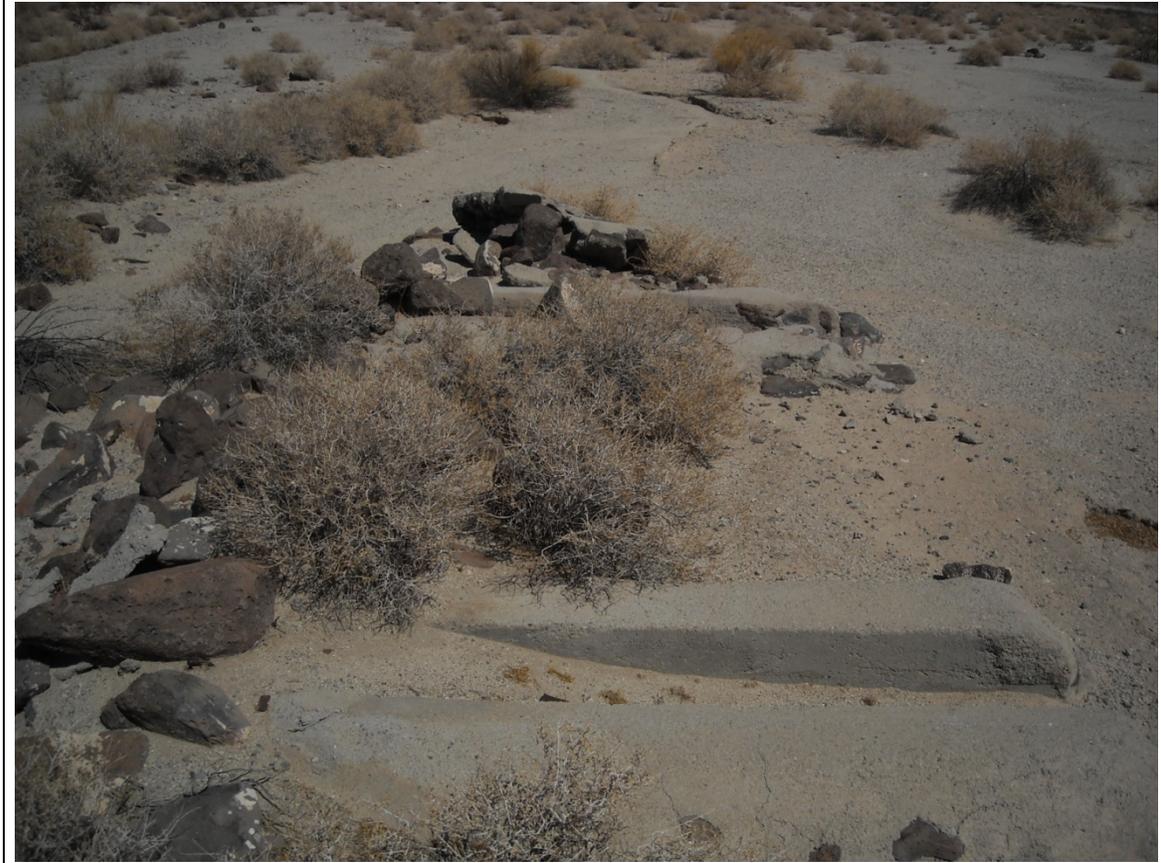
F-100 (Feature 100)

Photo description: Overview of Feature 100, view to the north. Photo #0760.

Description of Feature: This feature is being interpreted as a sign base. It consists of two concrete features measuring 10' x 4' with an 18" gap or trough through the middle. It is very similar to F-99 except there are two of them. The exact function is unknown. The feature is located near the center of the camp/administration area, on the east side of the main road running north/south through the Rice Army Airfield.

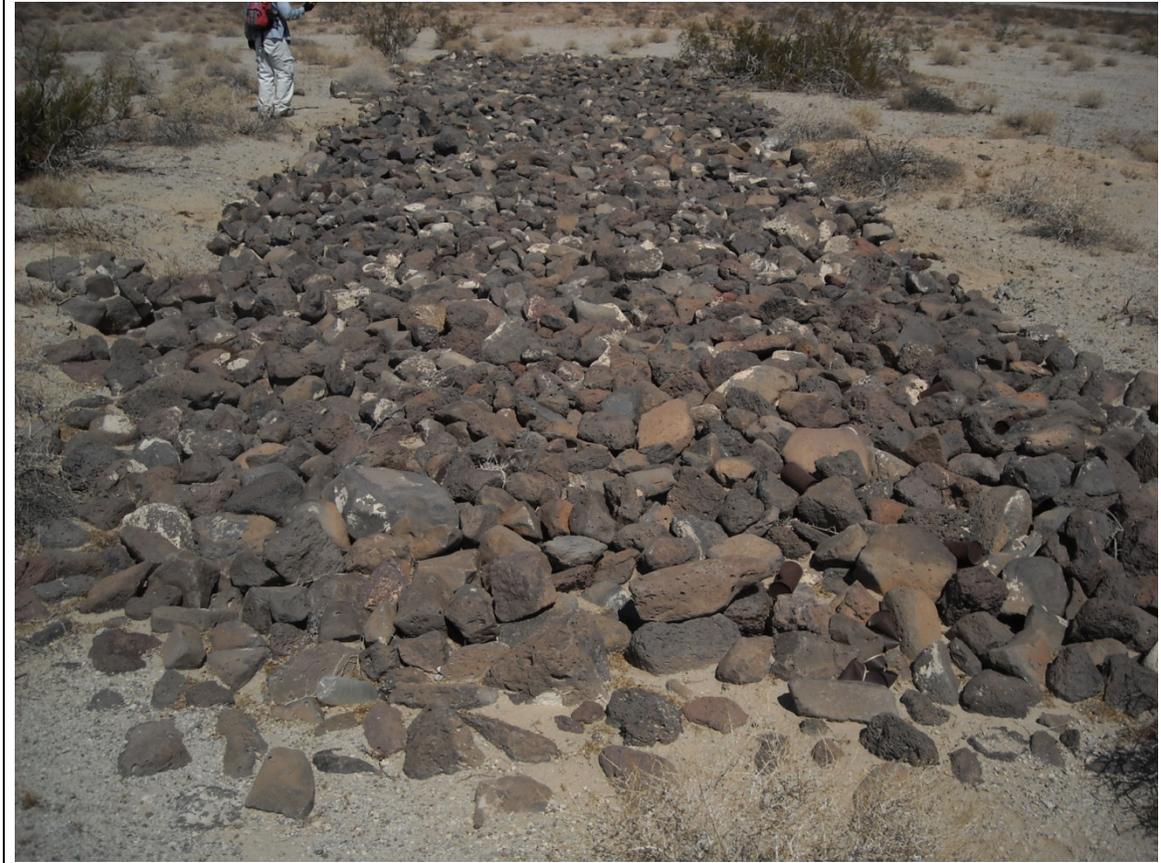
F-110 (Feature 110)

Photo description: Overview of Feature 110, view to the north. Photo #0770.

Description of Feature: This feature is a large, rock-lined or rock-covered pit. The feature measures 80' x 20' and the rocks are at ground level. The pit appears to be part of the overall septic or drainage system and F113 appears to connect to this feature. This feature is located near the eastern boundary of the southeastern quarter of the admin area of the airfield. There are no diagnostic artifacts in association with this feature, although a few non-diagnostic cans are in the rocks.

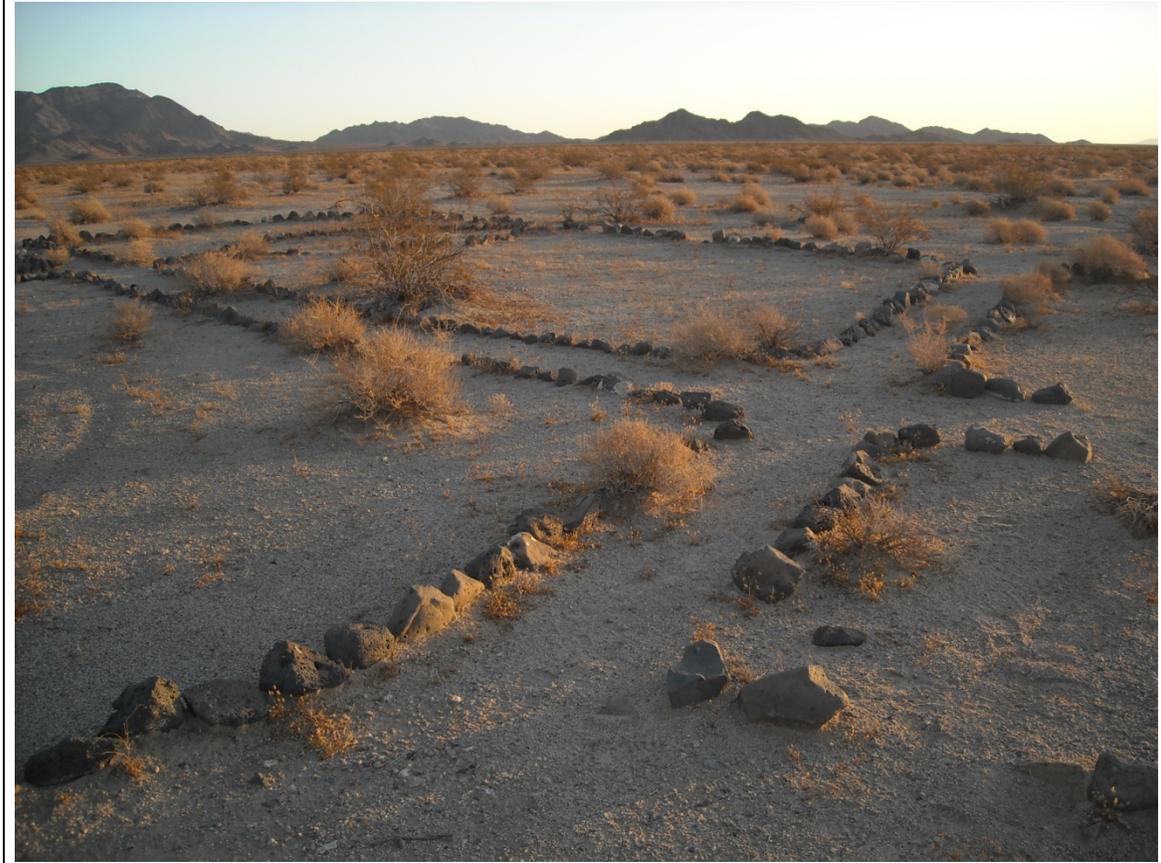
F-120 (Feature 120)

Photo description: Overview of Feature 120, view to the northeast. Photo #0785.
