**PHASE I ENVIRONMENTAL  
SITE ASSESSMENT**

**SALTON SEA UNIT 6**

**IMPERIAL COUNTY, CALIFORNIA**

**JANUARY 29, 2002**

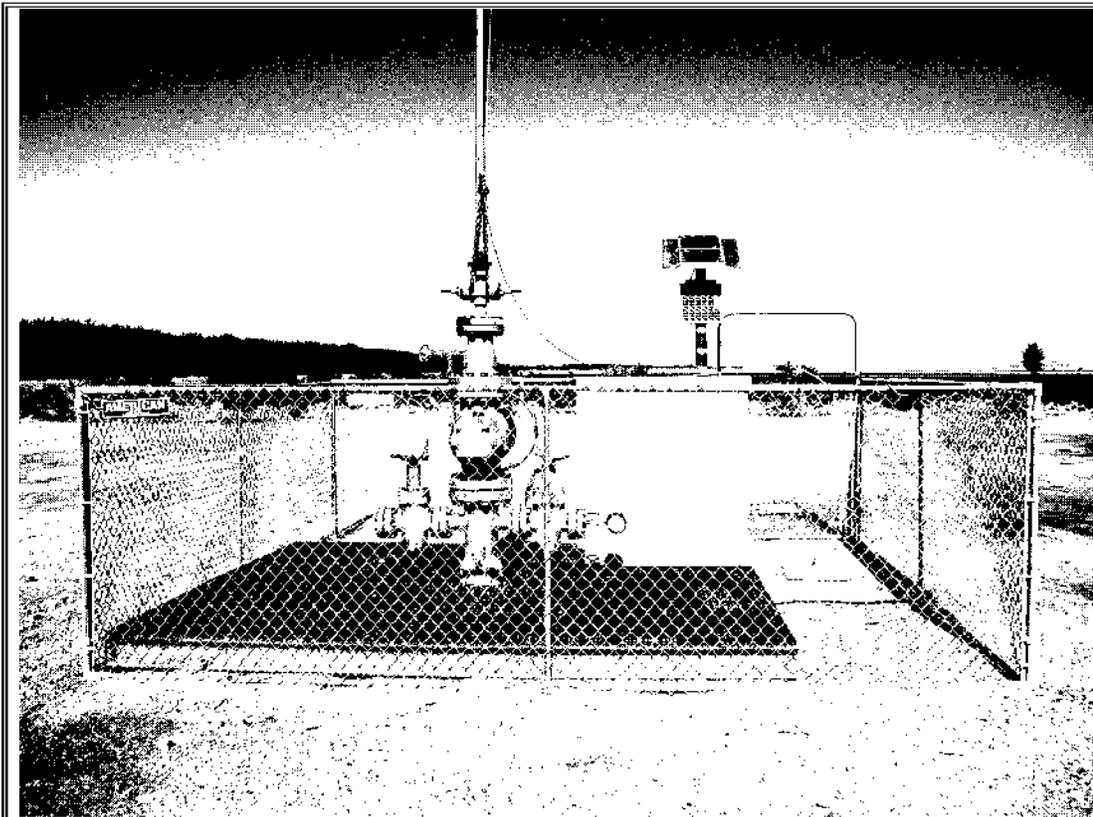
**Photograph 6**

**Comments:**  
View of  
Geothermal Well  
M-8 in the  
southwest  
portion of the  
site.

Three geothermal wells were observed at the site. Well M-8 was observed in the southwest portion of the subject Property, and wells M-9 and DR-12 were observed in the southeastern portion of the subject Property (See Photographs 6, 7 and 8, and Figure 2 for approximate locations). Monitoring, water supply, oil or gas production wells were not observed or reported onsite.

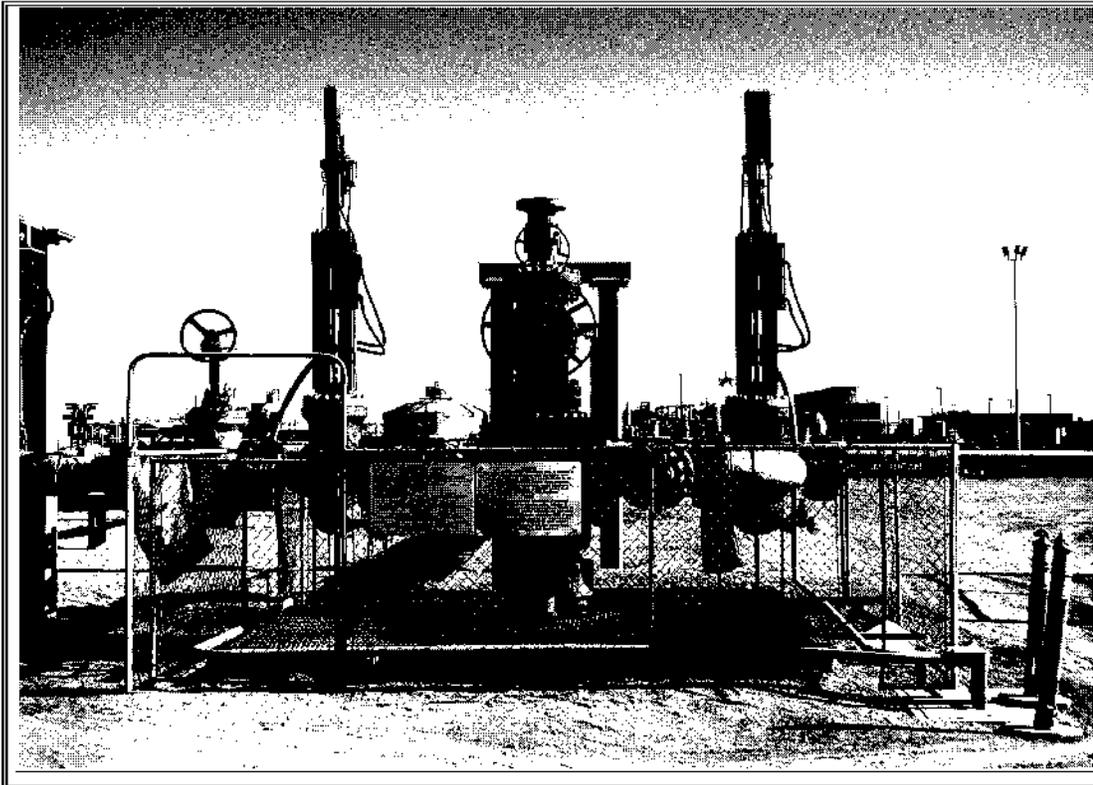
**Photograph 7**

View of  
Geothermal Well  
DR-12 in the  
southeast portion  
of the site.

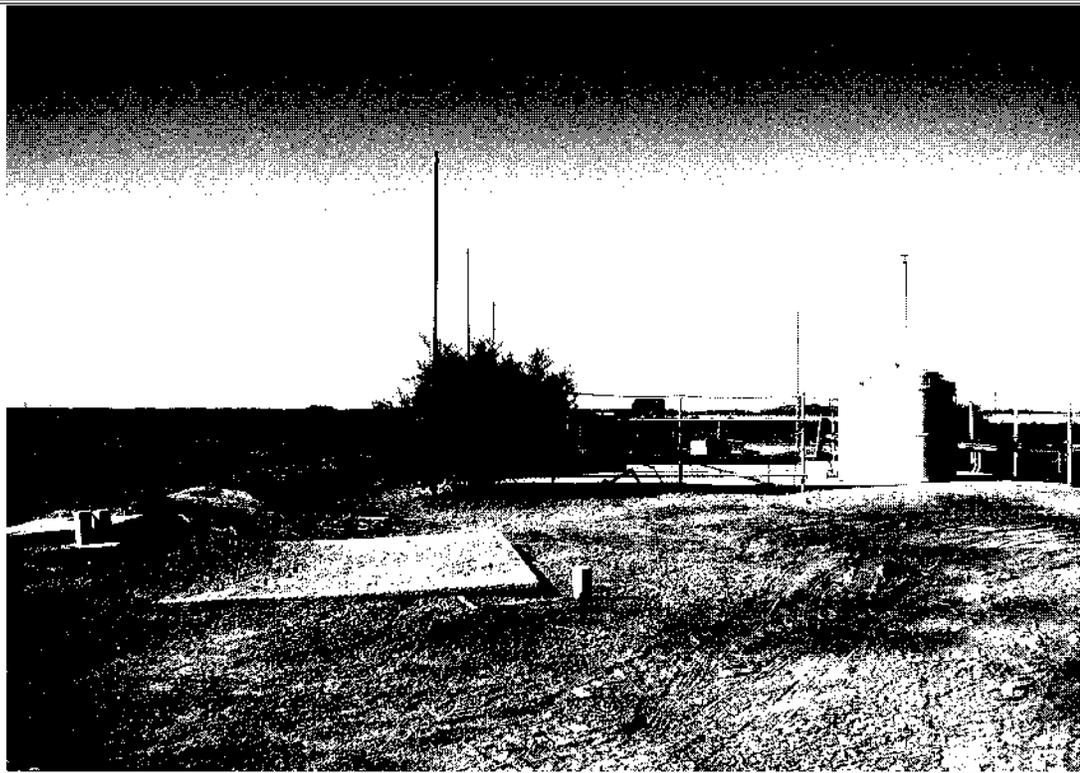
**Photograph 10**

View of electrical supplies (on pallets) and concrete pipe (in crates on the right) observed in the northeast portion of the site.

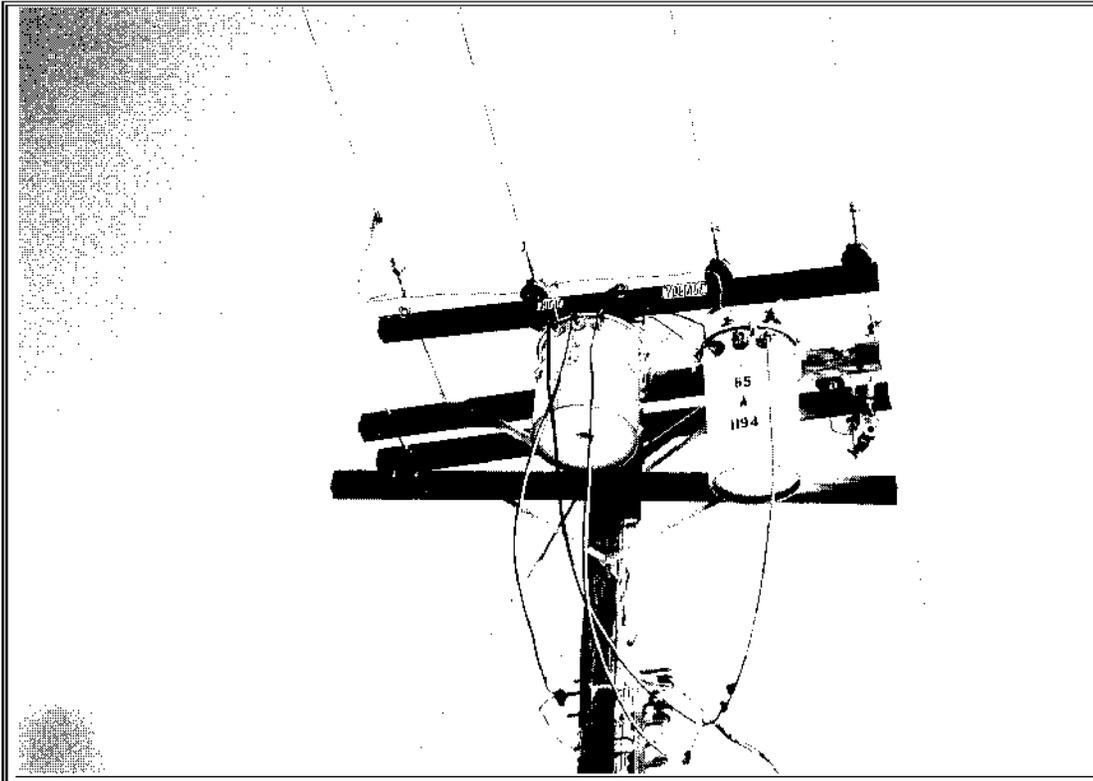
**Photograph 11**

Pole-mounted electrical transformers were observed at a few locations around the perimeter of the subject Property (Photograph 11). It is unknown whether the transformers are or were PCB-containing; however, the pole-mounted electrical transformers appeared to be in good working condition with no indications of leakage or staining observed.

View of pole-mounted electrical transformers (typical) observed along the northern property boundary.

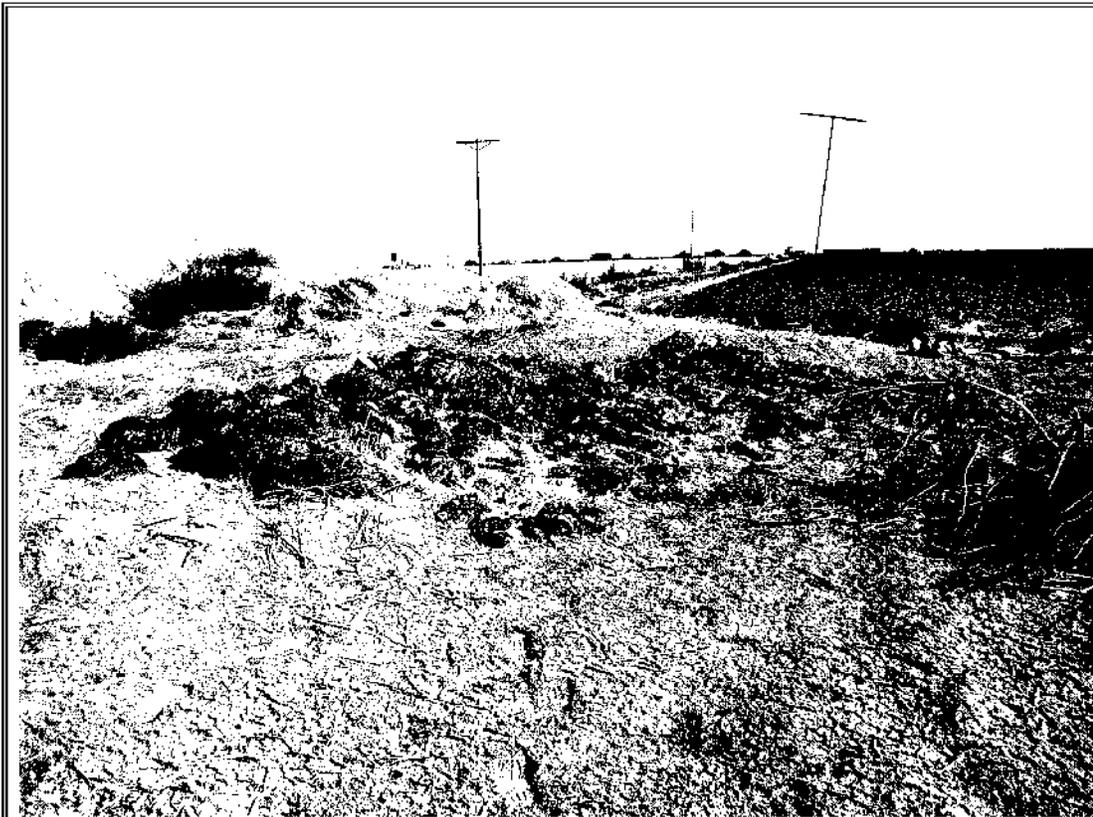
**Photograph 12**

A pile of black plastic sheeting was observed in the northwest corner of the subject Property (Photograph 12), and a burned area with bottles, wire, tires and other debris was observed in the southwest corner of the subject Property (Photograph 13).

View of old pile of plastic sheeting observed in the northwest portion of the site.

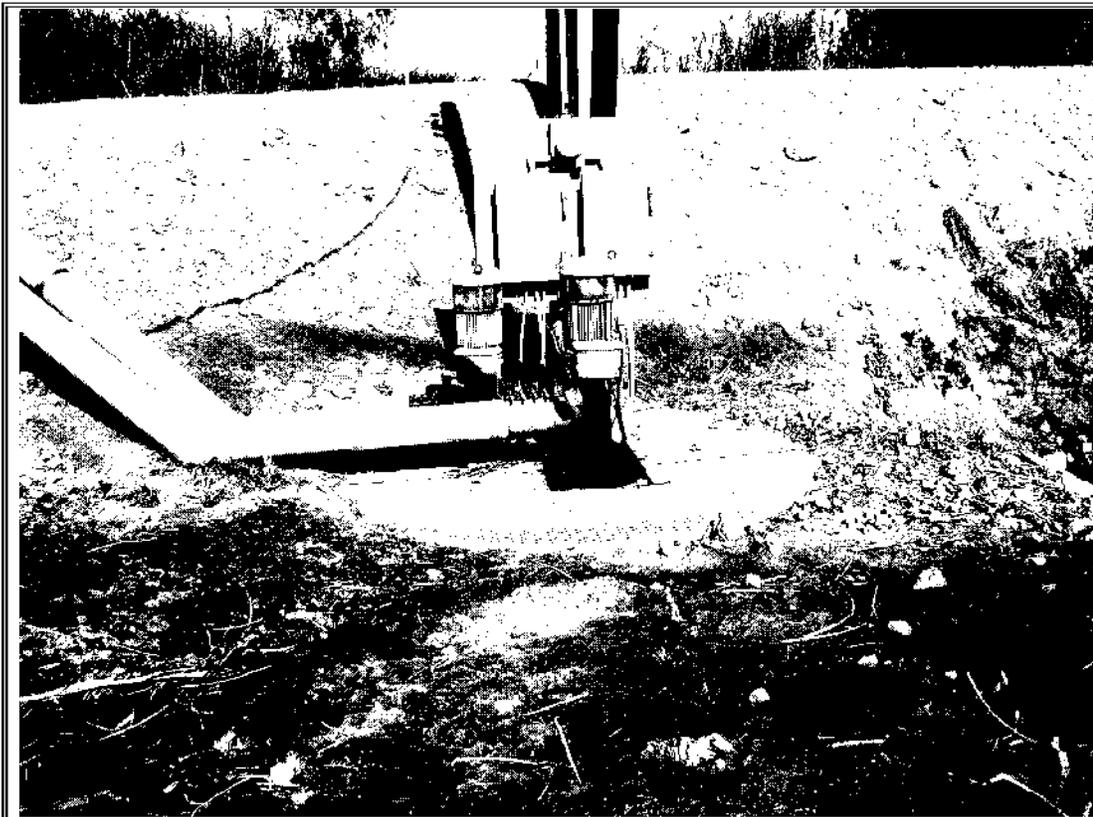
**Photograph 14**

View of Imperial Irrigation District Sump No. WP14 in the northwest corner of the site. This arrangement is typical of other sumps observed on and around the site.

Lateral drains, sumps and pumps are prevalent throughout the region (refer to Figure 1) to maintain groundwater at an acceptable depth below ground surface. Based on signs and other markings observed on the subject Property and vicinity, most of these drains, sumps and pumps are maintained by the Imperial Irrigation District. A view of one of these sumps observed in the northwest corner of the subject Property is shown in Photograph 14. As previously indicated, the property adjoining the subject Property on the west side of Severe Road was completely submerged at the time of the site reconnaissance.
