Cosumnes Power Plant Natural Gas Line – Preservation Trees

TO: EJ Koford / SAC
FROM: Russell Huddleston / SAC
DATE: May 2, 2002

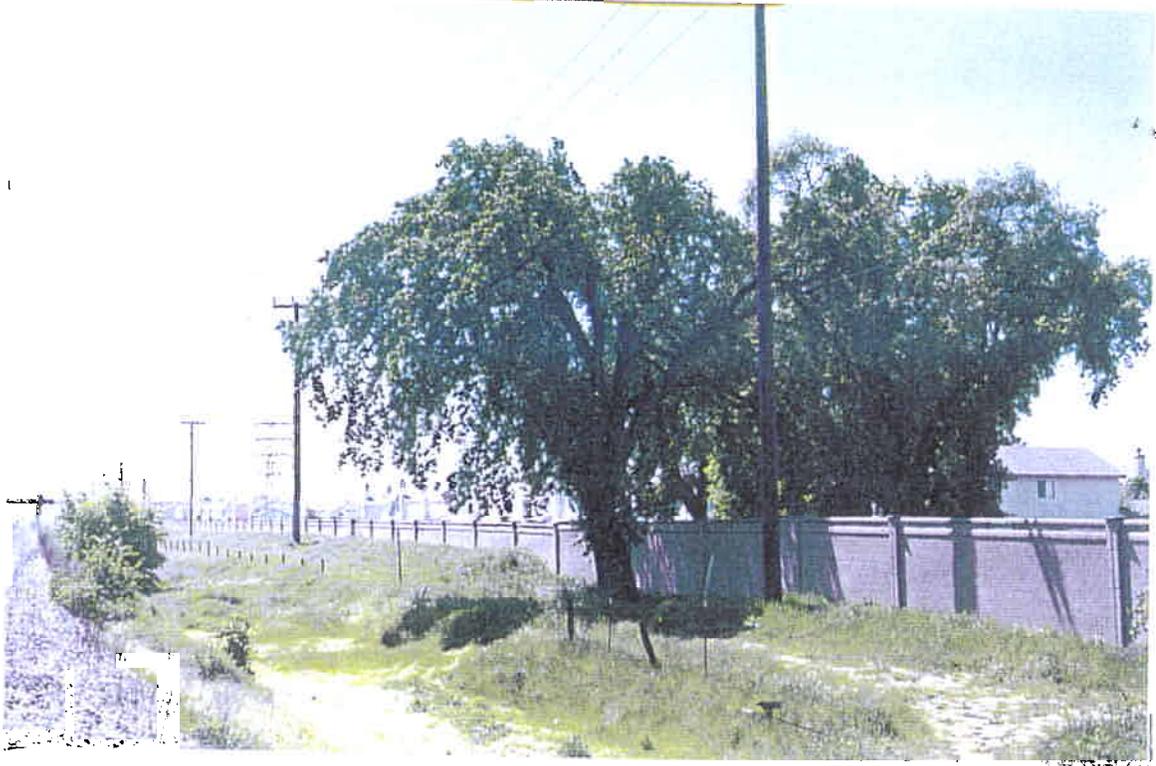
One large valley oak (*Quercus lobata*) was identified within the limits of the construction corridor (Figure 1). This tree was located between the Union Pacific railroad tracks and a residential area, just south of Elliot Ranch Road. The tree lies to the west of the existing Pacific Gas and Electric pipeline and should not require removal for the installation of the new natural gas pipeline (Figure 3).

Figure 1. Valley Oak #1, 47.5 inch diameter at breast height (4'-6"). Located just south of Elliot Ranch Road, in the construction corridor.

In areas where preservation trees are present in the construction corridor, efforts should be made to minimize impacts. To the extent practicable, orange construction fencing should be placed around the tree. Trimming of branches should be avoided if possible. Areas where preservation trees occur in close proximity to the construction corridor should be clearly marked and avoided. If trimming or removal of tree is required, the Sacramento Landscape Design and Tree Division should be contacted regarding the necessary permits.

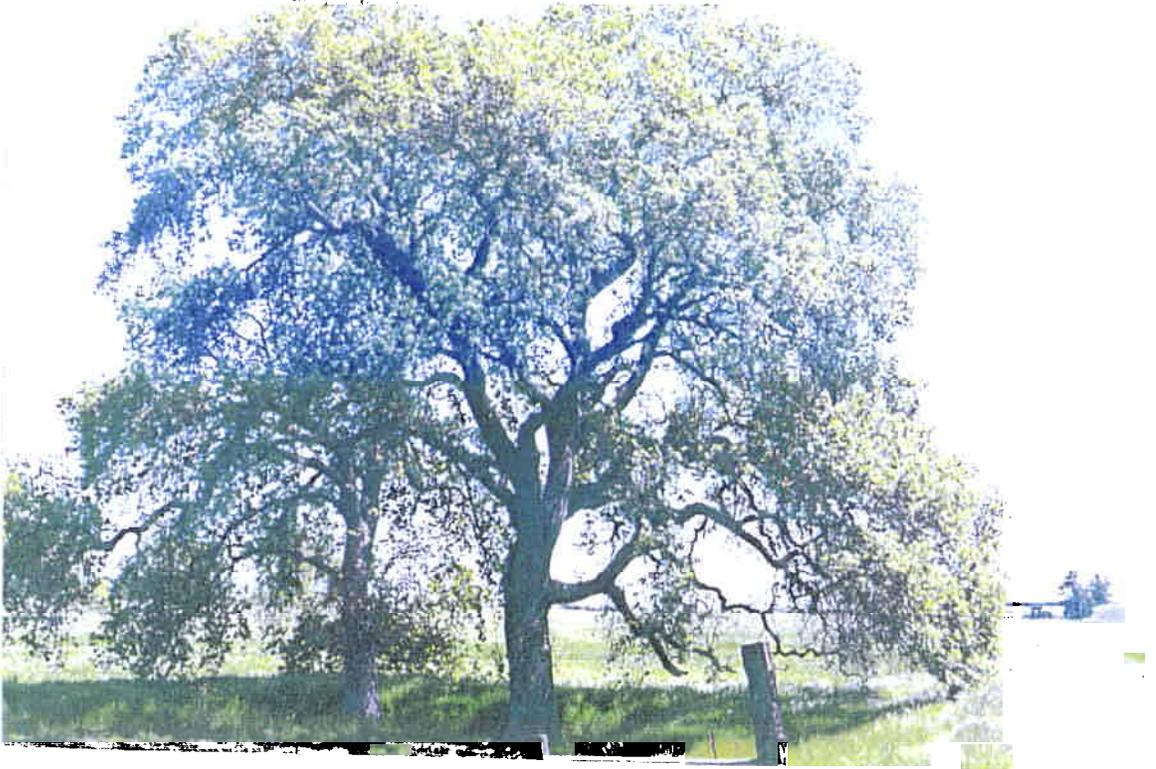
Two large valley oaks were also present on the Preserve, just south of the open water area (Figures 2 and 6). These trees occur just east of the construction area, and should not be directly affected by the project.

Figure 2. Valley Oak (#7 and #8). Located on the south side of the open water area on the Cosumnes Preserve, immediately adjacent to the construction corridor.

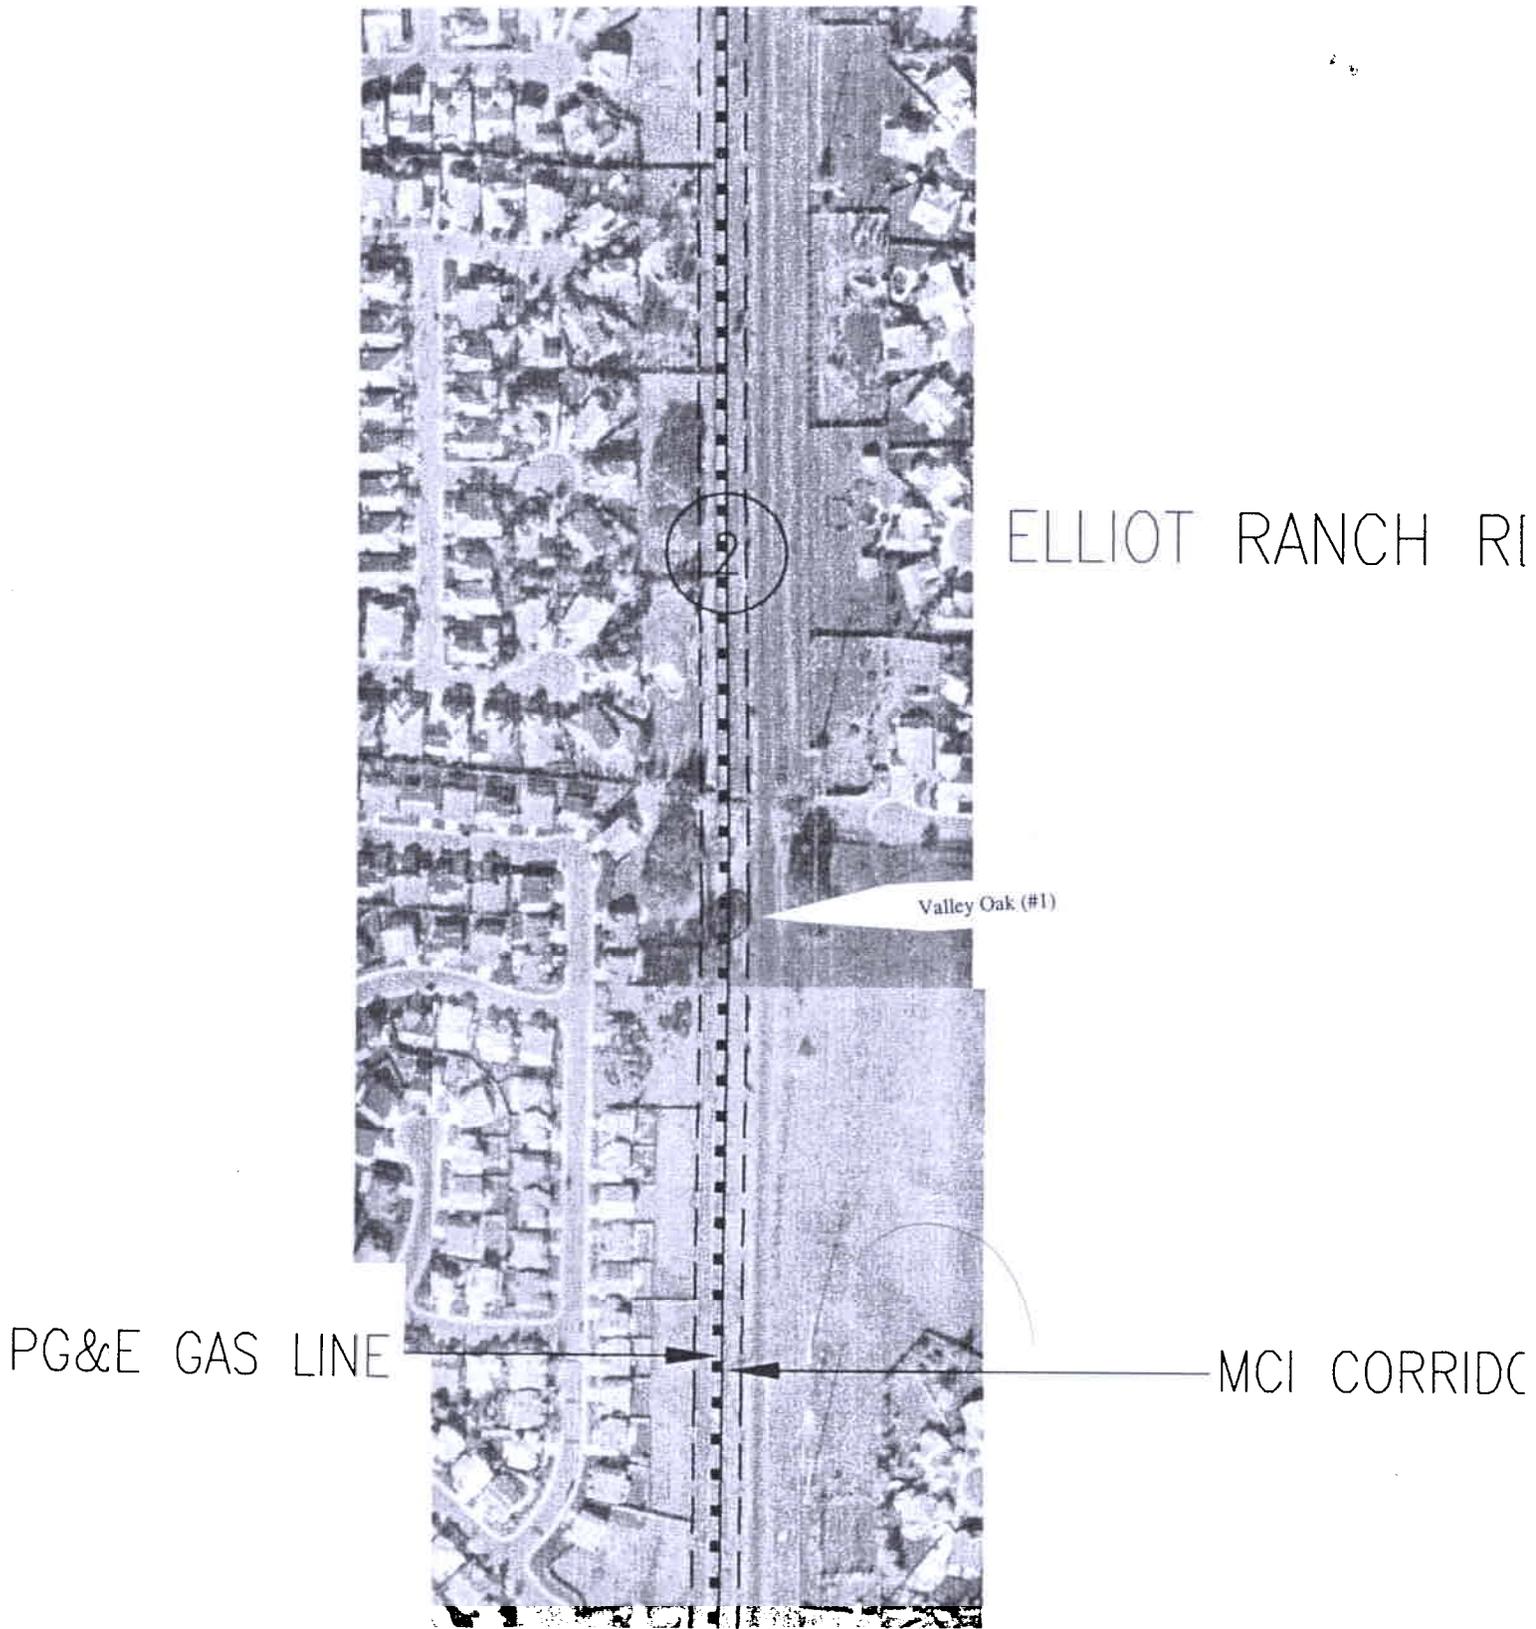
Figure 3. Location of Valley Oak #1, just south of Elliot Ranch Road, in the construction corridor.

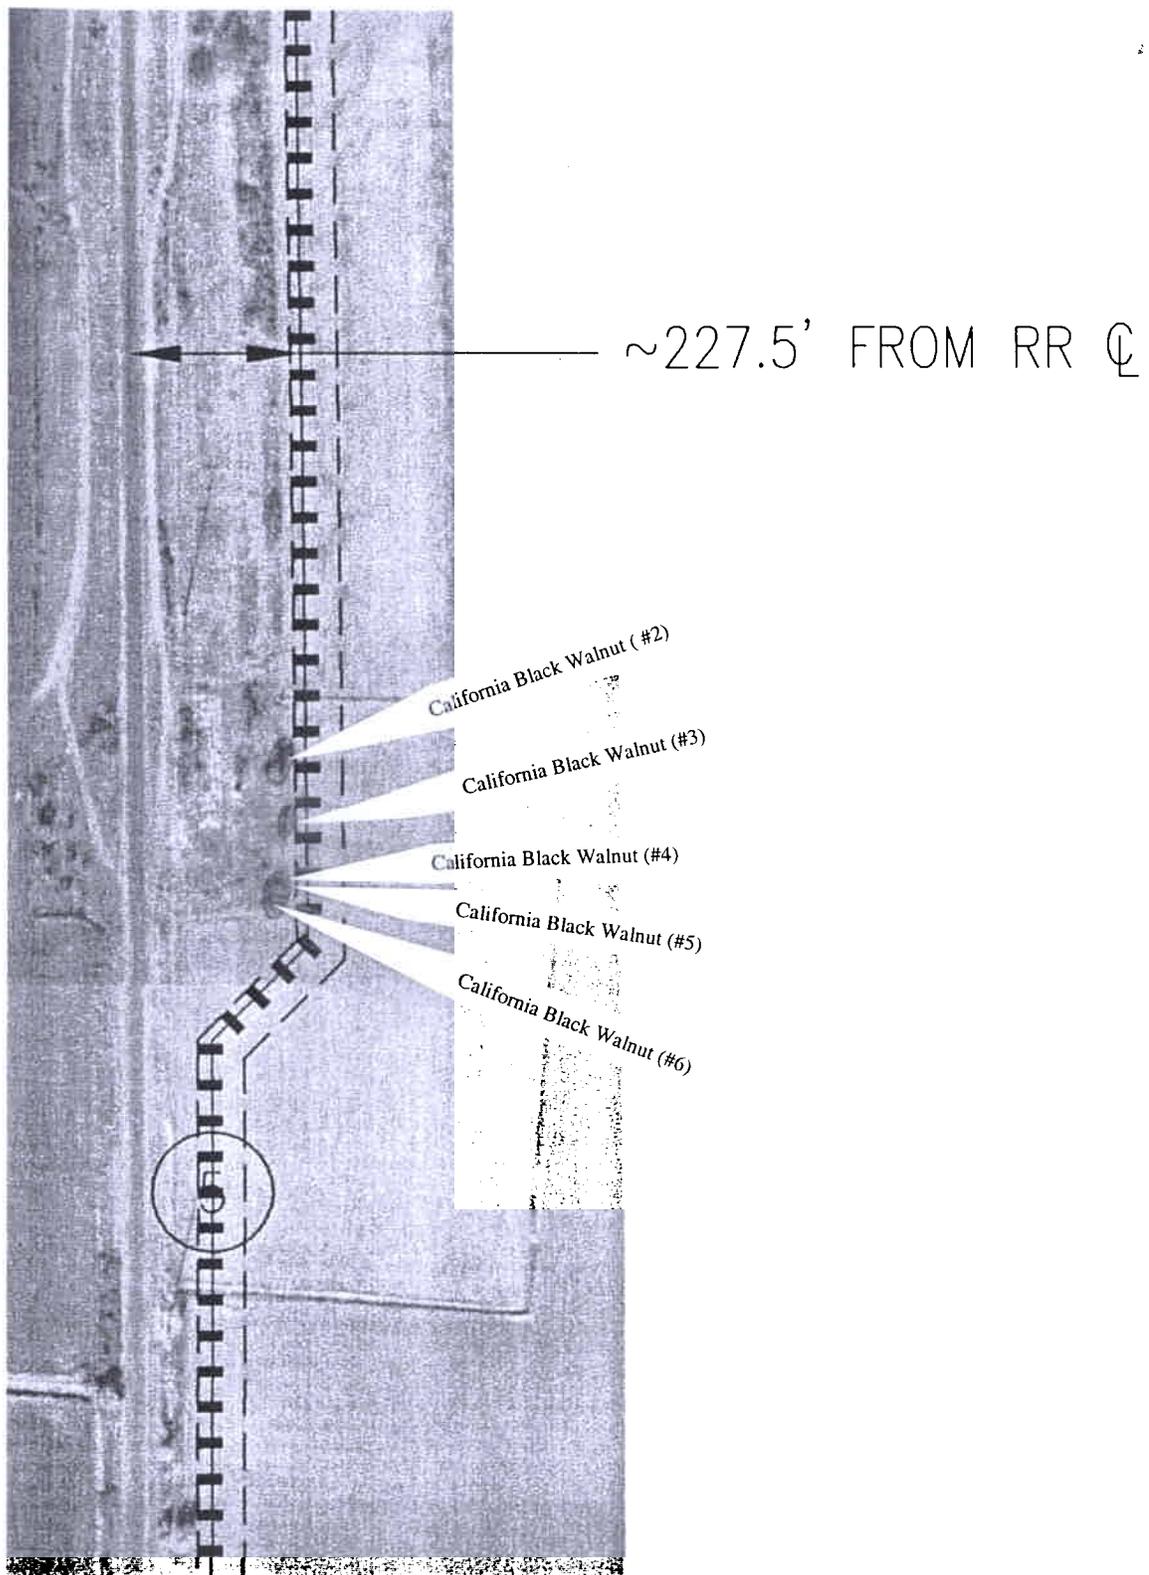
A small cluster of California black walnut (*Juglans hindsii*) trees was observed just south of Bilby Road (Figure 4). While native stands of this species are highly restricted in their distribution, it has been widely naturalized throughout California.

Figure 4. Location of California Black Walnut trees (#2- #6). Just south of Bilby Road, immediately west of the construction corridor.

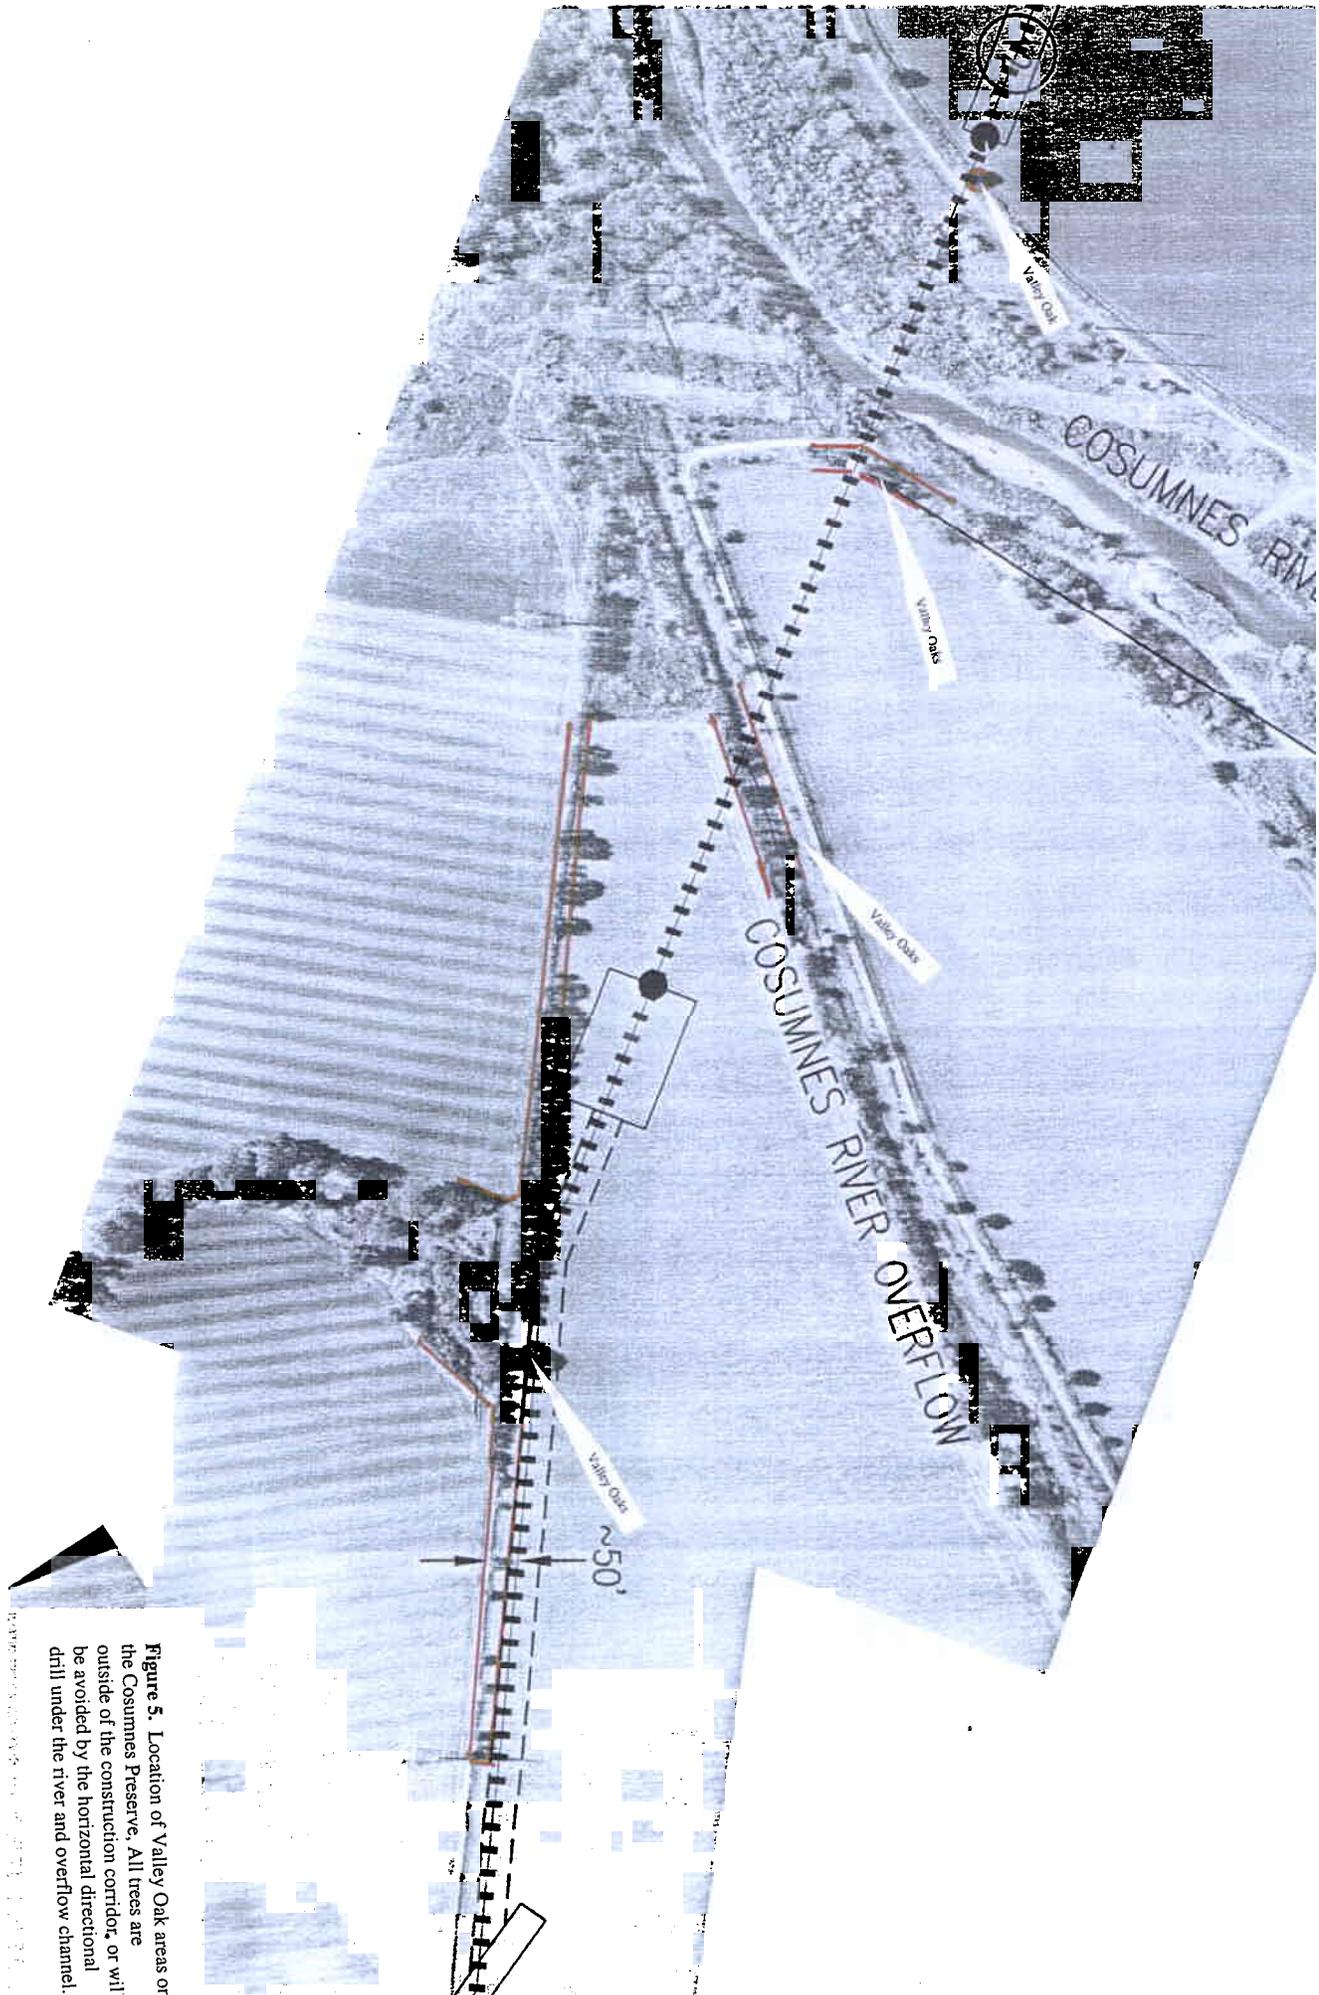
A large concentration of valley oaks was observed on the Cosumnes Preserve, west of Highway 99. Over 75 valley oaks were present along a farm access road (Figure 5). Trees in this area ranged from less than 6 inches up to 61.8 inches in diameter at breast height. These trees were all to the south of the construction corridor, and can easily be avoided during construction activities. Several valley oaks were also observed along the upper banks of the Cosumnes River overflow channel as well as along the outer riparian areas of the Cosumnes

River and Badger Creek (Figure 5). The pipeline will be installed by horizontal directional drill (HDD) in these areas; therefore, no trees should be adversely affected.

Figure 5. Location of Valley Oak areas or the Cosumnes Preserve. All trees are outside of the construction corridor, or will be avoided by the horizontal directional drill under the river and overflow channel.

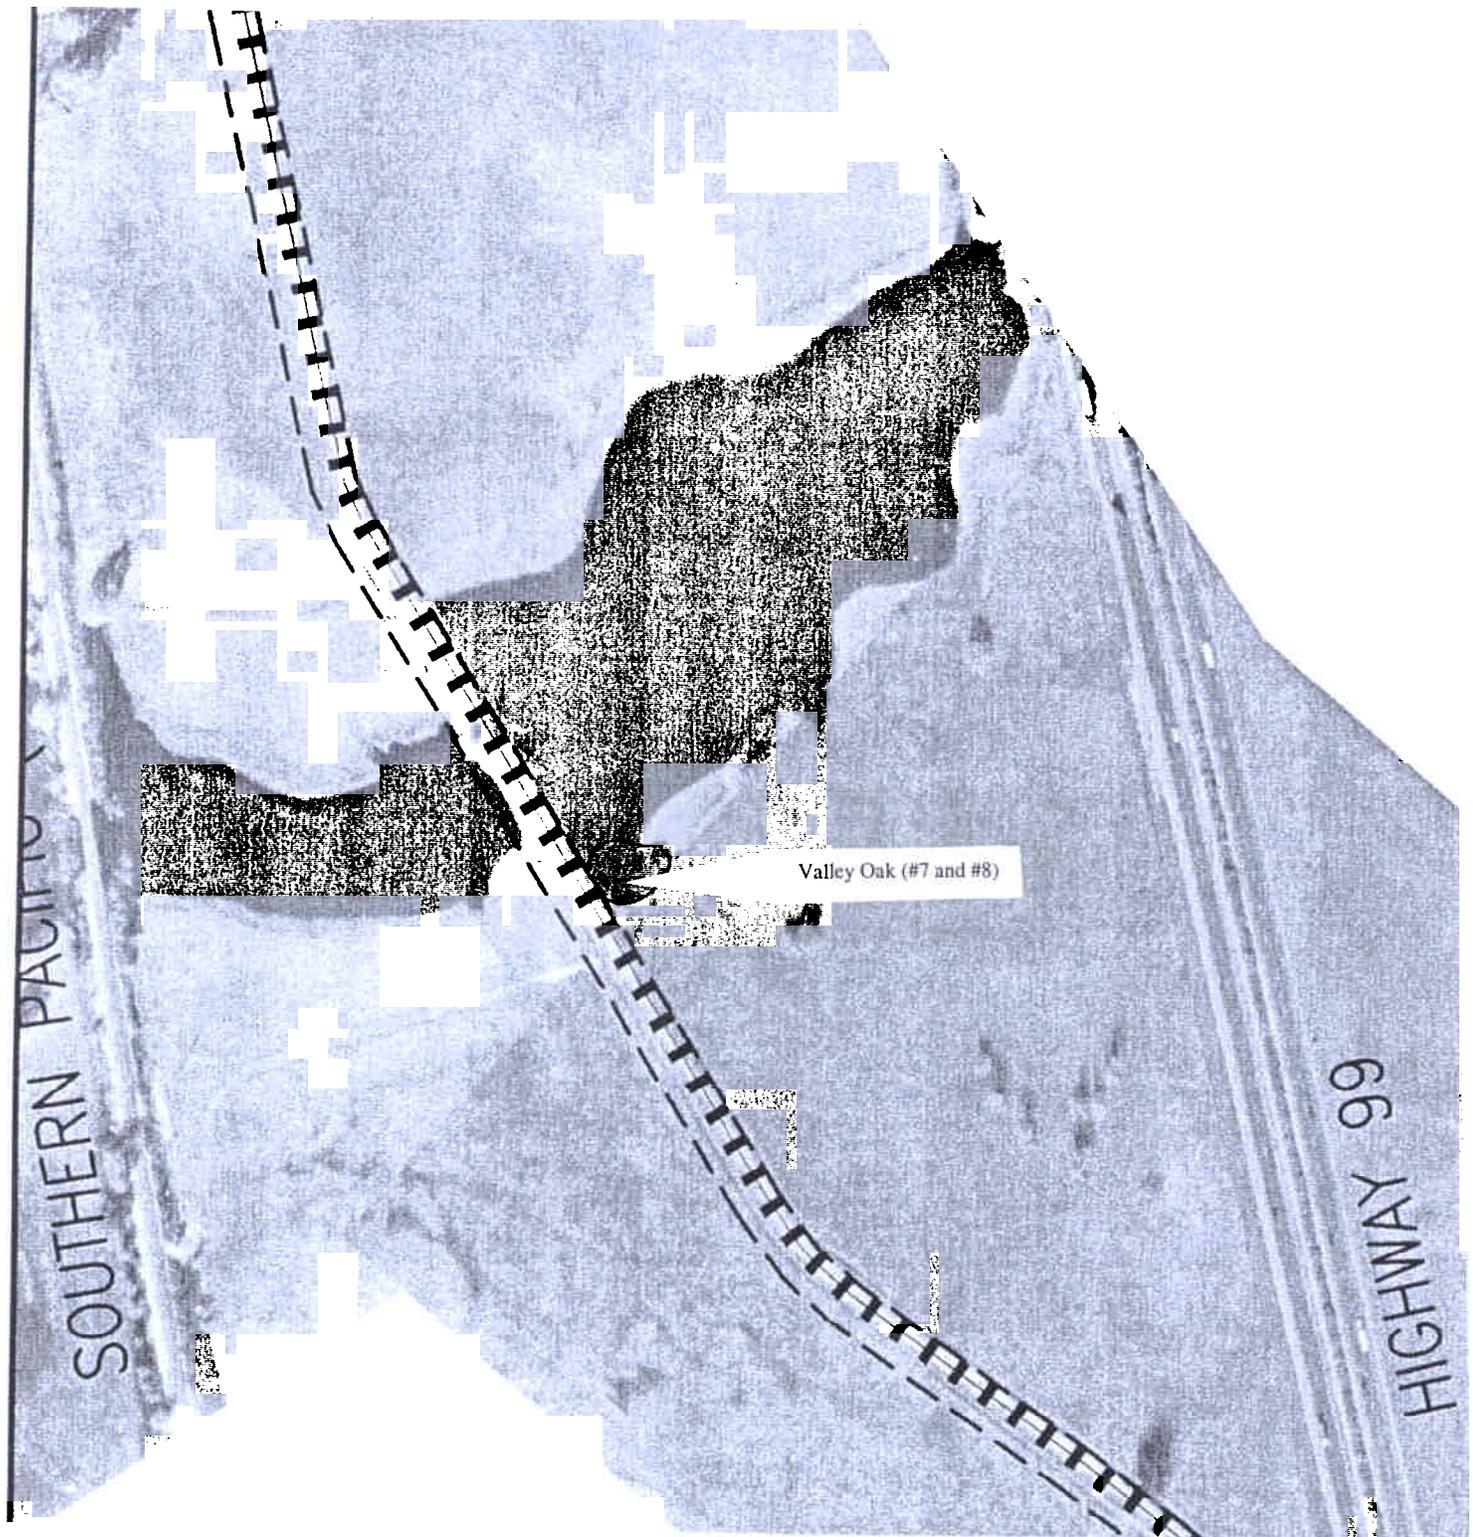
Figure 6. Location of Valley Oaks (Tree #7 and #8) south of the open water area on the Cosumnes Preserve, immediately adjacent to the construction corridor.

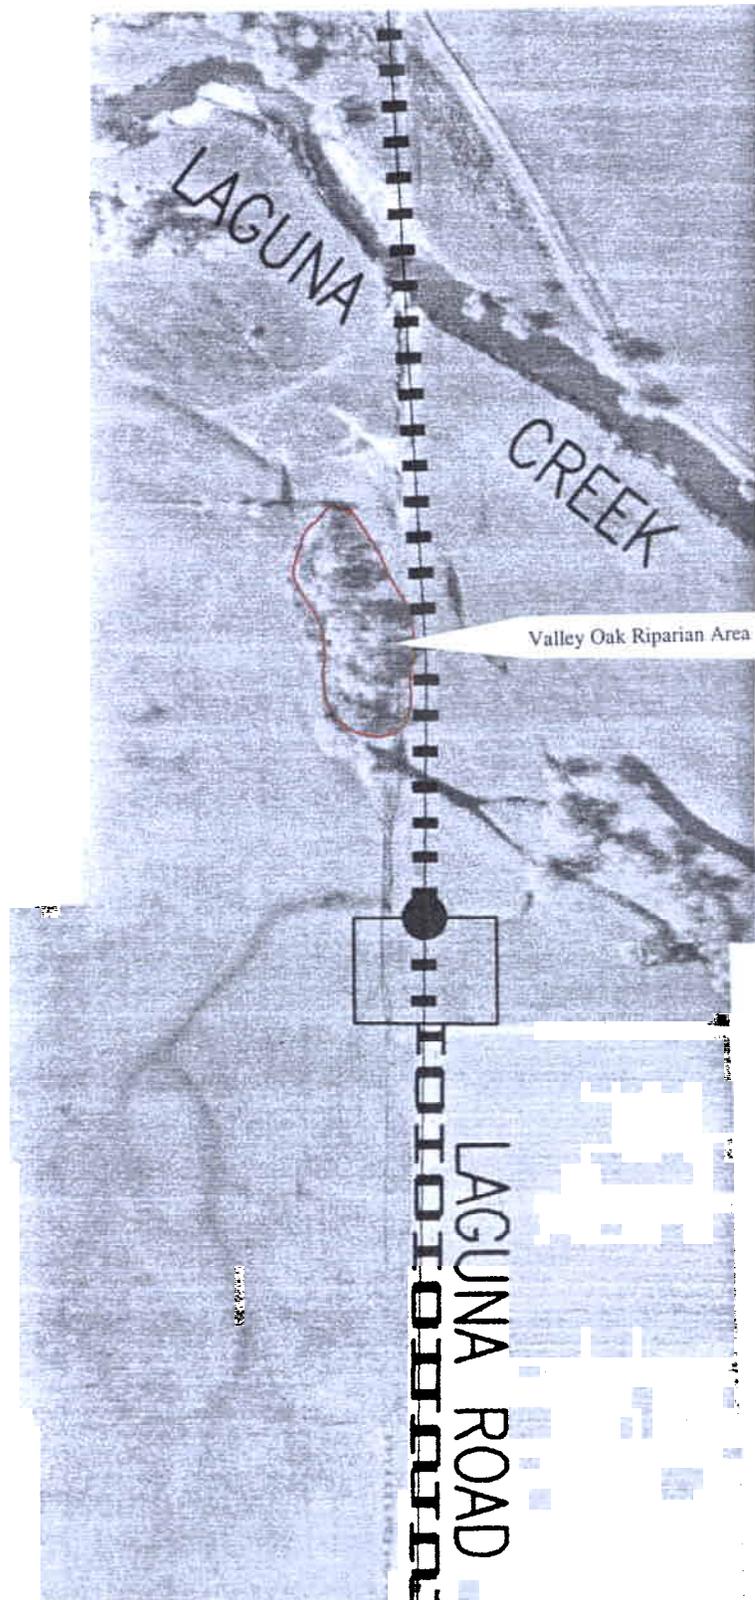
A small valley oak riparian area was identified just to the east of Laguna Creek (Figure 7). Several large trees are present in this area. HDD will be used to install the pipe in this area; and therefore, no impacts to this habitat are anticipated.

Figure 7. Valley Oak Riparian area, on the east side of Laguna Creek. The horizontal directional drill under the creek will avoid this area.
