**FIGURE 5.13-10
SCENIC ATTRACTIVENESS EVALUATION FORM FOR
SENSITIVE VIEW AREA AND KOP NO. 1**

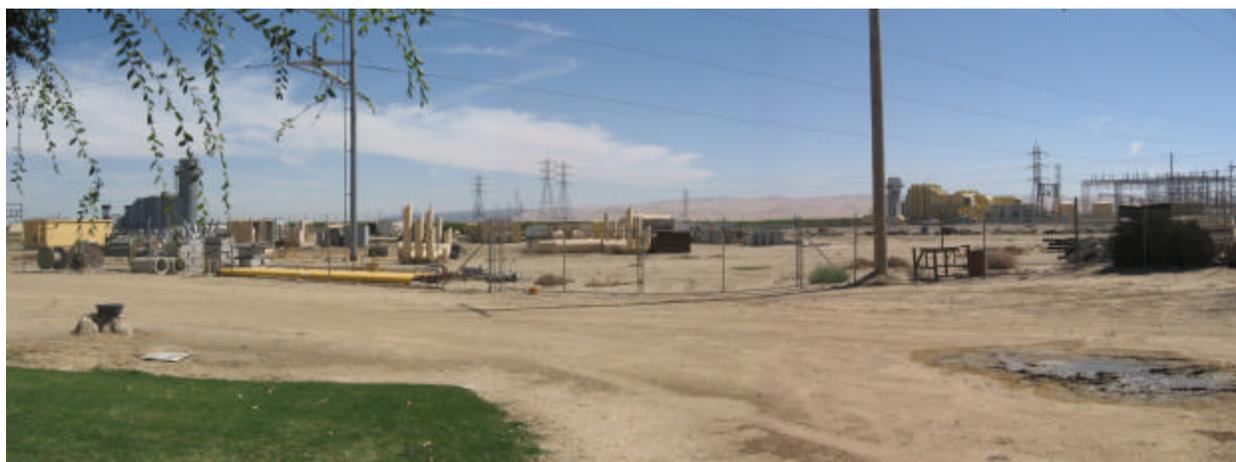
Landform	H (5)	H/M (4)	M (3)	M/L (2)	<u>L (1)</u>
Vegetation	H (5)	H/M (4)	M (3)	M/L (2)	<u>L (1)</u>
Water	H (5)	H/M (4)	M (3)	M/L (2)	<u>L (1)</u>
Color	H (5)	H/M (4)	M (3)	<u>M/L (2)</u>	L (1)
Adjacent Scenery	H (5)	H/M (4)	M (3)	<u>M/L (2)</u>	L (1)
Scarcity	H (5)	H/M (4)	M (3)	M/L (2)	<u>L (1)</u>
Modifications*	H (2)	H/M (1)	M (0)	<u>M/L (-2)</u>	L (-4)
Scenic Attractiveness Class C (6)

Narrative Landscape Description and Photograph. Sensitive Viewing Area and KOP No. 1 (Figure 5.13-13, see also Figure 5.13-4 for KOP location) was taken from the backyard view from the closest of five residences along West Panoche Road, adjacent to the existing Panoche substation. The terrain is flat desert with a variety of cultural modifications (including the existing substation, existing peaker power plants (Wellhead on the left and CalPeak on the right), transmission lines, and the existing storage yard (fenced in the photo above). All contrasts to form and line are created from cultural modifications. The mountains, in the distant background (over five miles away) provide some visual interest in the area. Vegetation and color within the area is varied (manmade green crop rows surround the desert tan barren landscape of the storage yard and substation grounds). No water sources are within the foreground of this area, although the California Aqueduct lies approximately two miles east of this location.

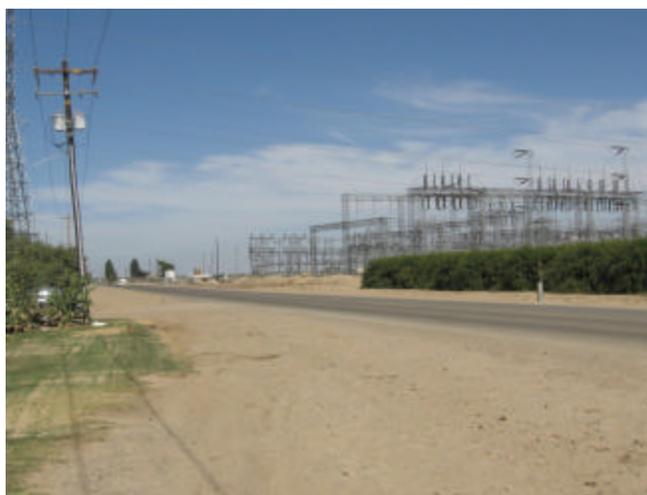
**FIGURE 5.13-11
SCENIC ATTRACTIVENESS EVALUATION FORM FOR
SENSITIVE VIEW AREA AND KOP NO. 2**

Landform	H (5)	H/M (4)	M (3)	M/L (2)	<u>L (1)</u>
Vegetation	H (5)	H/M (4)	M (3)	<u>M/L (2)</u>	L (1)
Water	H (5)	H/M (4)	M (3)	M/L (2)	<u>L (1)</u>
Color	H (5)	H/M (4)	M (3)	<u>M/L (2)</u>	L (1)
Adjacent Scenery	H (5)	H/M (4)	M (3)	<u>M/L (2)</u>	L (1)
Scarcity	H (5)	H/M (4)	M (3)	M/L (2)	<u>L (1)</u>
Modifications*	H (2)	H/M (1)	M (0)	<u>M/L (-2)</u>	L (-4)
Scenic Attractiveness Class C (7)

Narrative Landscape Description and Photograph. Sensitive Viewing Area and KOP No. 2 (Figure 5.13-14, see also Figure 5.13-4 for KOP location) was taken from the unobscured residence of three along West Panoche Road. Topographic relief across the setting is minimal, adding limited visual appeal to form and line characteristics. There are no water sources within the immediate project vicinity (although the California aqueduct lies within two miles of the site). Color variations (mainly from the crop rows) add visual interest to the area. From this view the distant mountains to the west are not visible. Moderately diverse vegetation consists of manmade agricultural crop rows (pomegranate tree rows shown here, nuts and fruits nearby). This landscape is modified by the presence of the PG&E substation and transmission lines. It should be noted that the other two residences along this same stretch of roadway are partially or completely screened by mature vegetation.

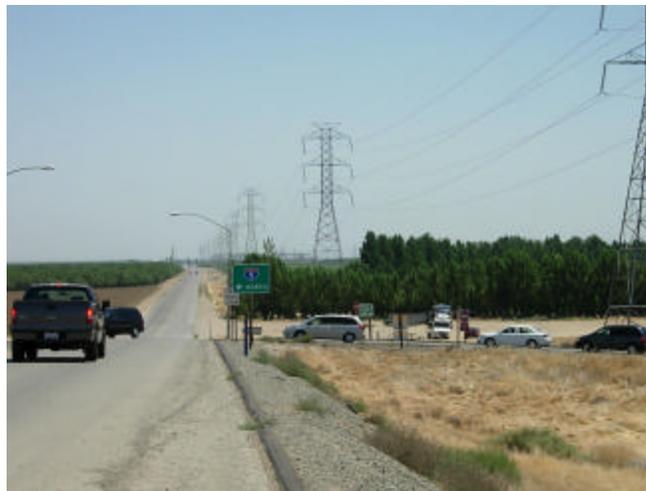
**FIGURE 5.13-12
SCENIC ATTRACTIVENESS EVALUATION FORM FOR SENSITIVE VIEW AREA NO. 3**

Landform	H (5)	H/M (4)	M (3)	<u>M/L (2)</u>	L (1)
Vegetation	H (5)	H/M (4)	<u>M (3)</u>	M/L (2)	L (1)
Water	H (5)	H/M (4)	M (3)	M/L (2)	<u>L (1)</u>
Color	H (5)	H/M (4)	<u>M (3)</u>	M/L (2)	L (1)
Adjacent Scenery	H (5)	H/M (4)	<u>M (3)</u>	M/L (2)	L (1)
Scarcity	H (5)	H/M (4)	M (3)	M/L (2)	<u>L (1)</u>
Modifications*	H (2)	H/M (1)	M (0)	<u>M/L (-2)</u>	L (-4)
Scenic Attractiveness Class C (11)

Narrative Landscape Description and Photograph. Sensitive Viewing Area and KOP No. 3 (Figure 5.13-15, see also Figure 5.13-4 for KOP location) was taken from the overpass of I-5 and West Panoche Road. A topographic rise of the overpass allows for more open, expansive views from this location. The area to the east of this location is flat valley lands; the area to the west of this location flattens to the base of the Panoche and Tumey Hills mountains. Clear views to the project site (about 2 miles in the distance) and clear views in the opposite direction (to the mountains) offer diversity of line and form and bring visual interest to the area. Variations in color and vegetation (due to agricultural crop rows and cultural modifications) add to the visual interest of the area. Transmission lines also traverse the area. The homogeneous vegetative pallet consists of intermittent desert scrub bushes and adds little interest to the area.
