**CALIFORNIA
ENERGY COMMISSION**

FINAL PROJECT REPORT

Pipeline Right-of-Way Monitoring and Notification System

**Gavin Newsom, Governor
April 2020 | CEC-500-2020-024**

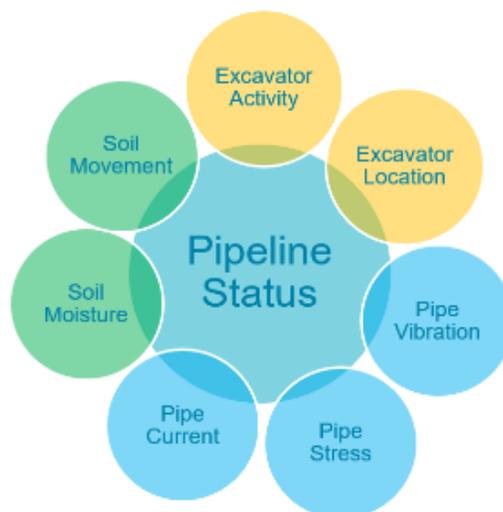
Figure 3: Overlapping Influences in the Pipeline ROW

The system must collect observations of multiple attributes at multiple locations within the ROW to form a detailed overall picture of pipeline status. Figure 3 lists attributes the demonstration system will monitor. It is important to understand that more than one of these influences may be active at a given time and that circumstances other than construction activity can cause pipeline damage.

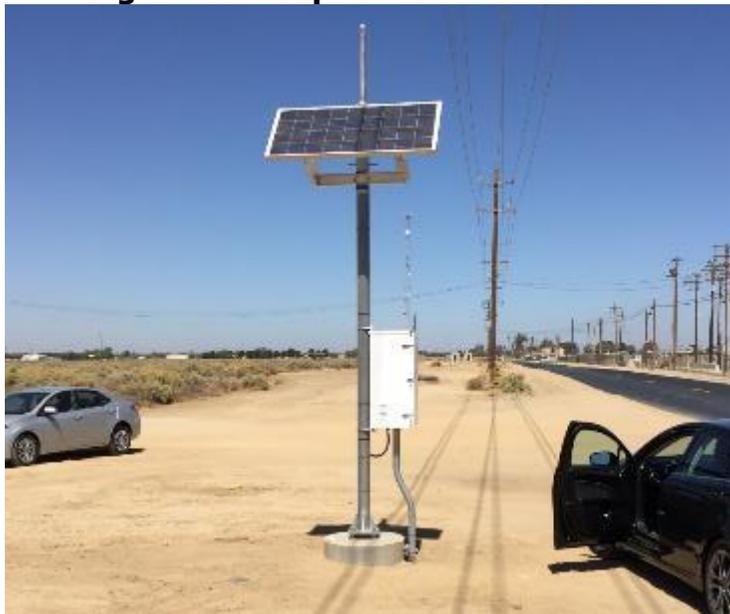
Figure 4: Completed Sensor Station

There is a large existing network of pipeline, totaling about 215,000 miles in California. A practical monitoring system must work for new and existing pipe and excavation equipment. To keep installation costs low, it is important that the footprint of the equipment attached to the pipe itself is small and done with minimal excavation, preferably in a keyhole opening. GTI elected to use “point” sensors installed on the pipeline at regular intervals to meet these needs. Distributed sensors, such as those based on fiber optics, can provide good coverage and localization of problems but require trenching to install. While distributed sensors may be appropriate for new construction, they are problematic for retrofit situations. Figure 4 shows the above ground portion of an actual sensor installation.

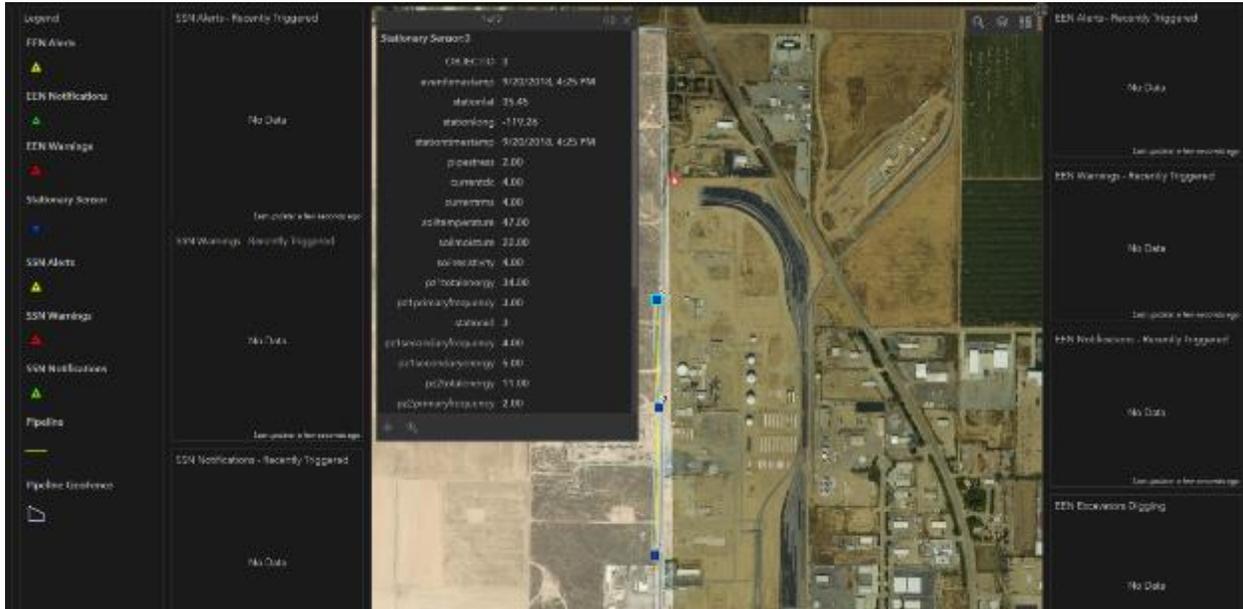
Figure 5: Dashboard for Right-of-Way Monitoring Concept

To be effective, the analytics portion of the system must filter data in such a fashion as to not overwhelm utility personnel unnecessarily. Figure 5 shows a sample version of the operator dashboard for viewing multiple sensor data feeds, providing an overall view of pipeline status.

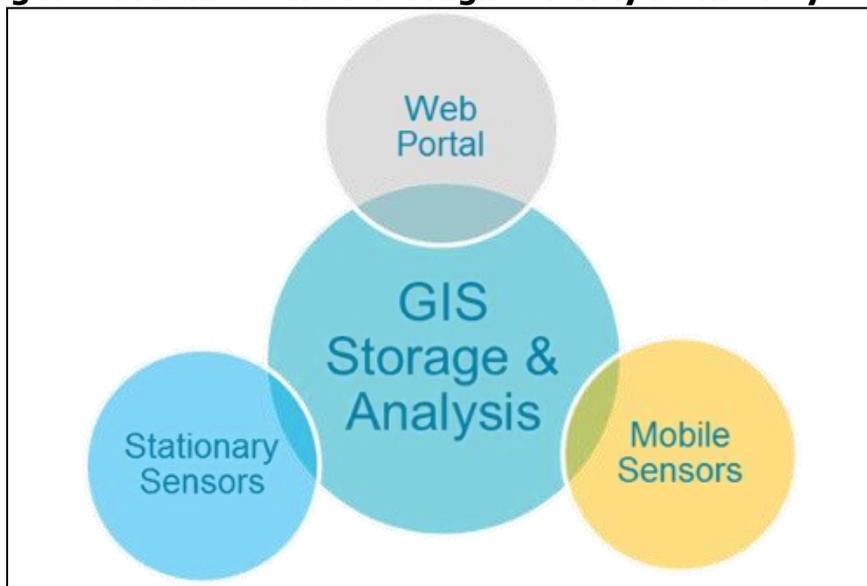
Figure 6: Architecture for a Right-of-Way Monitor System

1. A central, GIS-based repository that can store and analyze data.
2. A set of stationary pipeline sensors that transmit data to the repository.
3. A set of mobile sensors on excavation equipment that transmit data to the repository.
4. A web portal or user “dashboard” that provides the end users with alerts and visualizations of conditions on the pipeline ROW.

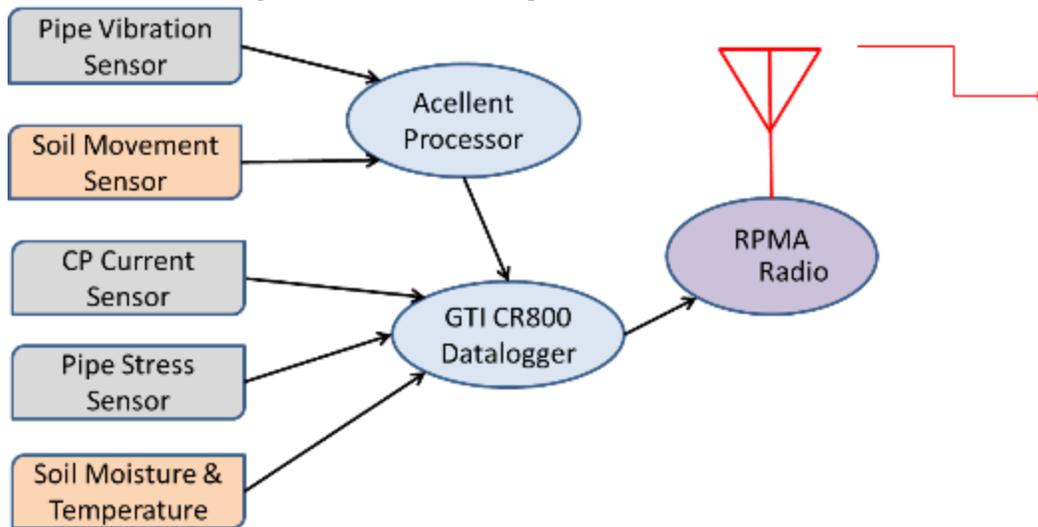
Figure 7: Stationary Node Architecture

With the high-level architecture defined, next the hardware required to provide the appropriate data feeds was selected. To select the correct hardware, the project team identified the key environmental parameters that needed to be monitored. Data about the vibration level on the pipe, the tensile stress and the cathodic protection current were captured. These parameters were selected because their effects can travel for long distances in the steel of the pipeline. Impacts on or near the pipe can cause vibration travelling thousands of feet. Disturbances such as landslides or settlement that deform the pipe cause stresses that can be extend for sizable distances. Cathodic protection currents travel for miles in the pipe metal; changes in current can indicate breaks in the coating or other problems. This hardware consists of the following sensors placed onto the pipe or in the adjacent soil (Figure 7):

- Soil Seismic Sensor
- Soil Moisture and Temperature
- Current Density Coupon
- Pipe Strain Sensor
- Pipe Vibration Sensor

These sensors will respond to activities other than excavation. Seismic activity would affect the pipe vibration sensor and the soil movement sensor simultaneously. Drastic increases in soil moisture or temperature can change the strain level in the pipe. Neither of these scenarios are caused by digging equipment near or in contact with the pipe. However, as monitoring for these types of activities was outside the scope of this project, the addition of further sensors to the soil to discriminate between these activities was not implemented at this time.

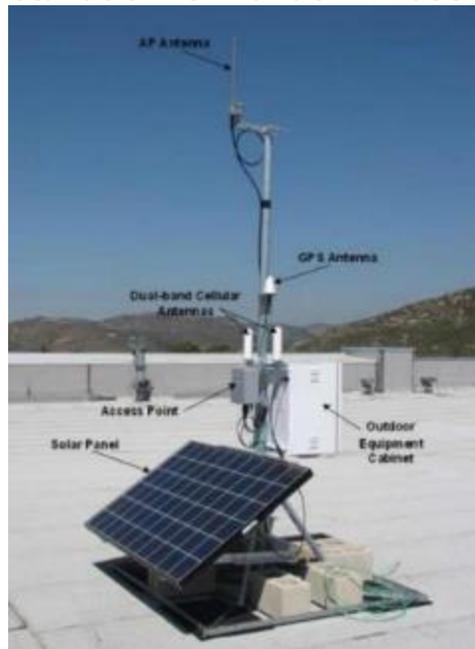
Figure 10: Typical Installation for Random Phase Multiple Access Point

Access points acted as a bridge between the RPMA radios and the Internet. One access point bridge can serve thousands of the RPMA radio nodes; the intention for this project is to provide 10 sensor nodes and two access points for each test site. The range of the RPMA radios can be several kilometers depending on the obstructions in the path. Figure 10 shows a rooftop installation of the RPMA access point bridge with a solar power supply.

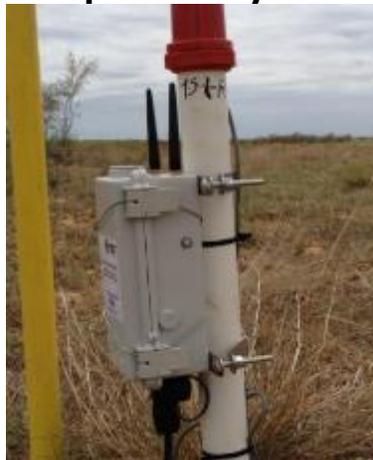
Figure 11: Close-Up of Canary Radio on a Test Post

Each stationary sensor installation will require one of the “Canary” RPMA radios mounted above ground (Figure 11) to provide communications to the nearest access point bridge from RPMA to IP. The access point is shared among all the stationary sensors within several kilometers.

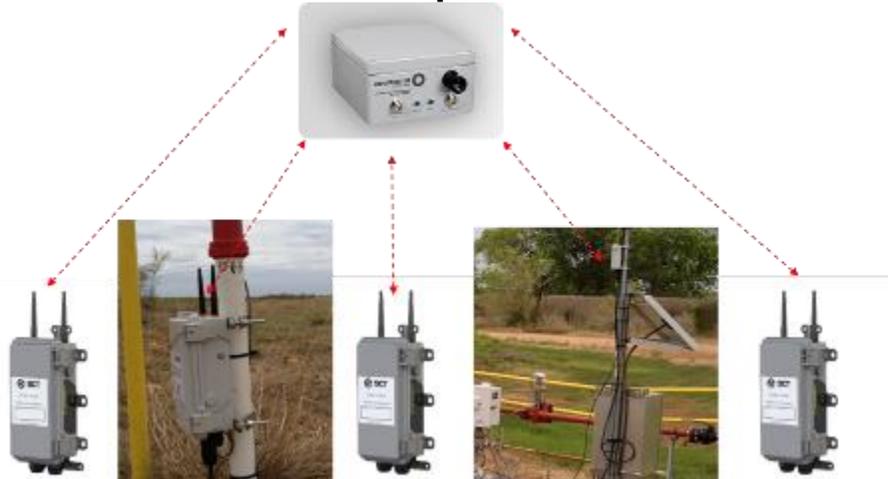
Figure 13: Random Phase Multiple Access Network Hardware

The technology chosen for this project is RPMA wireless. It is a fundamentally new technology designed to dramatically minimize total cost of ownership (TCO) while providing high link capability. RPMA has profound advantages in the key performance metrics of coverage and capacity, which allows for fewer access points, with much higher capability than any other public network approach. The RPMA hardware (Figure 13) consists of multiple end-points that transfer to an access point. The access point is also a bridge to the internet through a hard-wire or cellular link. Under good conditions, an end point can be several miles from the associated access point.

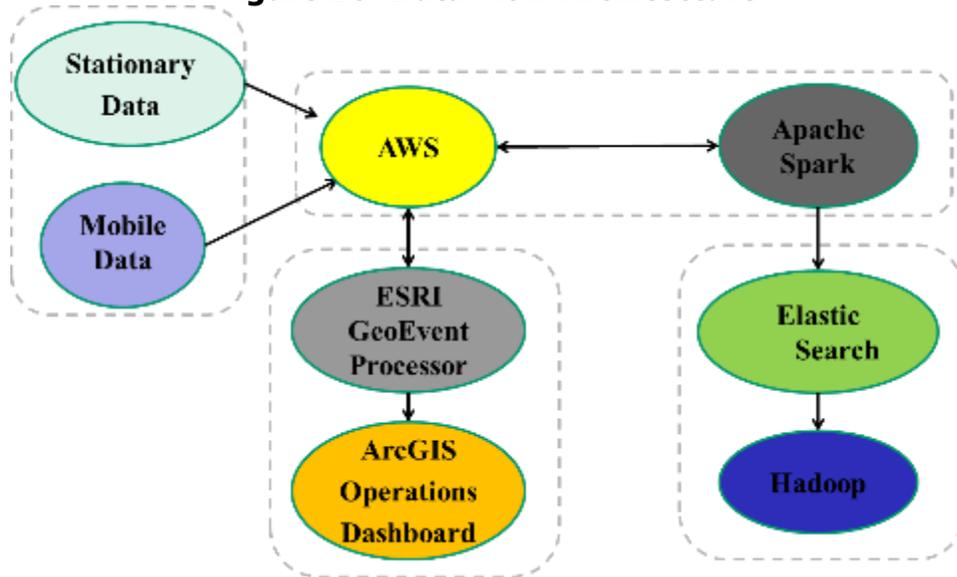
Figure 16: Data Flow Architecture

There are multiple technologies that must run in the background in order to support a seamless dashboard (Figure 16). The stationary and mobile sensors have wireless connections to carry their data to a server. The raw data needs formatting prior to display; the formatting functions are hosted on Amazon Web Services which provides temporary storage and

processing capacity. For immediate display, the data is then passed to Esri GeoEvent Processor, which determines if an alarm condition is in effect. The data is then passed to ArcGIS Operations Dashboard for visualization.

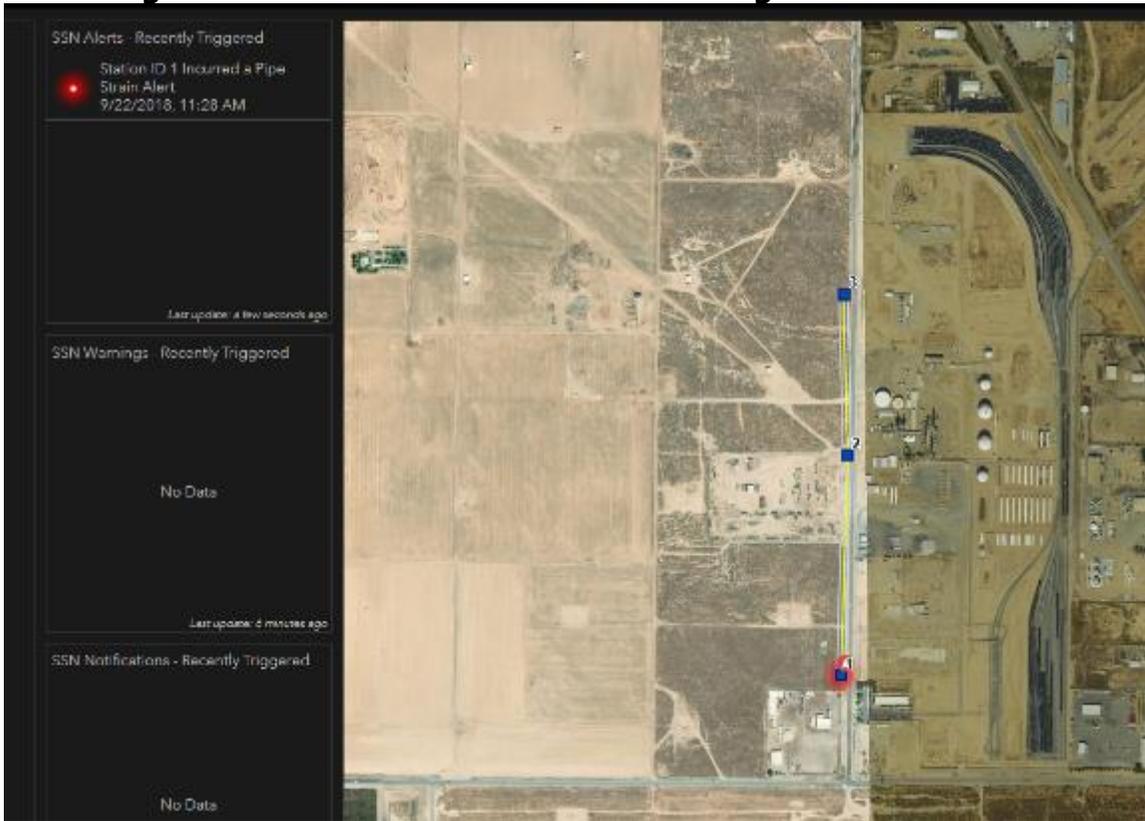
Figure 17: Real-Time Dashboard showing SSN Strain Alert

Incoming sensor readings are compared to threshold values for each of the monitored environmental parameters; if crossed, an alert appears in the dashboard both as a visual on the map and as descriptive text (Figure 17). GeoEvent processor provides a graphical programming environment to define alarm parameters and set thresholds. The programming flow shows vibration data from the stationary sensor network being passed through a filter to determine its severity and who needs to be notified (Figure 18). Notifications can be sent to the user dashboard and email or SMS messages can be sent.

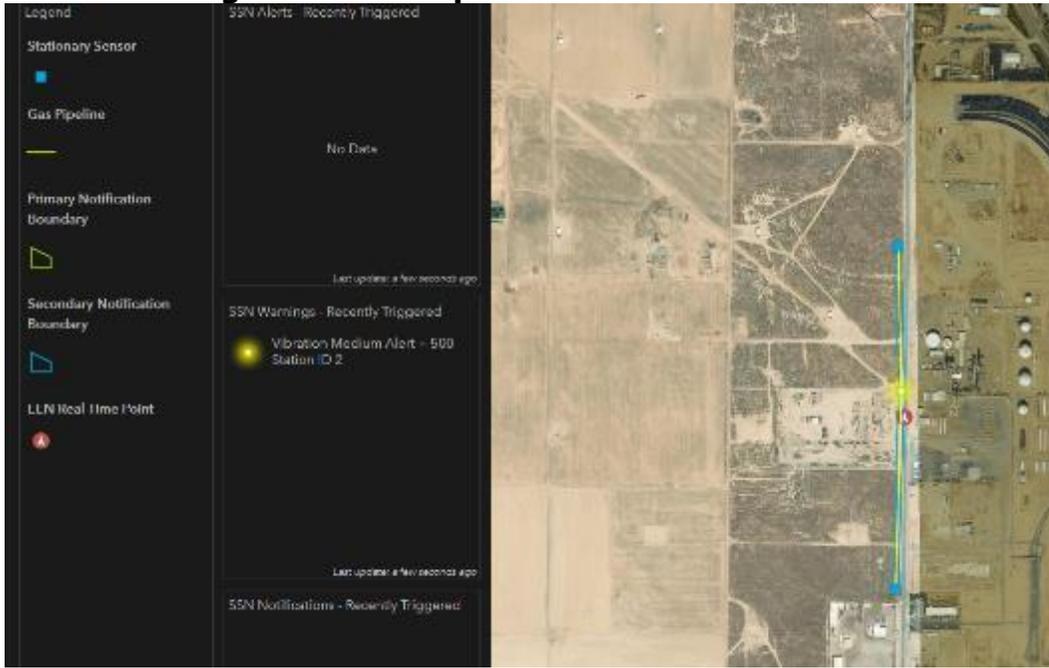
Figure 20: Example of Intermediate Alarm

Within GeoEvent Processor, it is possible to set several levels of notification relative to sensor parameters. Under this project two levels of notification were used – warning and alert. A warning was issued through the dashboard if a sensor value was approaching (but had not yet exceeded) an unacceptable level, allowing personnel to take preemptive action (Figure 20). An alert was issued when a sensor value crossed the threshold into an unacceptable range (Figure 21).

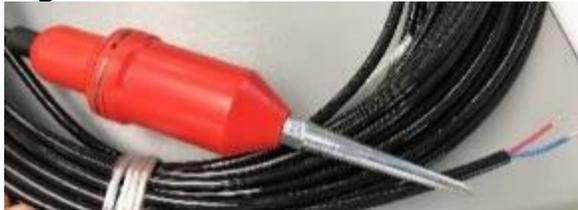
Figure 22: Soil Seismic Sensor

The Soil Seismic Sensor is the GS-30CT geophone (Figure 22). An enclosed geophone is mounted on a spike and buried to provide good coupling with the soil. The preferred output type is digital but getting the appropriate resolution will require amplification of an analog signal with post processing.

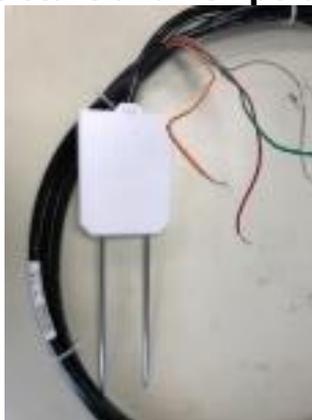
Figure 23: Soil Moisture and Temperature Sensor

The soil moisture, soil conductivity, and temperature sensor is the Campbell Scientific CS655 (Figure 23). This is a three-function sensor that make use of the SDI-12 standard for communication. The moisture sensor measures the dielectric constant of the soil and derives the volume moisture content through calculation. The temperature and soil conductivity are also acquired through this sensor.

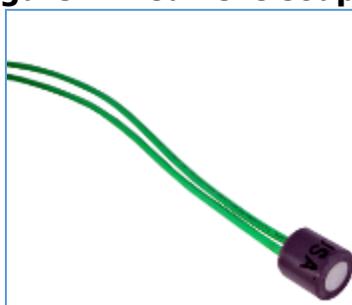
Figure 24: Current Coupon

The pipeline current density is measured through a steel coupon wired to the pipe (Figure 24). This device, obtained from Far West Corrosion, measures the current density through a one square centimeter surface area relative to the local soil. This provides insight into the state of the pipeline coating and the risk that corrosion is occurring. The coupon, made of steel like the pipeline, is a proxy for a coating flaw of the same area and provides a measure of the effectiveness of the cathodic protection. The soil moisture and conductivity values captured with the CS655 are also considered in the evaluation of this data.

Software is used to separate the AC and DC components of the pipeline current density. DC current is intentionally applied to pipelines to prevent corrosion. AC currents may be induced by the proximity of power lines or by ground faults in power systems. Excessive levels of AC current can cause corrosion and so must be monitored to determine if mitigation is necessary. The presence of electrified rail transit systems can also cause stray currents on pipelines that can compromise cathodic protection.

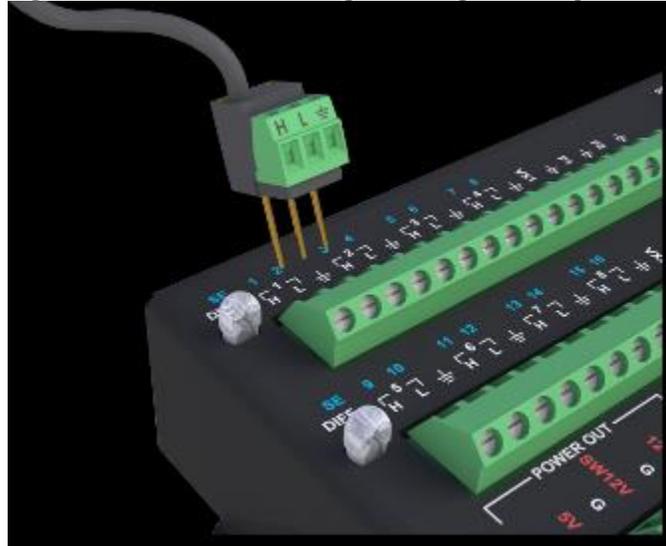
Figure 26: Strain Gauge Bridge Completion

The pipe stress sensor is a strain gauge, type CEA-06-125UW-350/P2 from Vishay Micro-Measurements (Figure 25). This sensor monitors the longitudinal stress on the pipeline. The pipe stress can be affected by factors such as frost heave, undermining, or soil washout due to flooding. Stress can travel for long distances in the pipeline, allowing observation of remote effects. This effect was considered when selecting sensors so as to achieve the greatest spacing between locations. A bridge completion block, Campbell Scientific type 4WFBS350, must be used to interface the strain gauge with the CR800 data logger (Figure 26).

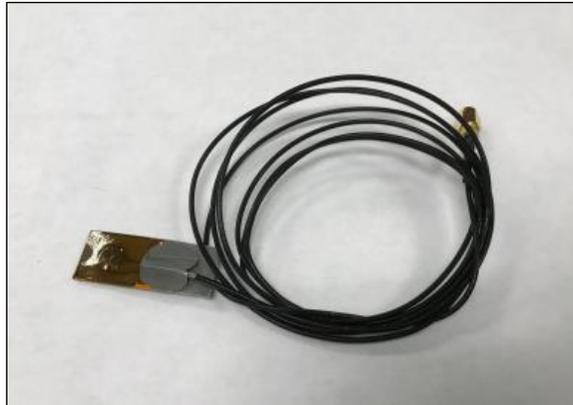
Figure 27: Piezoelectric Vibration Sensor

The vibration sensor was provided by Acellent Technologies and can detect impacts at some distance along the pipe (Figure 27). This is accomplished by attaching piezoelectric vibration sensors directly to the pipe. The vibration data is then processed by a custom data acquisition system (Figure 28).

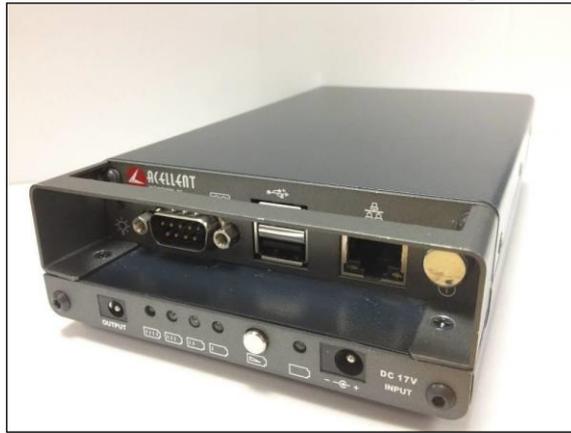
Figure 28: Acellent Vibration Data Acquisition System

Communication of sensor readings used the MODBUS RTU standard. The Acellent vibration monitor was configured as a MODBUS slave. It passed information to the Campbell datalogger (described in the next section) for storage. The Campbell then sent its own data and the Acellent data to the Canary RPMA wireless link in the MODBUS format.

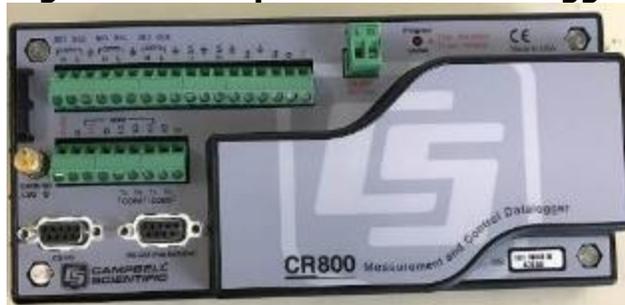
Figure 29: Campbell CR800 Datalogger

Sensors readings are aggregated into a single datalogger (Figure 29). Based on the following criteria, the CR800 datalogger from Campbell Scientific was used.

- Field-hardened device that can work in harsh environments.
- Appropriate number of channels for the sensors chosen.
- Capability to directly read strain gauges with no external amplifier.
- Compatible with off the shelf soil temperature and soil moisture sensors.
- Multiple serial ports supporting MODBUS and other protocols.
- On board processing and scaling of sensor data.
- On board storage of data to provide a backup for the radio system.
- Ability to transfer data to the radio system for transmission.

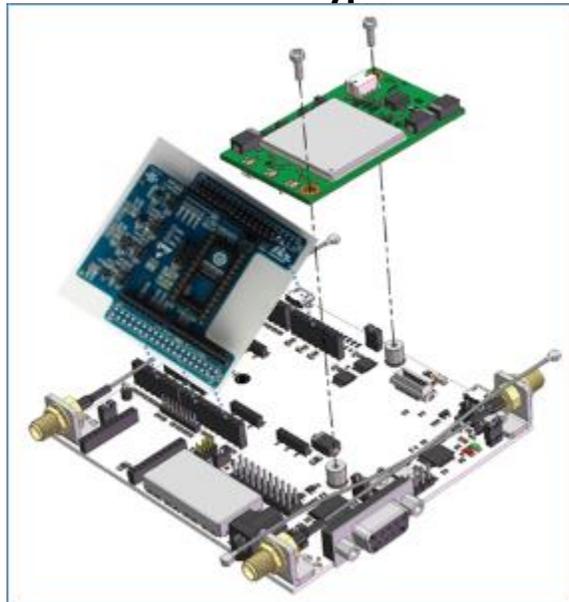
Figure 30: Mobile Prototype Sub-Assemblies

The initial mobile sensor prototype used off-the-shelf technology (Figure 30). A single module was identified that included both the GPS function and cellular connectivity, provided by the Multitech Corporation. This was combined with external sensor modules. The completed prototype included the following sensors:

- GPS/GLONASS - global positioning system receiver, potentially combined solution with the GLONASS positioning system. The receiver requires active antennas to operate correctly.
- 3D accelerometer and gyroscope type LSM6DS0 $\pm 2/\pm 4/\pm 8$ g and $\pm 245/\pm 500/\pm 2000$.
- 3D magnetometer type LIS3MDL $\pm 4/\pm 8/\pm 12/16$ gauss acts as a compass.
- Pressure sensor (LPS25HB*: MEMS 260-1260 millibar absolute digital output barometer).
- Capacitive digital relative humidity and temperature (HTS221).

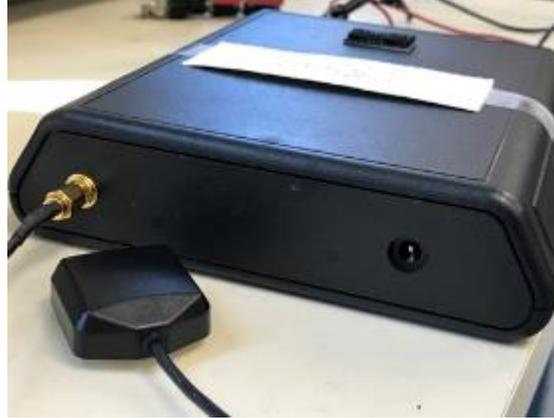
Figure 31: Mobile Prototype Packaged for Testing

During the project, the utilities providing tests sites gave guidance for their preferred embodiment of the EEN device. The goal was to have a demonstrable prototype that was closer to a commercial product. The packaged mobile prototype was tested using a rented backhoe on the GTI campus (Figure 31). While this prototype was found work, some additional features were requested by partner utilities, as described in the next section.

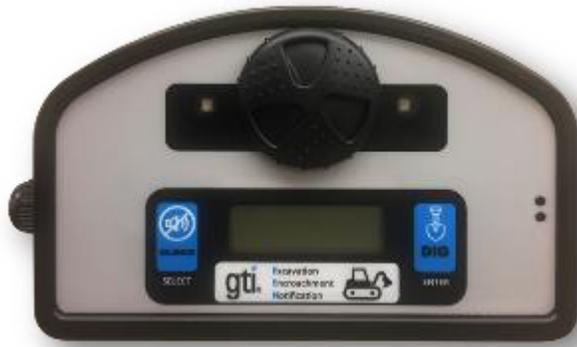
Figure 32: GPS EEN Near Commercial Version

Under a separate Energy Commission Agreement, PIR-05-015, specific to a large-scale demonstration of the GPS EEN technology was ongoing during this time. The financial resources available to that project were much greater and so it was able to take the concepts past prototype and into near commercial readiness (Figure 32). This version of the GPS EEN was the one that ultimately was used in the field deployment and testing.

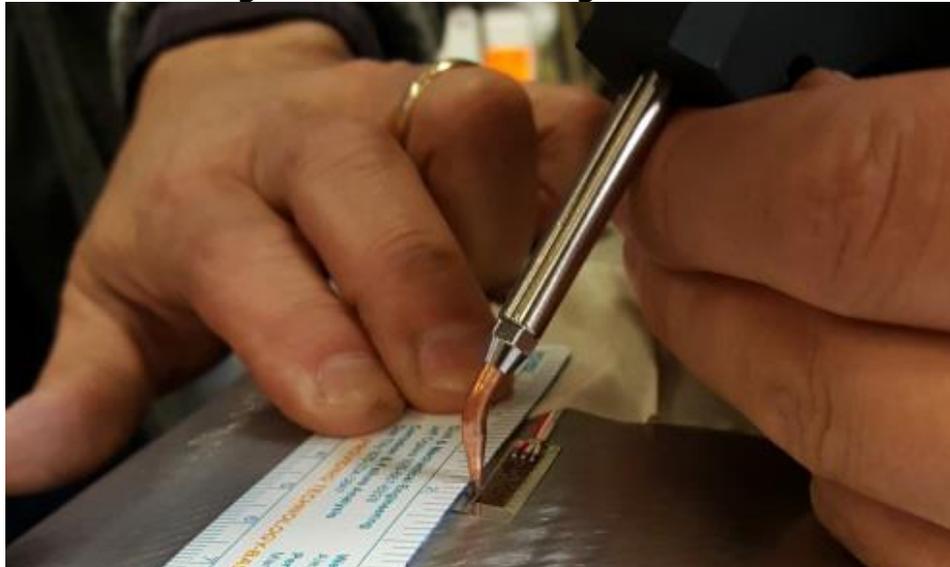
Figure 34: Tack Welding of Sensor

The welding is accomplished with a hand tool that is battery powered to facilitate field work (Figure 34). A tip of the size of a ball point is pressed against the shim and a pulse of current is injected that melts a small portion of the shim and the pipe metal in order to bond them together. A series of welds is needed to “tack” the sensor to the surface.

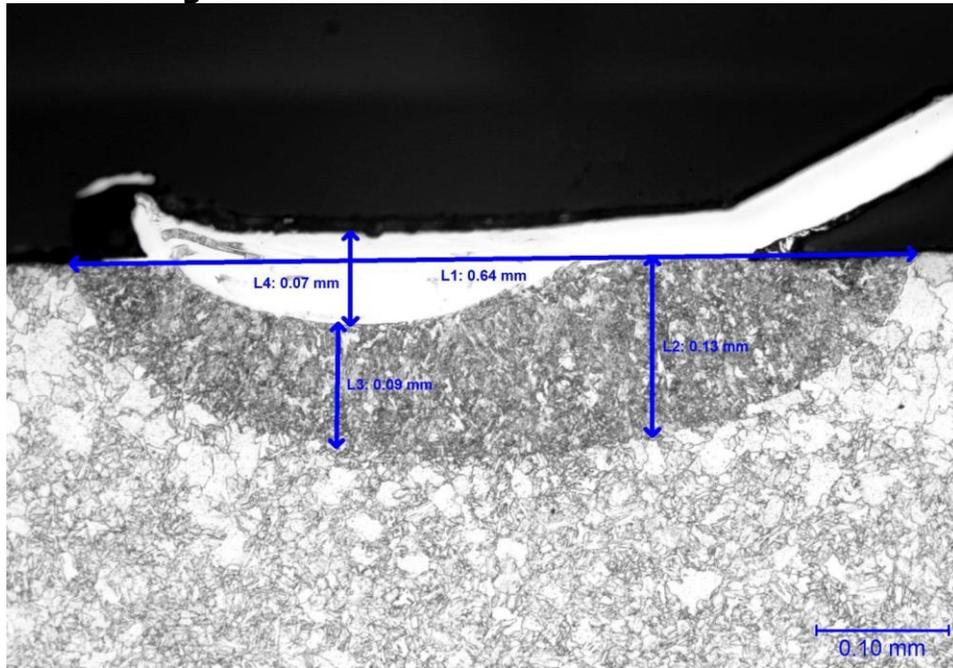
Figure 35: Resistance Weld Cross Section

Test samples were prepared for both utilities providing field sites. One utility subjected the sample to salt spray testing after the sensor area was covered with mastic; this test was passed. The second utility performed metallurgical tests on the samples. These are standard pipeline tests performed by utilities.

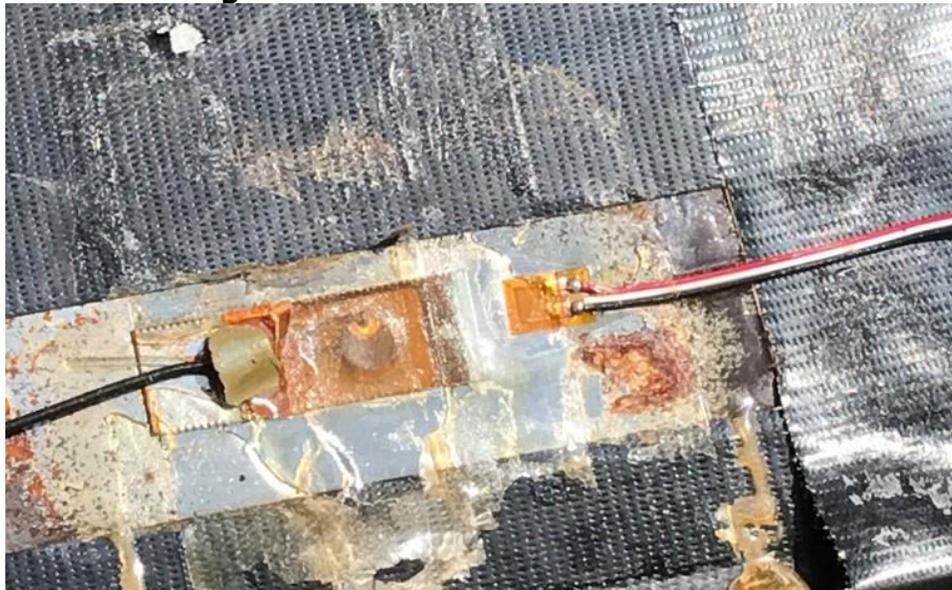
Figure 36: Adhesive Bonded Sensors

However, results of the adhesive bonding method testing were deemed acceptable to both utilities. Test applications of adhesive bonded sensors were performed under outdoor test facility conditions at both utilities, which allowed staff to become familiar with the process (Figure 36).

The piezoelectric vibration sensors (left side of Figure 36) and the seismic geophone sensors were connected to the Acellent vibration analyzer device. Pre-deployment testing of the Acellent hardware has been carried out in their laboratory in Sunnyvale, California. This testing will be the subject of a separate report issued by Acellent Technologies as part of PIR-14-015.

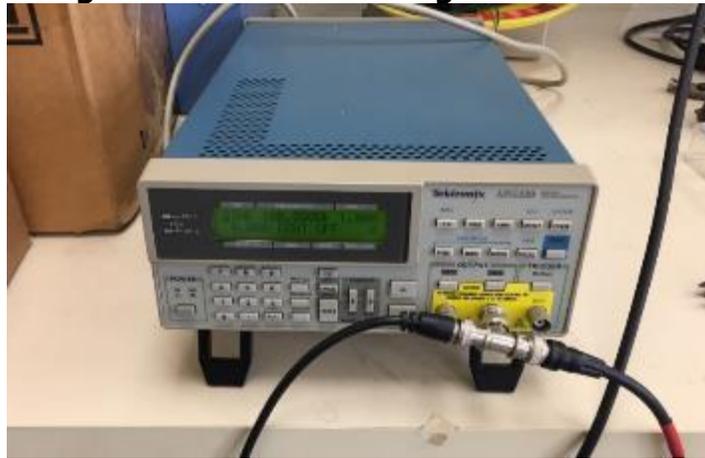
Figure 37: Calibration Signal Generator

The current input to the CR800 was laboratory simulated using a programmable waveform generator (Figure 37). This device can generate waveforms with sinusoidal characteristics and DC offsets. Sinusoids at 60 Hz and its harmonics were used along with offsets that would be typical under field conditions. This allowed appropriate software to be developed for the CR800.

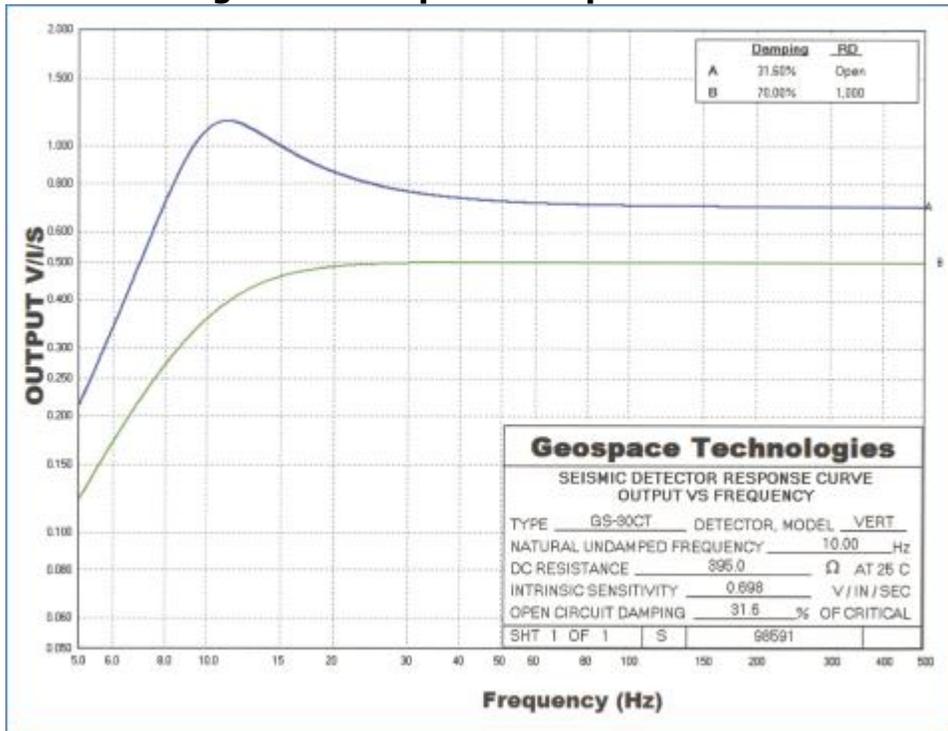
Figure 39: Geophone Response Curve

Based on its frequency response describe above, it was decided that the geophone would be connected to the Acellent vibration analyzer equipment. The Acellent equipment captures the seismic data and provides and provides information on the frequency and amplitude of the soil motion.

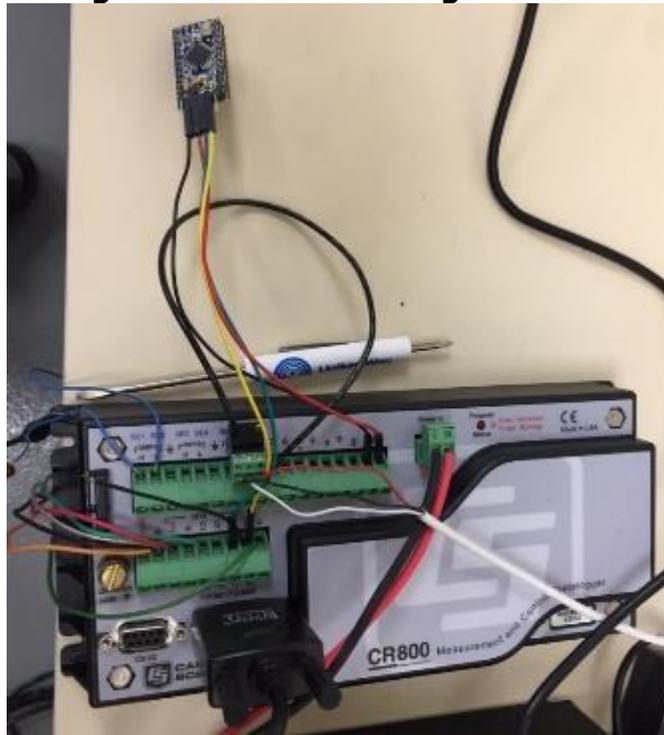
Figure 40: Bench Testing of CR800

The data stored internal to the datalogger can be recovered as a CSV file. There are four megabytes of internal memory that is shared between the program and data storage. The CSV file can be opened by other tools, such as Excel, to allow analysis. An example of such data is given in Appendix A. Up to four million readings can be archived internal to the CR800. This allows a backup copy of the data in the event the radio system fails. The data rate and number of sensors affects how quickly the internal storage is used. The oldest data is overwritten by the newest in a circular buffer when capacity is exceeded. The current data usage will allow slightly over four days of storage before overwriting occurs.

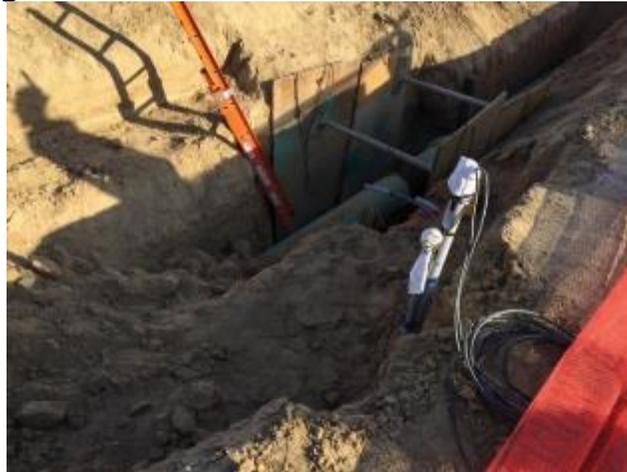
Figure 41: Excavation for Sensor Installation

A properly shored trench that provides 360-degree access to the pipe is required. The trench should be at least 4' wide and 8' long as seen in Figure 41. Safe access to the excavation must be provided. Conduits to bring sensor cables to the surface can be placed in advance. The pipe surface must be kept dry during the installation so as not to contaminate the adhesive. The excavation must be free of water; pumps may be required. The temperature affects the curing time for the epoxy used to attach sensors. At this site, temperatures exceeded 100°F with very low humidity. While unpleasant for personnel, hot and dry conditions are excellent for adhesive bonding. It was not necessary to bring in heaters or water pumps. The heat did accelerate the curing time of the epoxy adhesive.

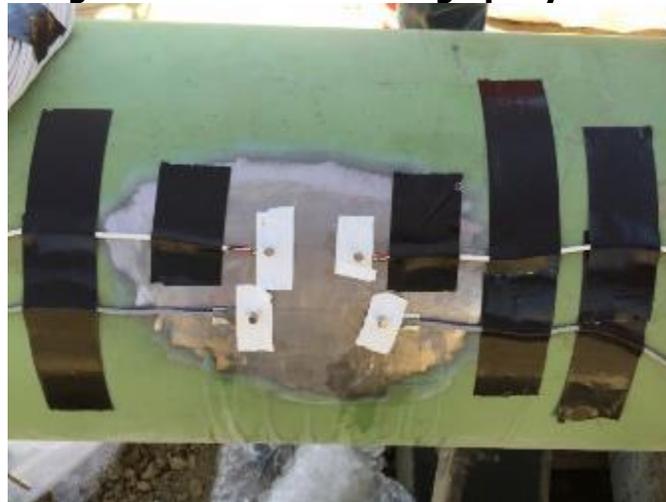
Figure 43: Sensors During Epoxy Cure

- Use a stirring rod to apply epoxy to pipe surface. Position sensors with tweezers and/or dental pick.
- Cover sensor with Teflon tape, then apply magnet or other clamping mechanism over the tape (Figure 43).

- Wait for epoxy to cure based on ambient temperature: roughly four hours at 74 degrees F. Supplemental heat may be needed during cold weather.
- Care must be taken to exclude water from the sensor area during the cure time.

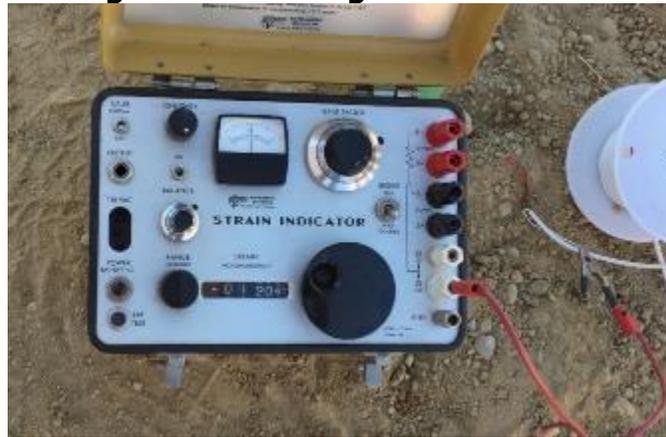
Figure 44: Testing Strain Sensors

- Remove magnets and Teflon tape from sensors.
- Test strain gauges with an appropriate instrument (Figure 44) or with an ohm meter. If the gauge is properly bonded, pressing with a finger or pencil eraser will not cause a change in strain level.
- Test vibration sensors with Acellent instrument or oscilloscope.
- If a sensor installation is found to be questionable it should be removed and/or replaced. If a "spare" sensor was installed, the best practice is to cut the cable from the suspect sensor to prevent later confusion.

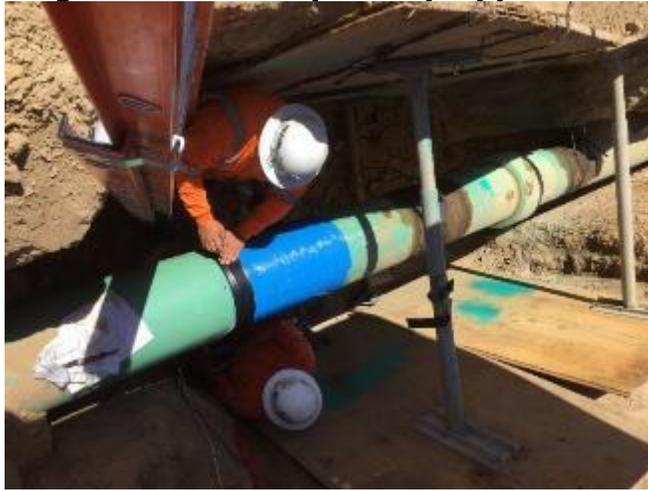
Figure 46: PVC Tape Wrap Application

- Over the sensor protection patch, perform a spiral wrap of the pipe with Viscotaq as per manufacturer instructions. Start wrap at least 6" before sensor area; continue wrap to 6" beyond sensor area.
- Counter wrap the pipe with a layer of PVC tape over the top of the Viscotaq (Figure 46).
- Test all sensors again prior to backfill.
- The first (blue) layer is pliable material that bonds well to itself and the pipe metal to exclude water. It also bonds with the (black) PVC layer that provides bump and abrasion protection.

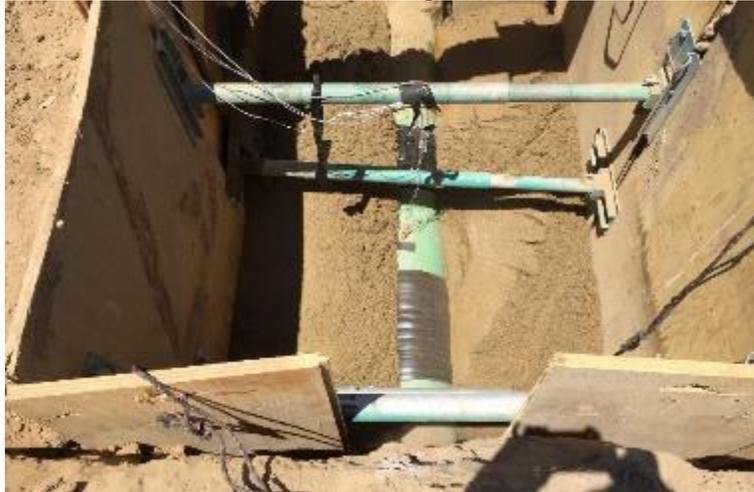
Figure 49: Excavation Partially Filled over Sensor Area

- Flow the fill material from alternate sides of the sensor area to achieve a fill level to roughly 18" above the top of the pipe (Figure 49).
- When the fill level has been achieved, allow the fill to set for 1-2 hours until the surface becomes firm enough to walk on.

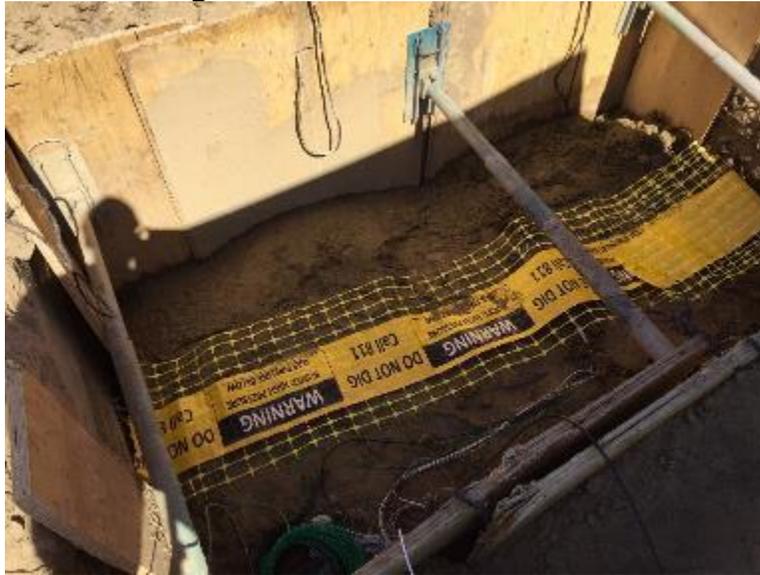
Figure 50: Sensors Installed

- After the fill has set sufficiently, make a roughly 12" by 18" excavation by hand, about 18" to the side of the pipeline. Insert the soil sensors into this excavation with the geophone in the center.
- Place the soil moisture and current coupon sensors at opposite ends of the hand excavation.
- Taking care to place the soil sensor cables on the bank, fill the 12" by 18" excavation by hand (Figure 50).
- After all sensors are installed under flowable fill, repeat tests using datalogging equipment and/or testers to verify that all sensors are working.

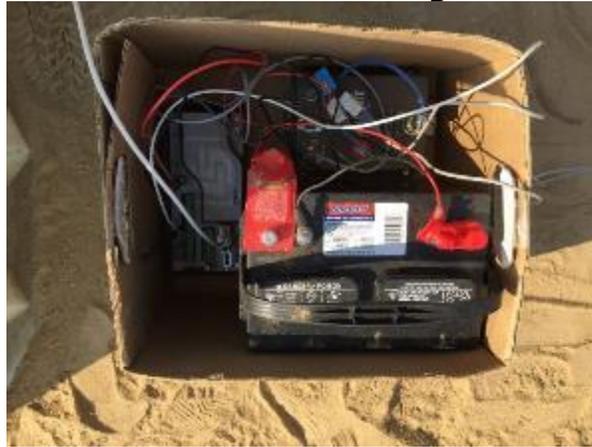
Figure 51: Instrumentation Running on Battery Power

The permanent instrument enclosures were not complete at the time of the hydro-test. The instrumentation was temporarily used for a three-day period to capture this data (Figure 51). This provided test data for some of the major systems. There was no cathodic protection in place during the hydro-test, preventing testing of the current coupon. The instrumentation was run from a combination of batteries and/or generators. The RPMA radios were not available making it necessary to recover the test data by directly connecting to a laptop (Figure 52).

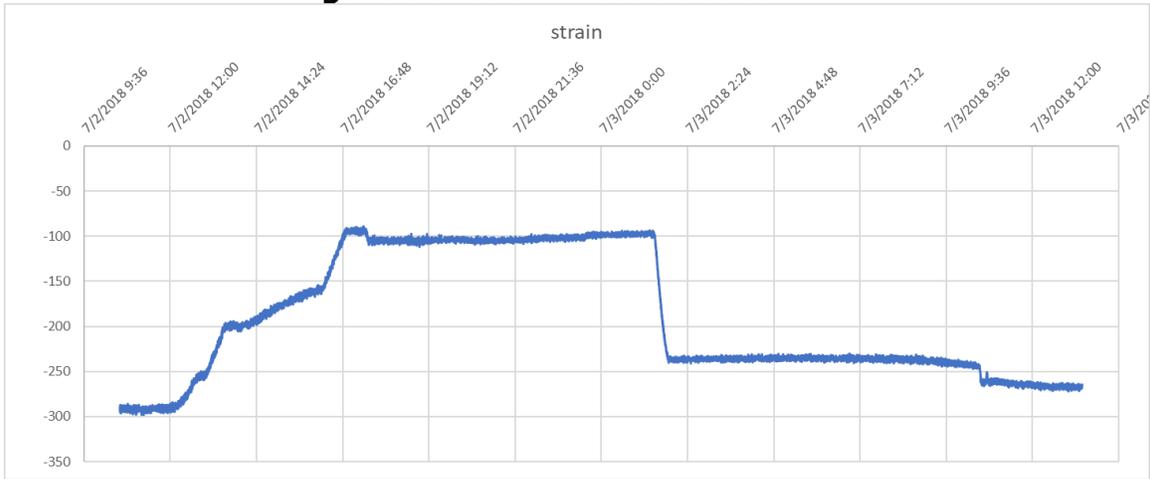
Figure 53: Strain Data at South End

The following plots show longitudinal pipe strain data that was captured over the course of the hydro-test. It should be noted that the starting or “zero point” of a strain gauge is arbitrary. One can establish an artificial zero by adding an offset to all the readings. Given that the installations were not completely backfilled at this time, we chose not to. The pressure profile ramps up to a spike value for roughly 15 minutes (Figure 53). The pressure is then held at 80% of maximum allowable operating pressure for eight hours. After that time the pressure was released, and removal of the water started. The tail end of the graph is still somewhat elevated as not all the water had been purged yet. The first hydro-test strain plot shows a station that was run purely on battery power for the entire duration of the test (Figure 53). The strain very clearly follows the hydro-test pressure profile.

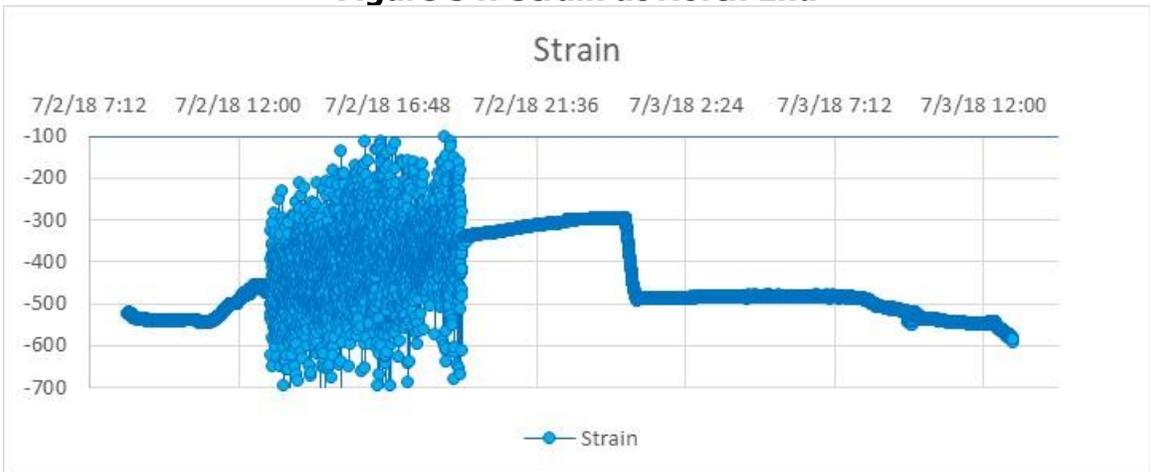
Figure 54: Strain at North End

The strain data recorded at a location 4000' north on the pipe showed a noise artifact for part of the test (Figure 54). This noise is attributable to the use of a generator to recharge the instrumentation batteries. The battery voltage plot for the same location clearly shows when the generator was being run to charge the batteries (Figure 55). The noise is caused by inadequate grounding of the generator. Even a small fraction of the AC current going to earth ground through instrument cables causes significant noise. Truck mounted temporary generators do not provide intrinsic earth grounding. In some locations, it is possible to drive a temporary ground into the earth and connect the generator to this. The earth is so dry at this location that a hand driven ground rod was ineffective. The permanent enclosures, which were not complete at the time of the hydro-test, have large surface-area grounding structures that are buried at pipeline depth (roughly 6').

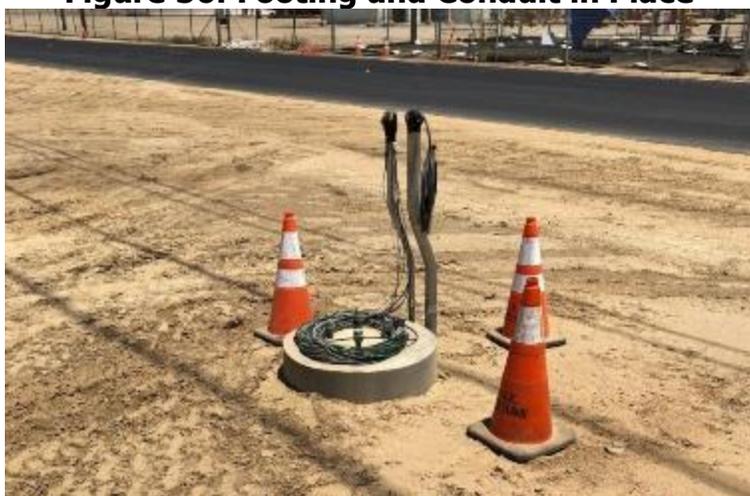
Figure 56: Footing and Conduit in Place

After the hydro-test was complete, the instrumentation was removed to a safe storage area in the construction yard until the permanent enclosures could be completed. The sensor cables were pulled through conduits and brought above ground. Footings were poured at two locations to support the pole for the instrumentation cabinet during July (Figure 56). The remainder of the soil backfill was put in place on top of the slurry fill covering the pipe.

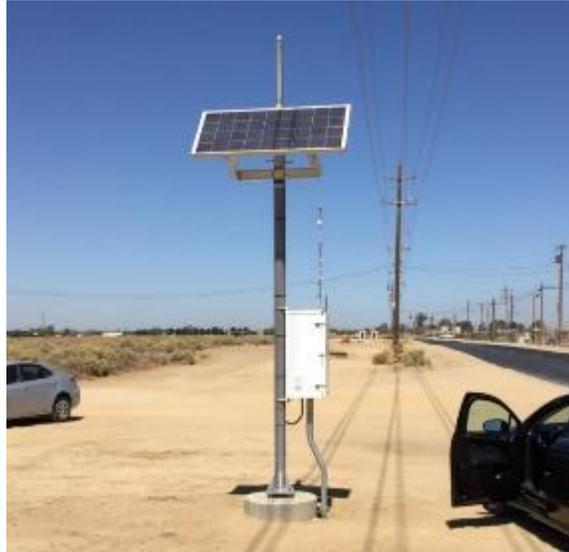
Figure 57: Solar Powered Enclosure in Place

The poles were put in place and the permanent enclosures with their solar power system installed (Figure 57). The CR800 dataloggers were installed and wired and cables from the previously installed sensors were brought to the surface in conduits. The Acellent vibration processors and RPMA radios would be installed later. Space was left at the top of the 15' pole for the radio enclosure. This installation is typical for two of the three locations on this site.

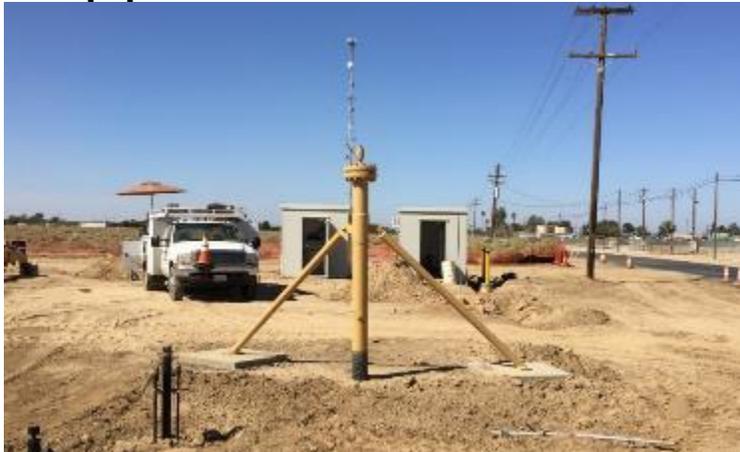
Figure 58: Equipment Sheds at Location 3 Under Construction

The third location on the test site to house instrumentation was inside the fence of a permanent station being constructed by a partner utility. The array of sensors is the same as the other locations, but the instrumentation resided in an equipment shed that will be supplied with AC mains power (Figure 58). A 15' mast was provided between the two sheds for the RPMA radio equipment antennas. The equipment in these sheds was temporarily powered by a generator, pending the completion of the AC power tie-in.

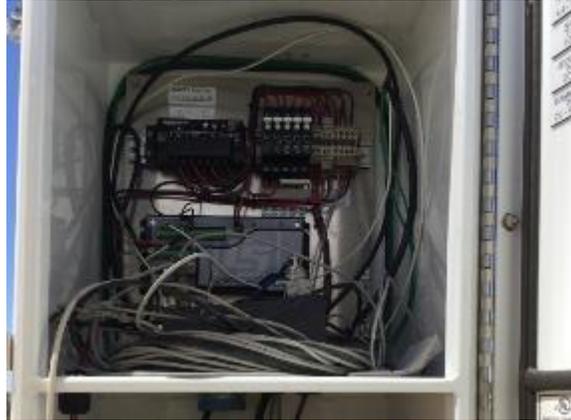
Figure 59: Equipment Enclosure Interior View

A series of tests were carried out to verify the response of the system to vibrations and impacts. This testing involved locations one and two only; the equipment shed at location three was under construction at the time. For this series of tests, the Acellent signal processing equipment was installed in the enclosure and connected to the sensors. The utility provided a soil compactor and an excavator to support this testing (Figure 59).
