**CALIFORNIA
ENERGY COMMISSION**

FINAL PROJECT REPORT

Pipeline Right-of-Way Monitoring and Notification System

**Gavin Newsom, Governor
April 2020 | CEC-500-2020-024**

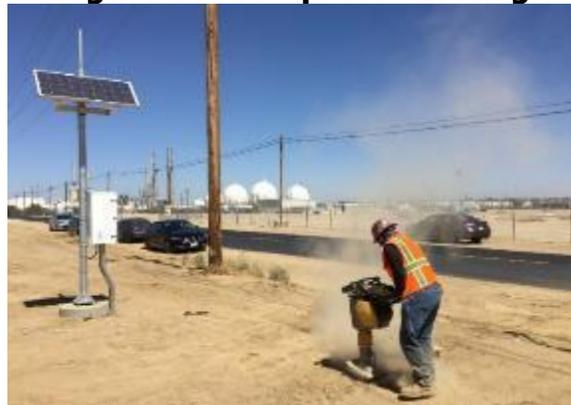
Figure 60: Compactor Testing

Compactor testing put repeatable vibrations into the ground at known locations between station one and station two. This would provide data on the sensitivity of the vibration sensors mounted on the pipe and on the attenuation of the soil-pipe system. The compactor testing began 50' south of location one and proceeded continuously over the pipeline to a point 50' to the north (Figure 60). The testing continued proceeding north toward location two with the compactor being moved to discrete points rather than run continuously (Figure 61). These points were 100', 200', 400', 600', 800', and 1,000' north of location one. The compactor was run for roughly two minutes at each point. The last point in this series was roughly 43' south of location two. To complete the series the compactor was run continuously from this point to on 50' to the north of location two.

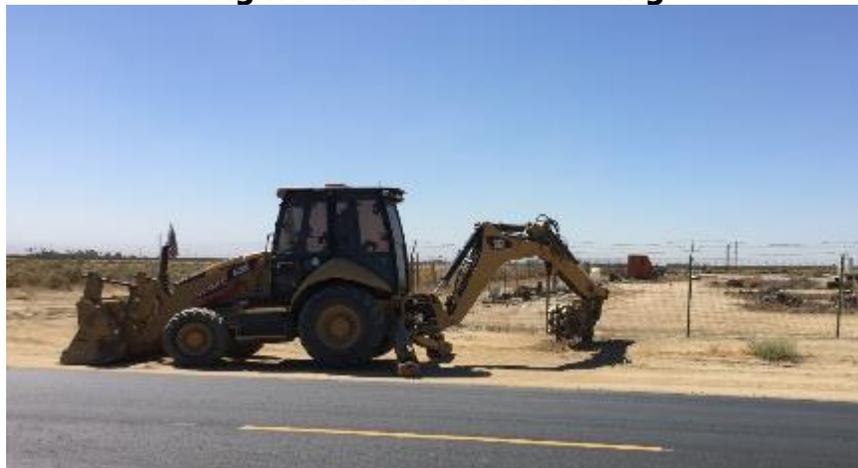
Figure 62: Excavator Testing

The excavator testing made use of a piece of equipment that is typical of what is used for digging and trenching operations (Figure 62). The impact signals generated by the excavator, while not repetitive like a compactor, should be larger in magnitude. This test was carried out at the same set of discrete points as the compactor but in reverse order. The excavator started at a point 50' to the north of location two and proceeded to a point 50' to the south of location one. At each point the excavator removed a small amount of soil, impacted the arm onto the ground several times, and then replaced the soil. At no time was more than 12" of soil removed or was there any hazard to the pipeline.

At the end of this testing sequence the excavating equipment withdrew from the site and the data was recovered from the recording equipment. It was found at this time that the Acellent equipment had failed to record any vibration events and also appeared to be overheating.

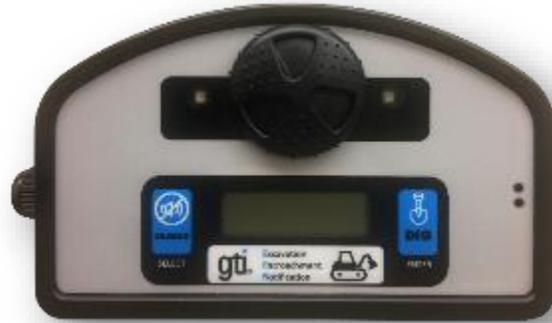
Figure 63: EEN Device Prototype

A basic assumption of this project, as discussed in Chapter 1, is that excavation equipment is a primary threat to buried infrastructure. This assumption is supported by multi-year studies performed by PHMSA, results of which are highlighted in Chapter 1. Mobile sensors with GPS technology provide the location, heading, speed, and status of excavation/construction equipment (Figure 63).

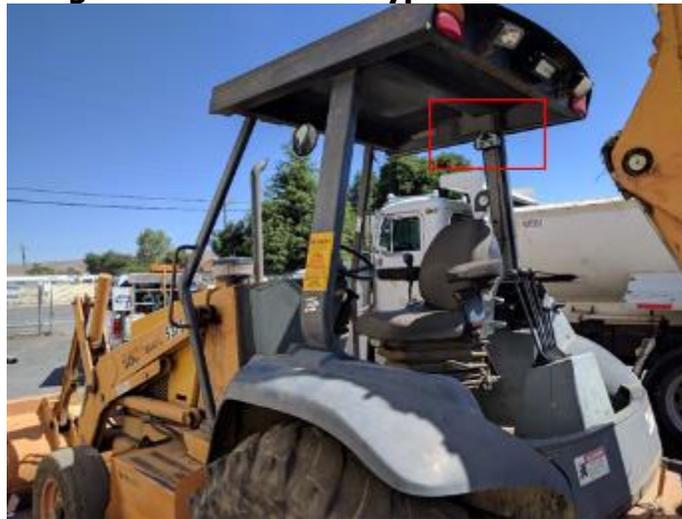
Figure 64: EEN Prototype on Excavator

A first-generation prototype of the EEN device was constructed and tested early in this project. An additional project was funded by the Energy Commission (PIR-15-015) that produced pre-commercial prototypes. These devices were more advanced than the original prototypes and were readily available at the time of field testing. The original test plan had included simultaneously testing the stationary vibration sensors and EEN sensors on excavators in same ROW (Figure 64).

During the actual field testing access to excavation equipment was limited to less than one day. There were issues with the stationary vibration sensing equipment, discussed in the next section, such that the utility hosting the test site did not provide a second round of excavator testing. In place of the excavator testing, the EEN device was placed in several vehicles that were used on the test site. This allowed several key attributes of the EEN devices to be tested, including:

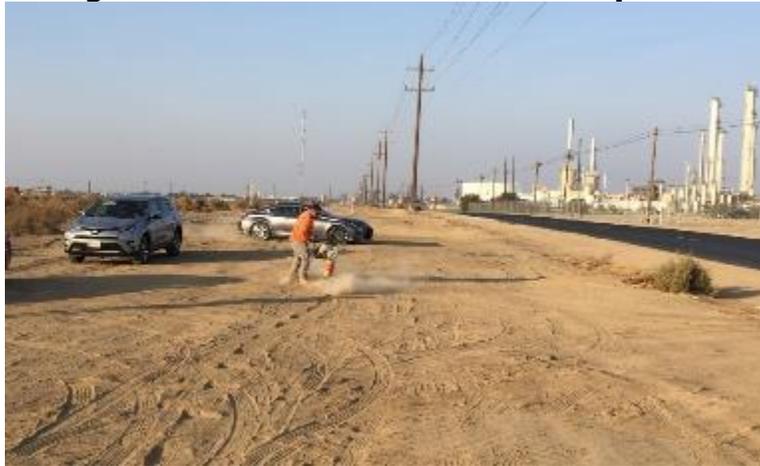
Figure 66: Vibration Test with Compactor

the compactor was moved to a location 75' from the sensors (Figure 66). The compactor was operated for two minutes continuously in both locations.

The raw data was recorded by the Acellent vibration monitor and a processed version of the data was passed to the Campbell datalogger (CR800) for storage and forwarding. The radio system was not active the day of the vibration test and so storage in the web-hosted system was not available.

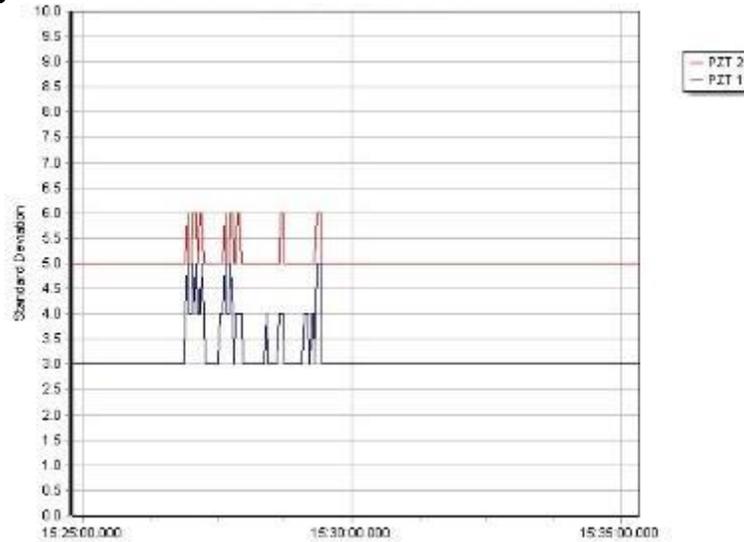
Figure 71: Standard Deviation for PZT Sensors Only

When looking at only the response of the piezoelectric sensors, there is indication that they were able to detect the nearer of the two vibration tests (Figure 71). When looking specifically at the far test, with the compactor 75' from the sensors, the geophone still shows a small response to the excitation (Figure 72). The two piezoelectric sensors do not show any deviation from their baseline values whatsoever.

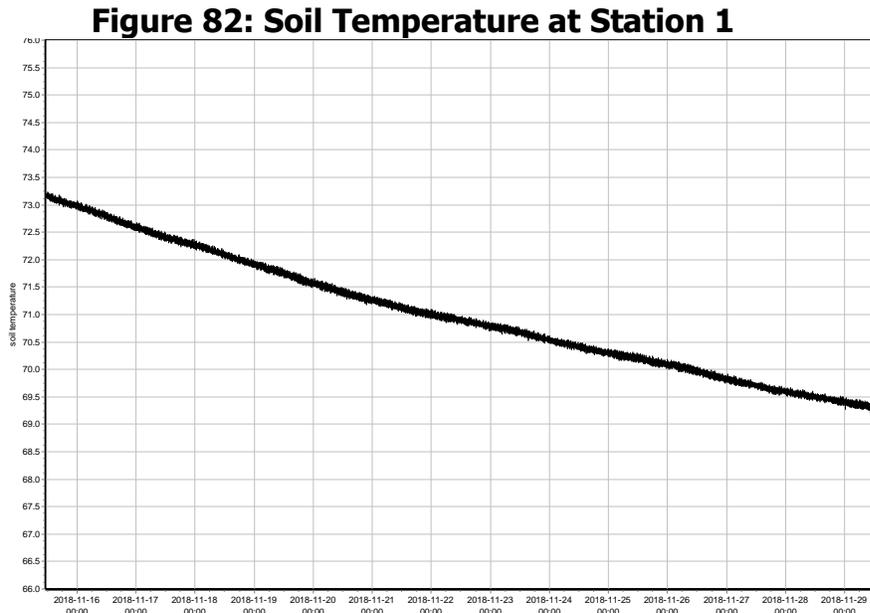
Figure 82 shows the seasonal decline in soil temperature at sensor Station 1. The data for Station 2 is nearly identical. In the case of Station 3 the trend is the same, but the values are roughly three degrees Fahrenheit higher for the same period. As noted in the previous section, the Station 3 excavation was open and exposed to direct sun for two months longer than the other two.
