FINAL PROJECT REPORT

Carbon Dioxide-Based Cleaning of Military Textiles

December 2021 | CEC-500-2021-056

TERSUS Solutions
5941 Mario Drive
Denver, CO 80219
(303) 907-9465
www.tersussolutions.com

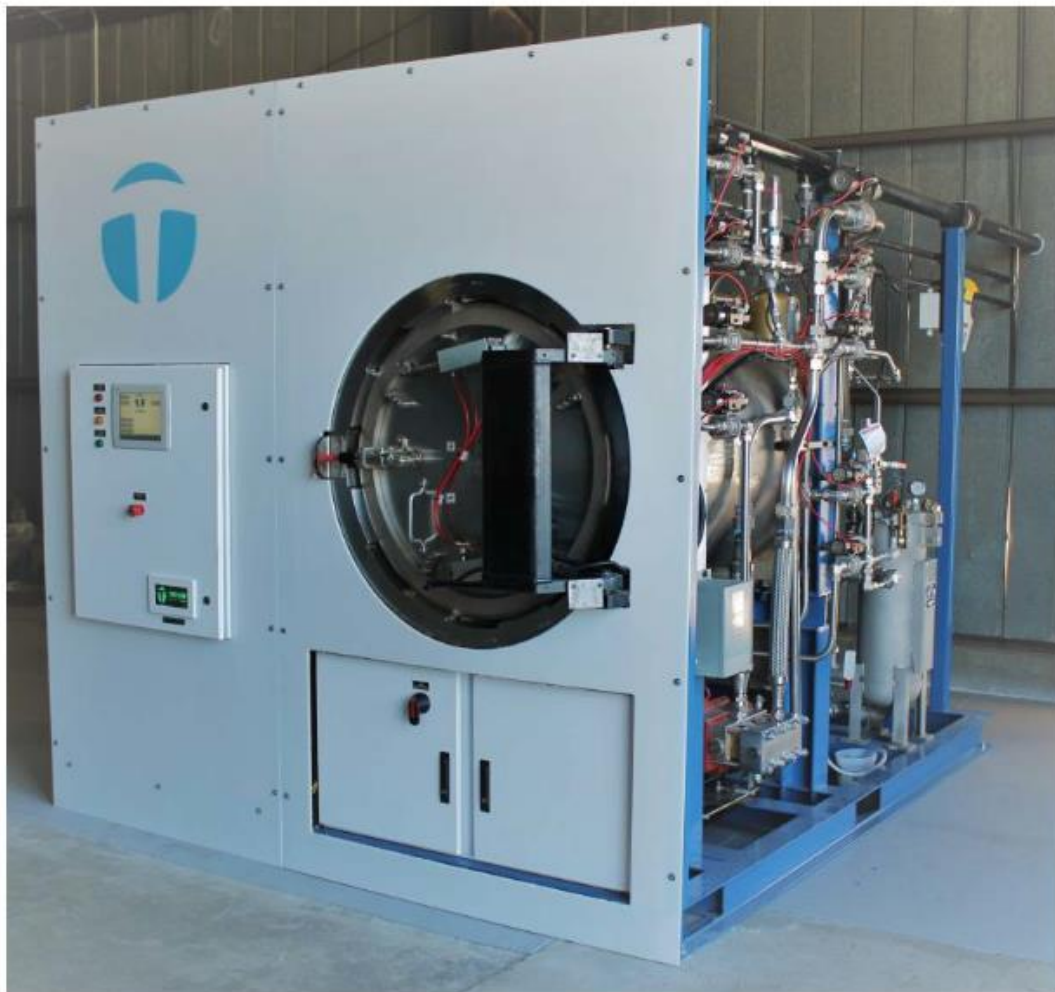
Figure 2: TERSUS AA-75

The cleaning cycle of gaseous CO₂ is introduced into the cleaning chamber and pressurized into liquid form (about 700 psi and 60 °F). Garments go through a cleaning cycle, after which the chamber is de-pressurized, thereby returning the CO₂ to a gaseous form and leaving the garments dry and cool to the touch. Unlike conventional water-based cleaning, no heat is required to dry clothes which results in longer lasting fabrics and significantly faster cycle times. All the CO₂ is circulated through a filter to remove particulates, distilled (to remove impurities like body oils and other extraneous items) and returned to be reused. The only waste stream is the oils and additives that are extracted via distillation, which, depending on application, can be recycled for other uses, such as in bio-diesel blends.

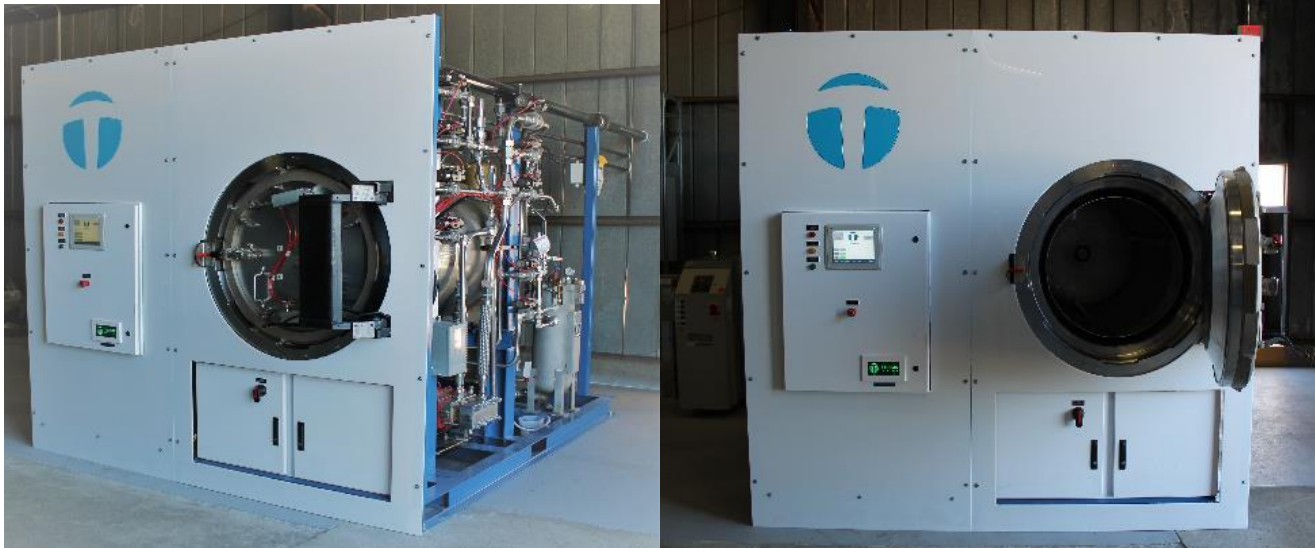
Figure 11: TERSUS AA-75 Installation Complete

Installation Complete

The last piece completed was installing a gate and fence that closed in the space and isolated the machine from the rest of the warehouse. The space had to be isolated to prevent TERSUS employees from entering the Navy warehouse space. A large gate was installed after reviewing the process flow of how garments would travel from the adjacent building and into the TERSUS space. The gate was large enough to allow large laundry carts to pass through and was locked using a specified Navy lock. The installation and commissioning of the machine satisfied the Phase 1 and Phase 2 requirements by the CATEx agreement (Figure 11) (Appendix A).

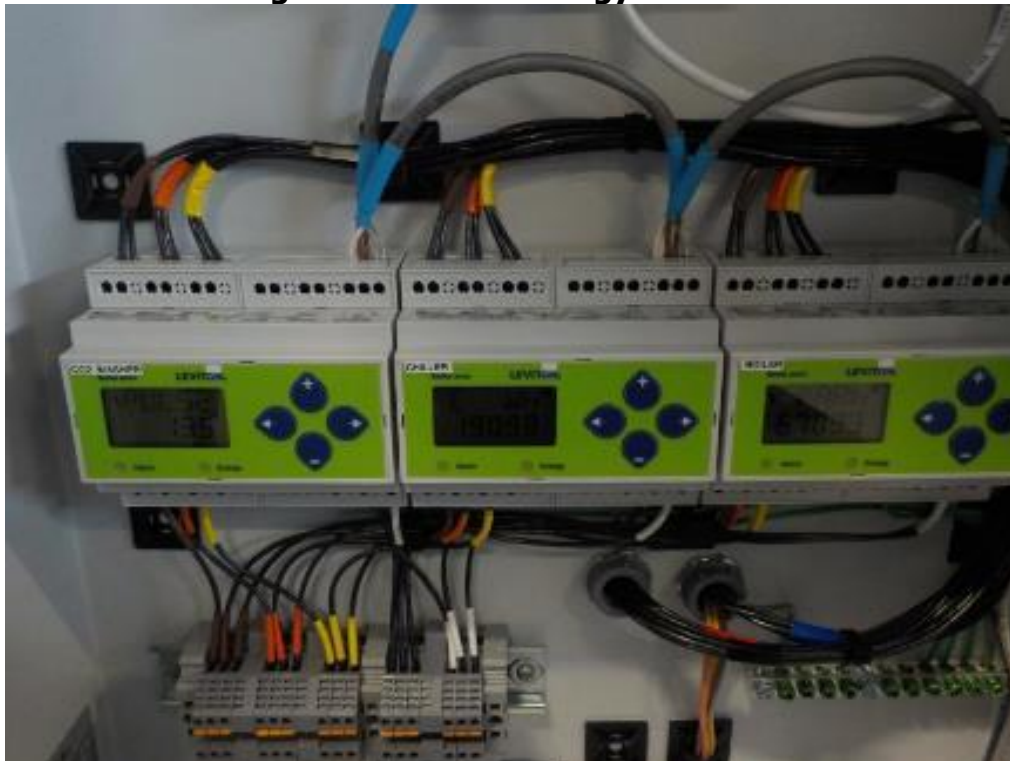
Figure 14: Phase Energy Monitors

The energy data collection was split into three different components: The machine itself (energy drawing items are the pump motor, basket motor and controls), the chiller (circulation pump and main refrigeration circuit) and oil heater (circulation pump and heating elements). The data loggers accounted for the voltage, three phase amp use, and power factors when calculating the total kilowatt per hour use. Figures 14 and 15 show the energy monitoring setup that was used during the demonstration.

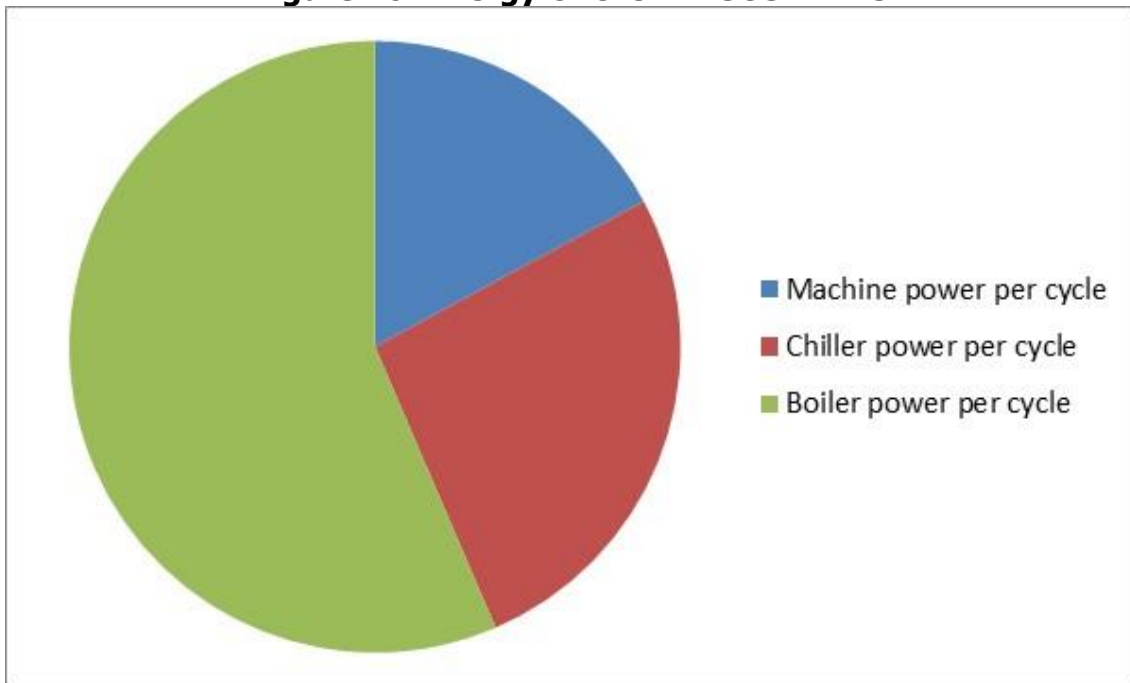
Figure 16: Energy Of the TERSUS AA-75

This gives a total energy usage average for the entire system of 39.8 kWh per cycle for 75 pounds (lbs) of textiles. Figure 16 shows a breakdown of the power used per piece of equipment.

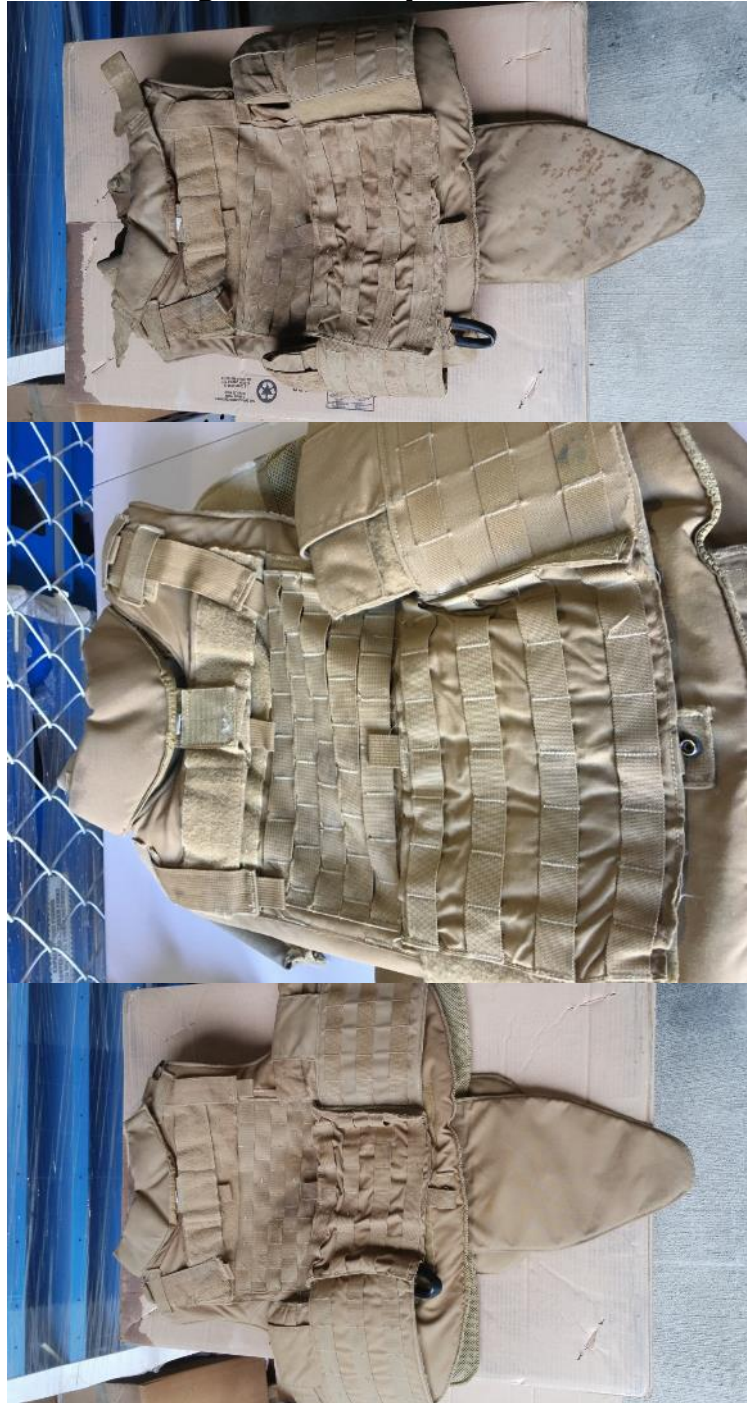
Figure 20: Dirty MTV Vest

With these advantages, the TERSUS liquid carbon dioxide system becomes the best way to clean MTV vests, particularly the collars. After extended use, the yokes become dirty, oily and unpleasantly odorous. This results in many complaints. With the low viscosity and surface tension of liquid carbon dioxide, the TERSUS system can remove the body oils from the vests, especially the yokes, without the need to add detergents or heat. Detergents have the potential to degrade the Kevlar if not completely washed out. Using heat to remove water, as in traditional laundry processes, can degrade the Kevlar. If not properly dried, mold and mildew can form within the Kevlar. Furthermore, when tumbling the collars in the dryer, the

Figures 20 and 21 show an MTV vest before and after being cleaned with the TERSUS liquid carbon dioxide process.

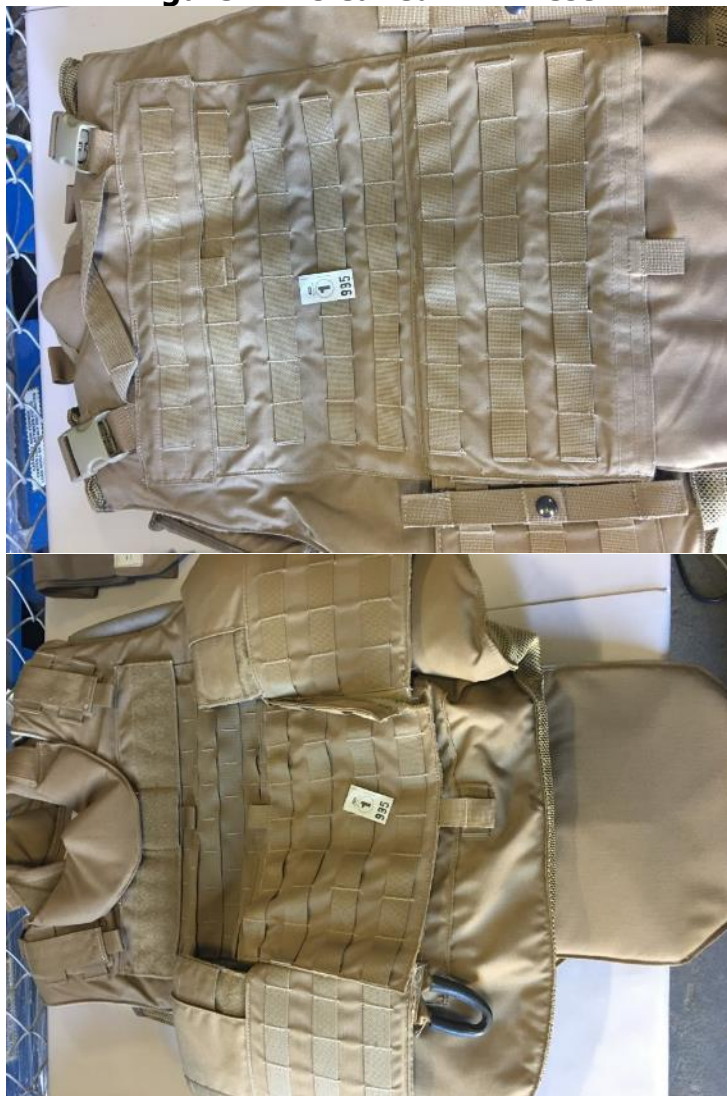
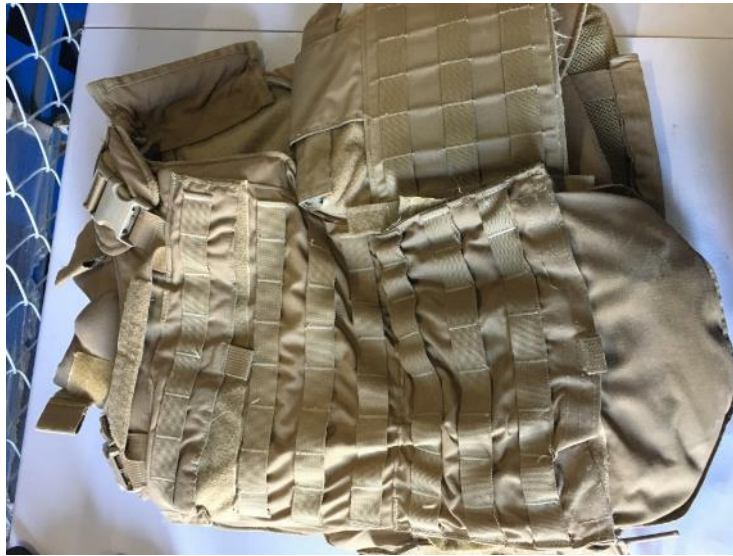
Figure 22: Cleaned MTV Vest

The results after processing in the TERSUS AA-75 (Figures 22 and 23).

The body oils contaminating the yoke area were removed. TERSUS was informed that after the demonstration period, when the yokes were able to be cleaned, the number of complaints dropped significantly. This was stated by the warehouse manager and insurance manager of the garments. Cleaning the MTV vests with TERSUS greatly improves the comfort of the garments, by the removal odors and body oils that can cause associated rashes and itchiness. Not only does the TERSUS process clean the MTV vests very well but the process maintains the ballistic properties of the Kevlar.
