Phase I
Environmental Site Assessment

Orange Grove Project Site

San Diego County, California

June 6, 2008

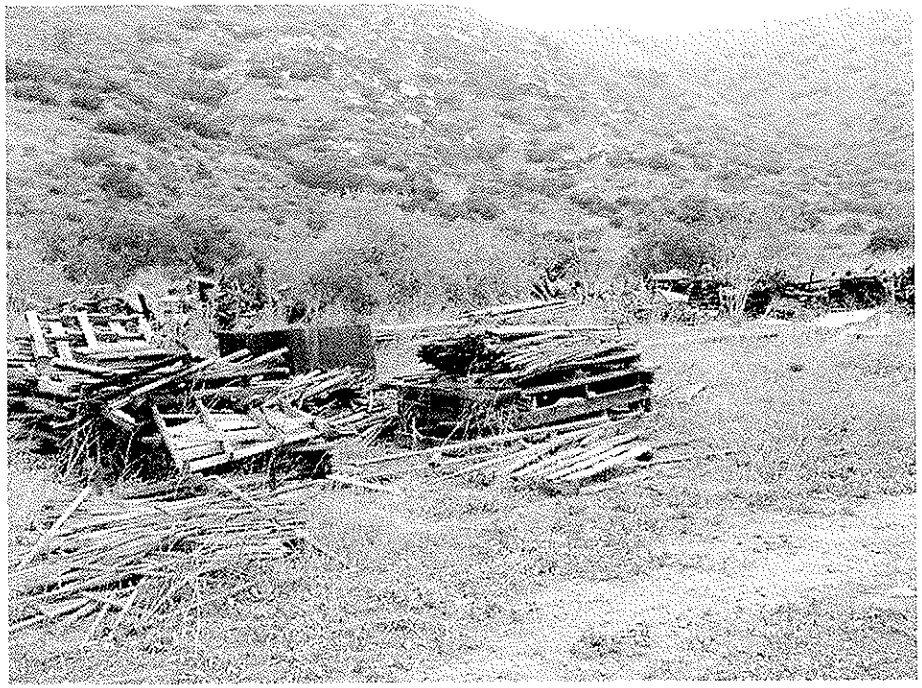
Refuse piles were observed on the west end of the Subject Property, located between Pala Del Norte Road and the citrus orchard. These refuse piles are comprised of mainly wood, but include other items such as car tires and paper wastes. There were also three sets of bee hives next to the waste piles. Two plastic 5-gallon buckets on a pallet were found approximately 50 feet east of the refuse piles. One was used for holding a tar type material which has dried and the other held an unknown substance.

Photo Description:
Beginning of refuse piles located on the west end of the Subject Property.

Photo Description:
Northern end of the refuse piles located on the west end of the Subject Property.

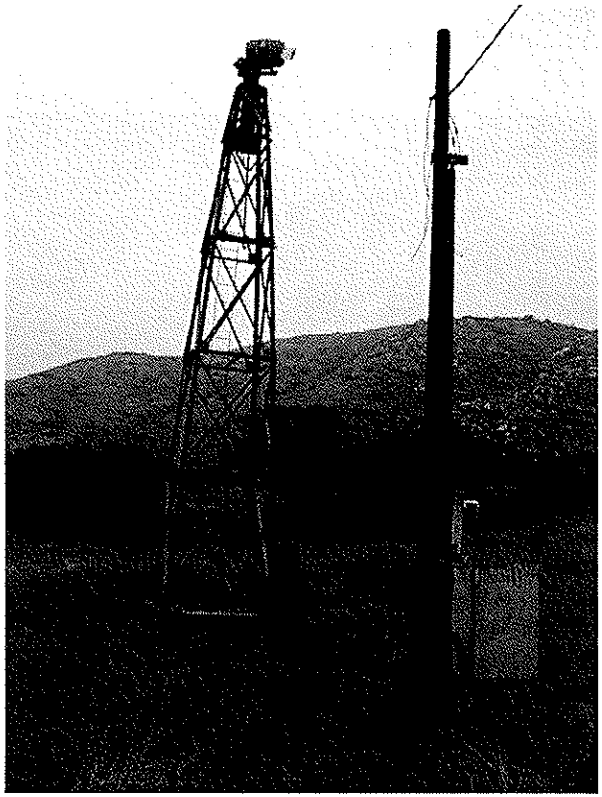
Photo Description:
Turbine and electrical transmission pole located on the eastern portion of the Subject Property.

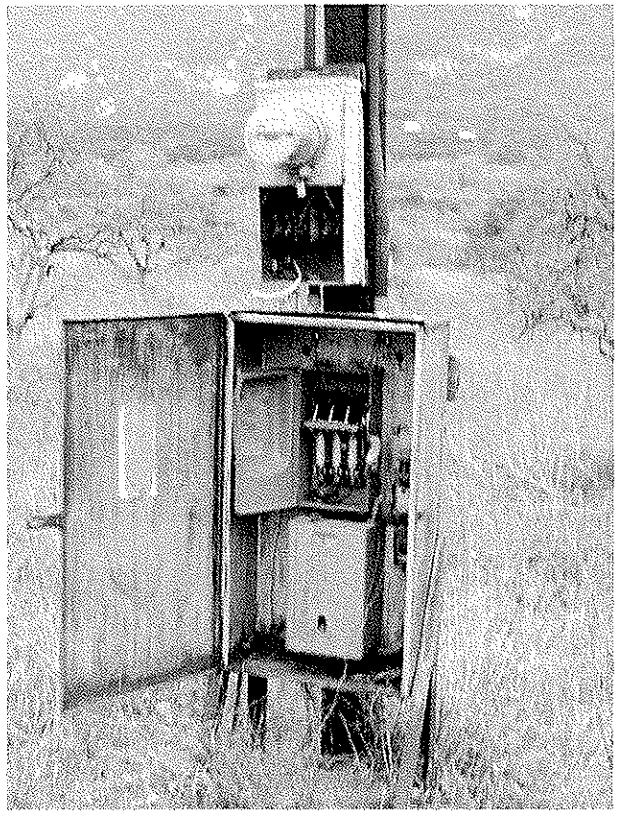
Photo Description:
View of the control box/electrical meter on the electrical transmission pole located on the eastern portion of the Subject Property.

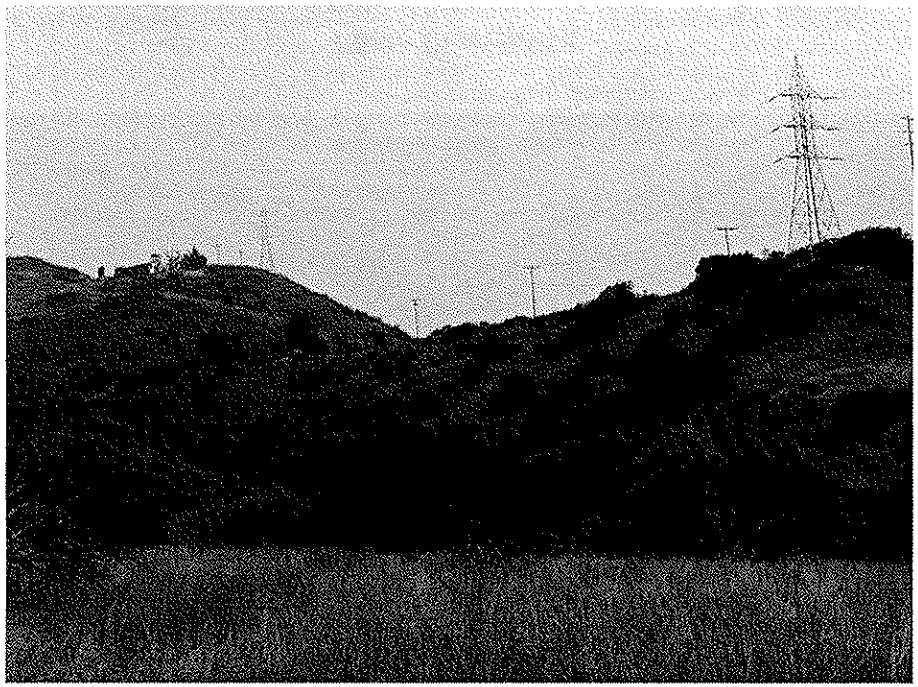
Photo Description:
View northeast of undeveloped hillside on the Subject Property and on adjacent lands including SDG&E transmission line easements and private residences.

Photo Description:
View east of distressed citrus trees in the foreground and undeveloped hillside terrain in the background.

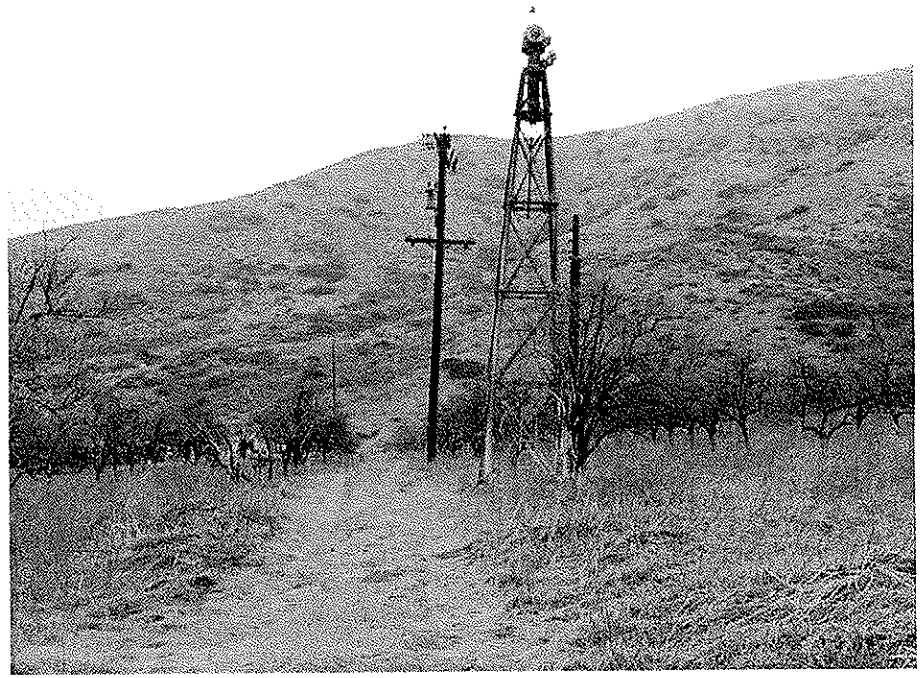
Photo Description:
View west of two electrical transmission poles and the western turbine.

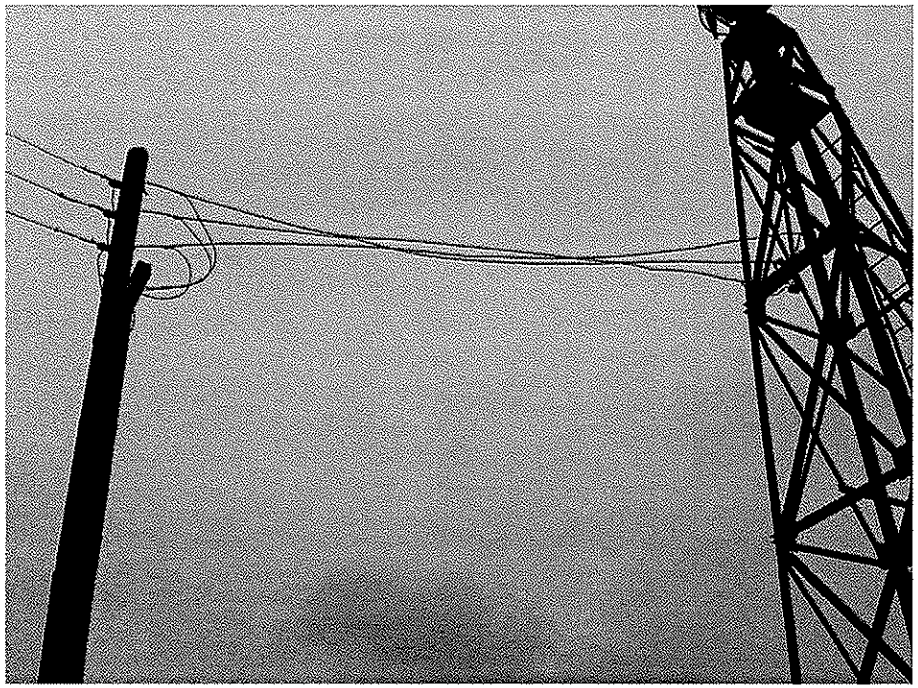
Photo Description:
Existing connection between the western turbine and the adjacent electrical transmission pole.

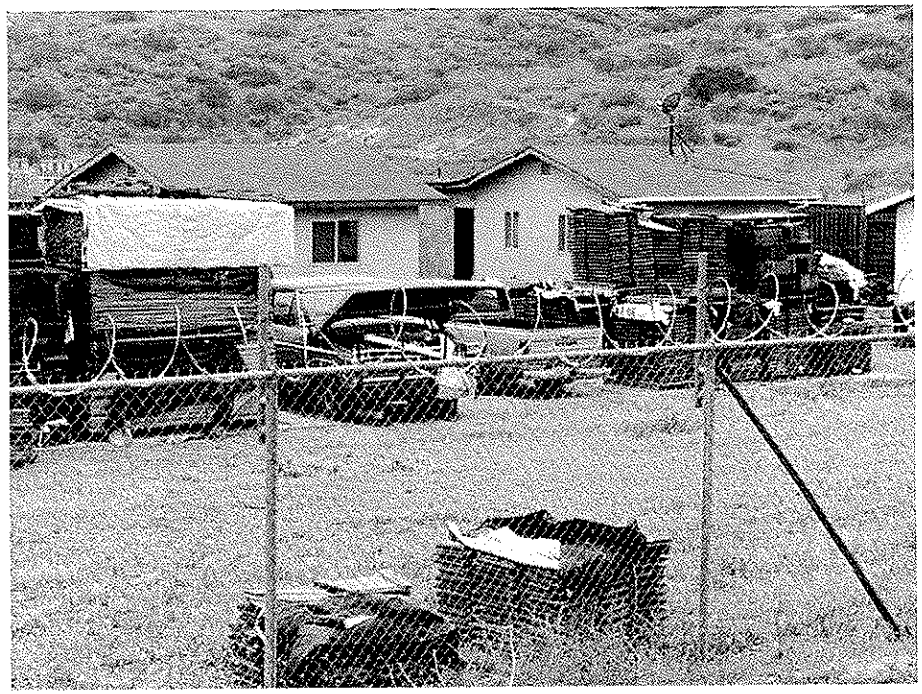
Photo Description:
Middle section of the storage facility, looking southwest.

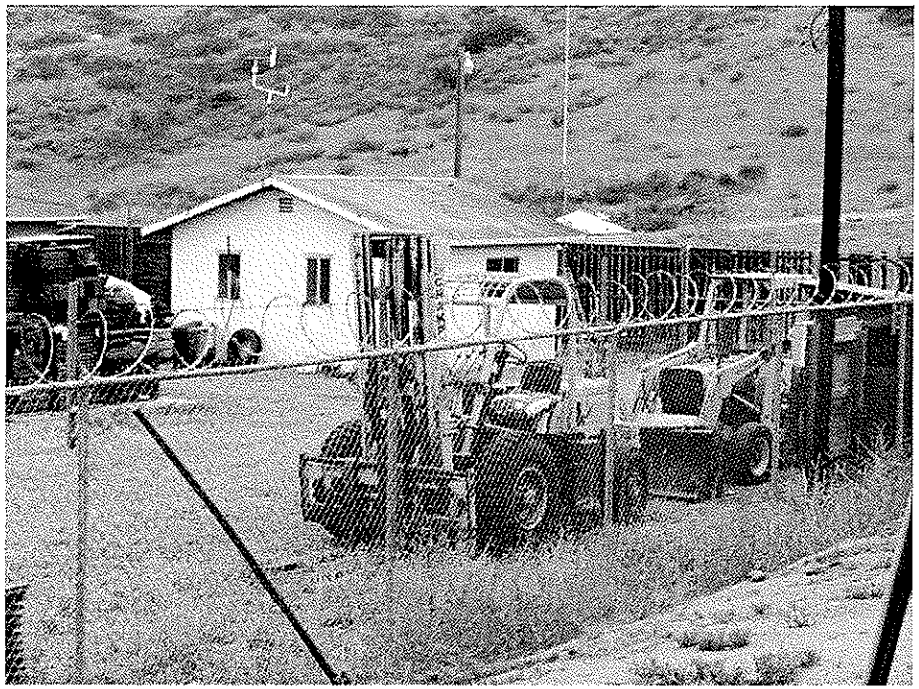
At least six rusting 55-gallon drums were noted in the storage facility area. The drums appeared to be on pallets but no labels were visible. No evidence of leaking was observed around the drums.

Photo Description:
West end of the storage facility, looking southwest.

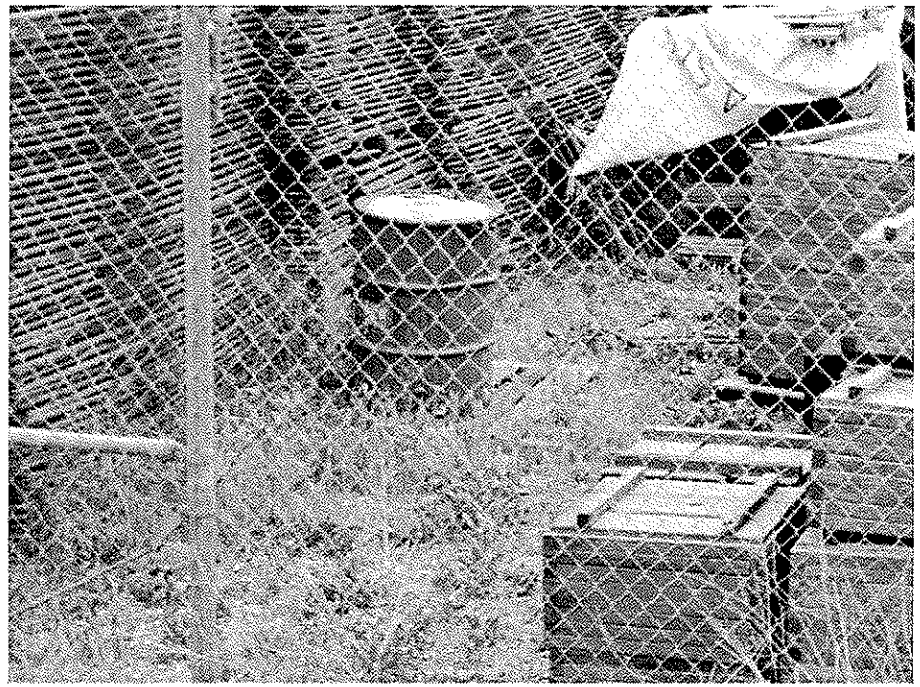
No drums were observed on the Subject Property. At least three 55-gallon drums were noted in the storage facility area. Two of the drums were set on gravel and the other was situated on a pallet, no labels were visible. One drum was outfitted with a hand pump with no indication of the contents. No evidence of leaking was observed around the drums.

Photo Description:
Storage drum located at the east end of the storage facility.

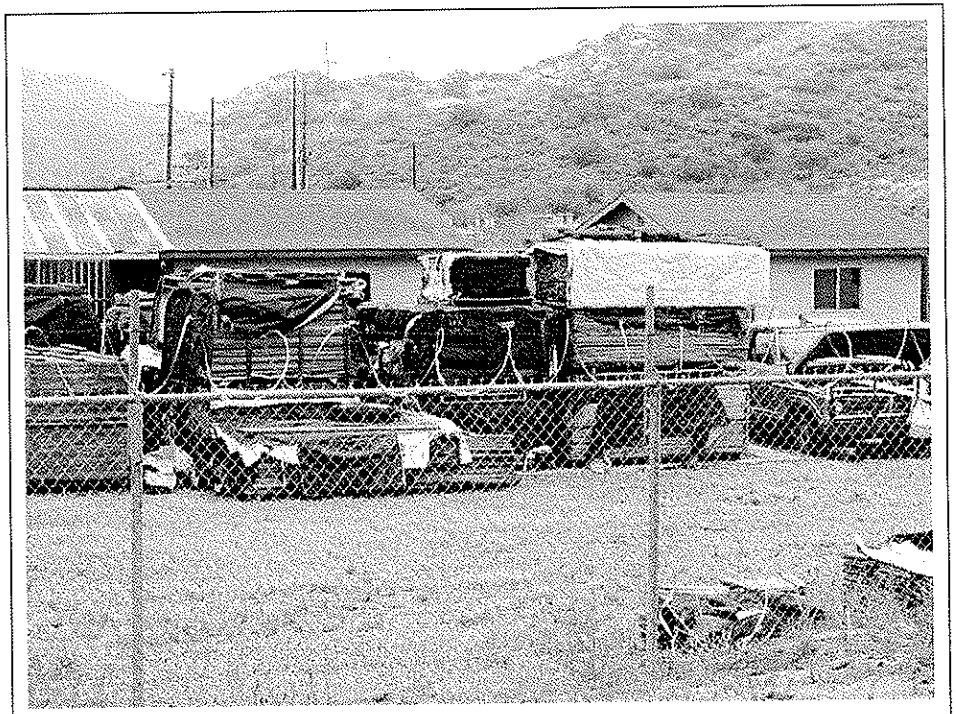
Photo Description:
Storage drums located on the west end of the storage facility.

Photo Description:
Materials stockpile located in the middle section of the storage facility.

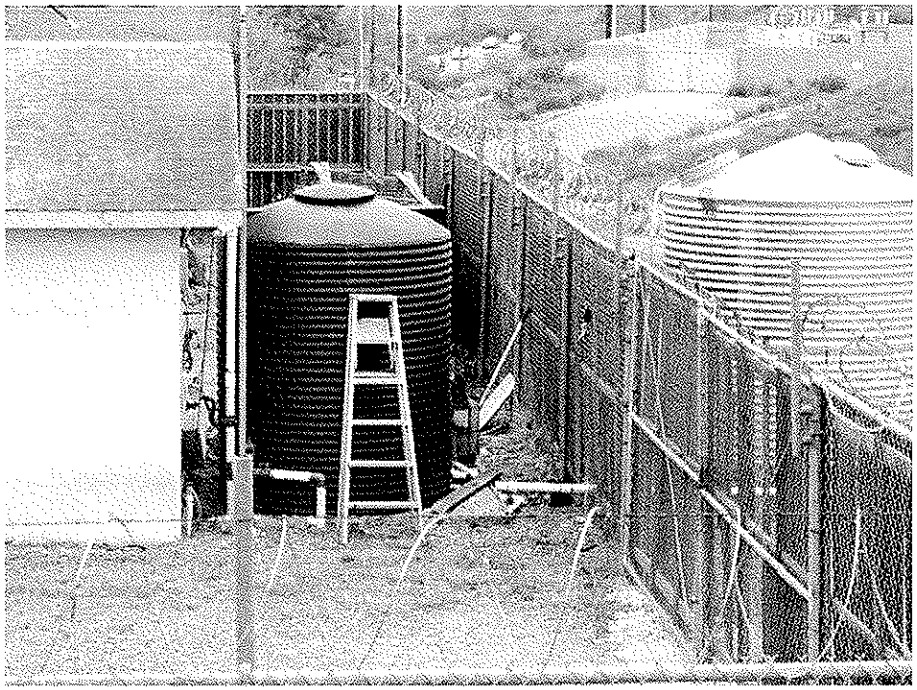
Two ASTs were observed on the west end of the offsite storage facility and appear to be utilized for storing water (based on tank construction material, and plastic water piping connected to both tanks). Mr. Sykes reported that only water tanks have been present at the SDG&E property to the best of his knowledge (Sykes, 2008). No other ASTs were observed on the SDG&E property and no evidence of underground storage tanks (USTs) was observed.

Photo Description:
Above ground storage tank (AST) located on the west end of the storage facility.

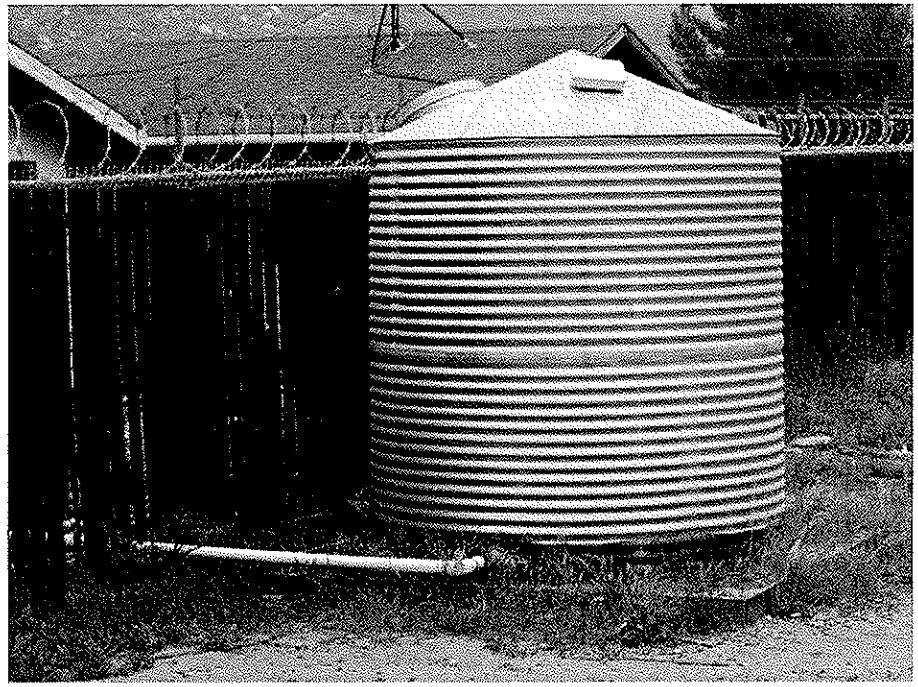
Photo Description:
AST located on the immediately outside of the west end of the storage facility.

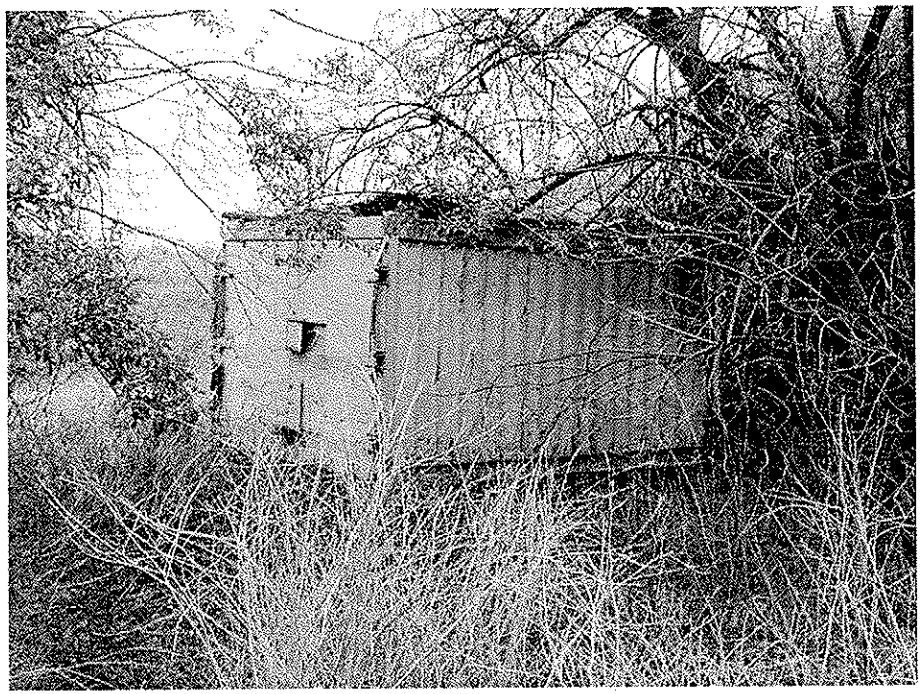
Located approximately 100 feet south of the western end of the storage facility were three small storage structures. The first storage structure was a metal storage container, a milvan, which was unlocked and open with nothing inside. The other two were wooden storage sheds, one of which was locked. The unlocked wooden storage shed was empty. The remnants of two vehicles were observed located approximately 100 feet south of the western end of the storage facility, adjacent to the three small storage structures. Various refuse items were scattered around the storage structures.

Photo Description:
Metal storage container located approximately 75 feet south of the storage facility.

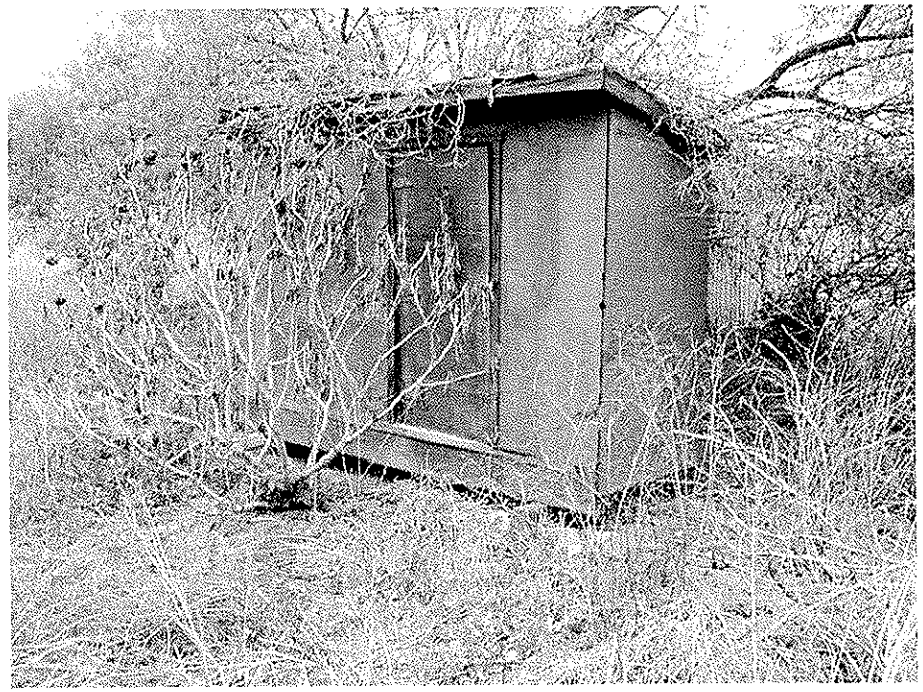
Located approximately 75 feet south of the western end of the storage facility were three small storage structures. The first storage structure was a metal storage container that was locked. The other two were wooden storage sheds, one of which was locked. The unlocked wooden storage shed was empty. The remnants of two vehicles were observed located approximately 75 feet south of the western end of the storage facility, adjacent to the three small storage structures. Various refuse items, including a paint can and wood planks, were scattered around the storage structures.

Photo Description:
Wooden storage shed located approximately 80 feet south of the storage facility.

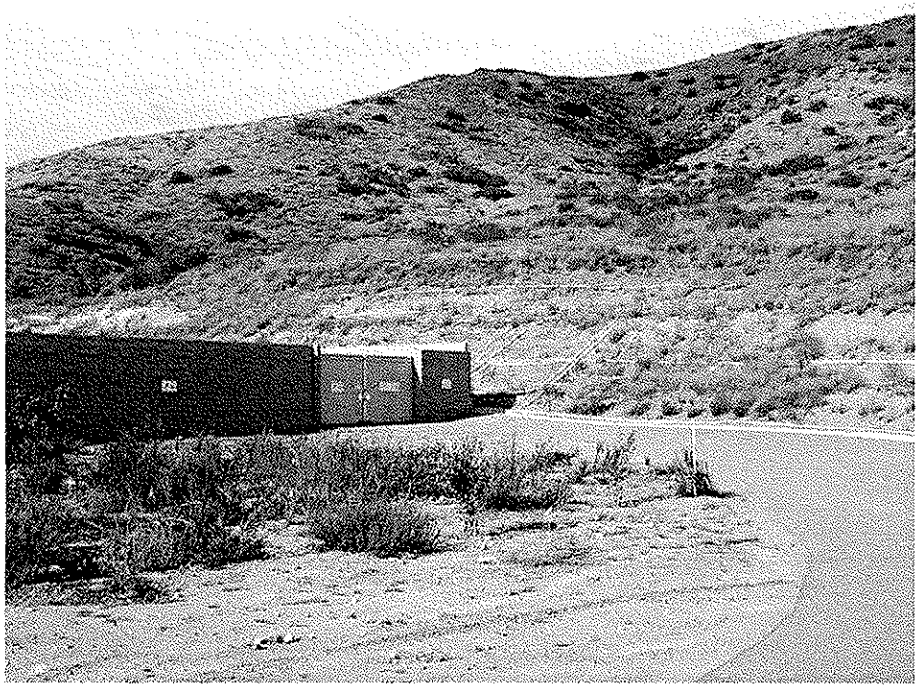
Photo Description:
Front of the SDG&E Pala Substation, looking northwest.

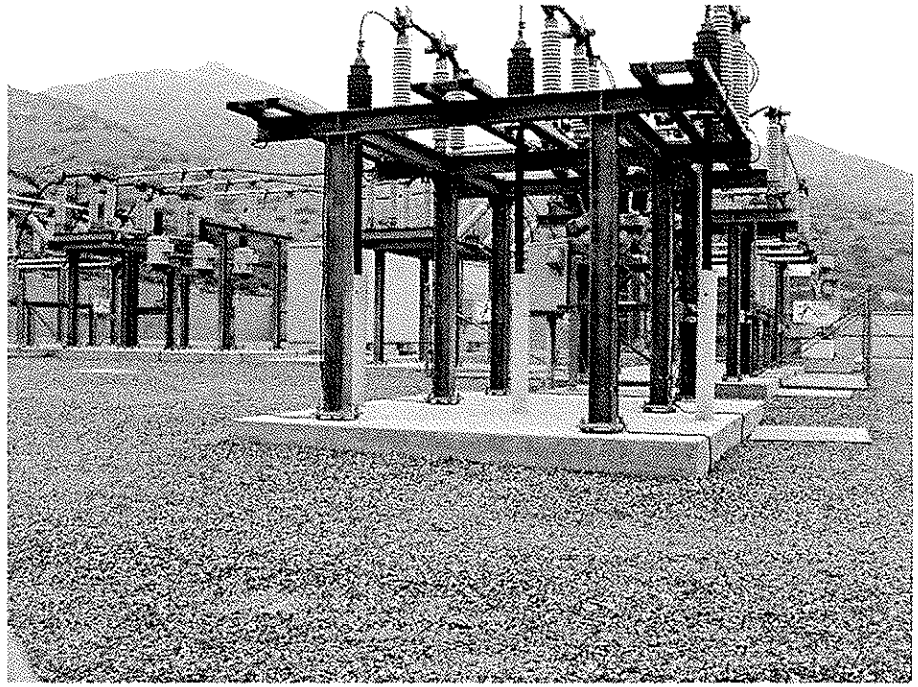
Photo Description:
View of inside of the Pala Substation from beyond the substation wall, looking east.

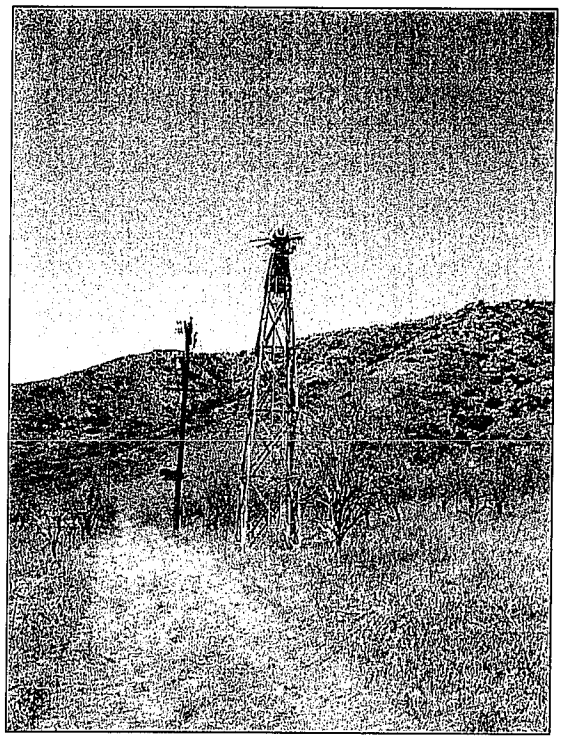
- The older pole-mounted electrical transformer in the central portion of the lemon grove may be contaminated with polychlorinated biphenyls (PCBs). No leaks or staining were observed in the vicinity of the transformer and as such no

Photograph 1. Electrical transformer in central portion of the lemon grove.

immediate action is recommended. However, should this transformer be removed from the site, it should be tested for the presence of PCBs.

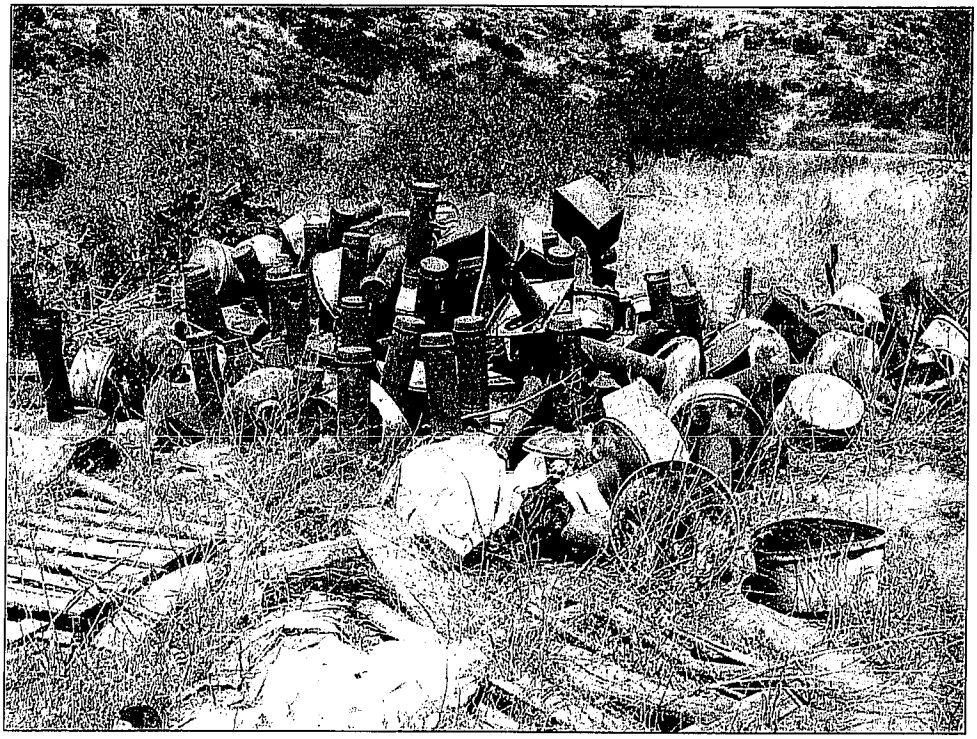
Photograph 3. Storage of metal piping to the west of the lemon grove.

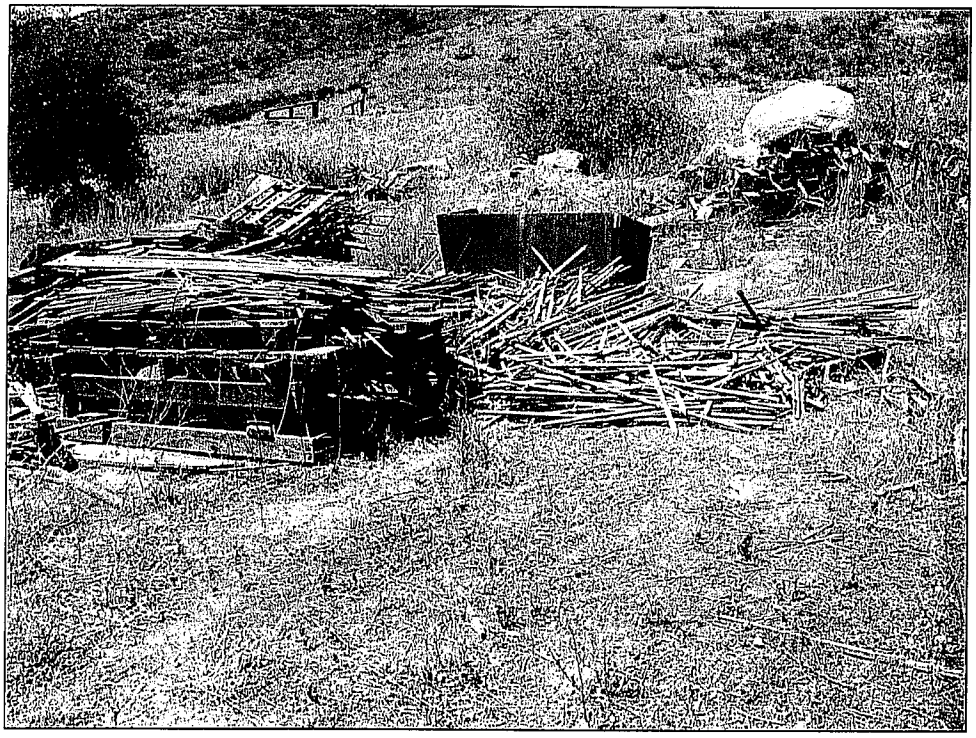
Photograph 4. Storage of wood to the west of the lemon grove.

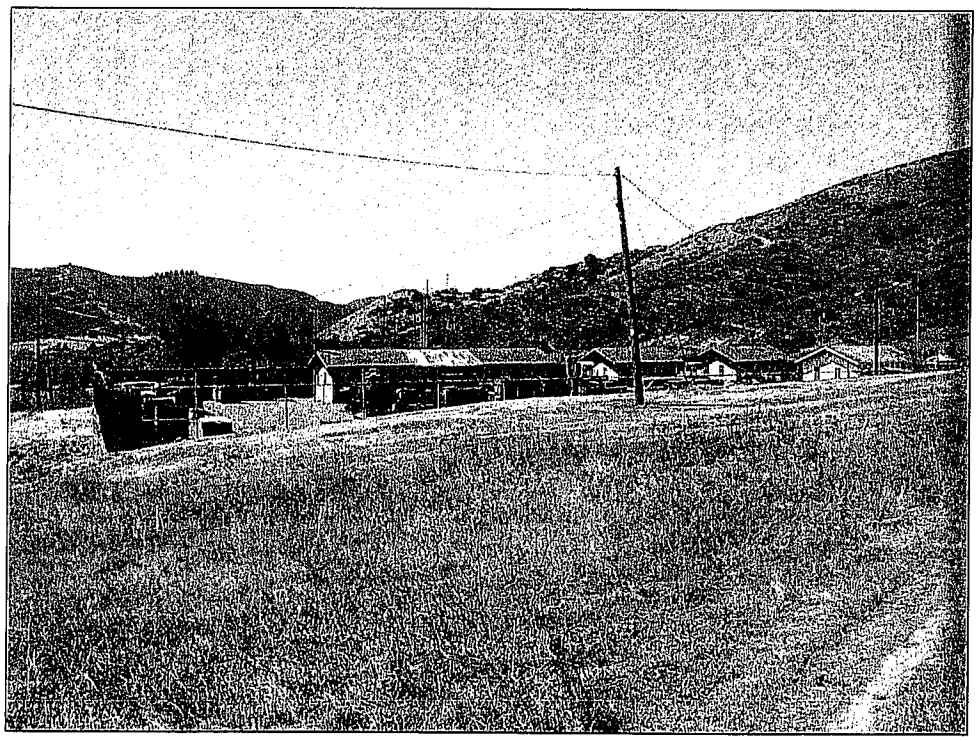
Photograph 8. View of the enclosed compound to the south west.

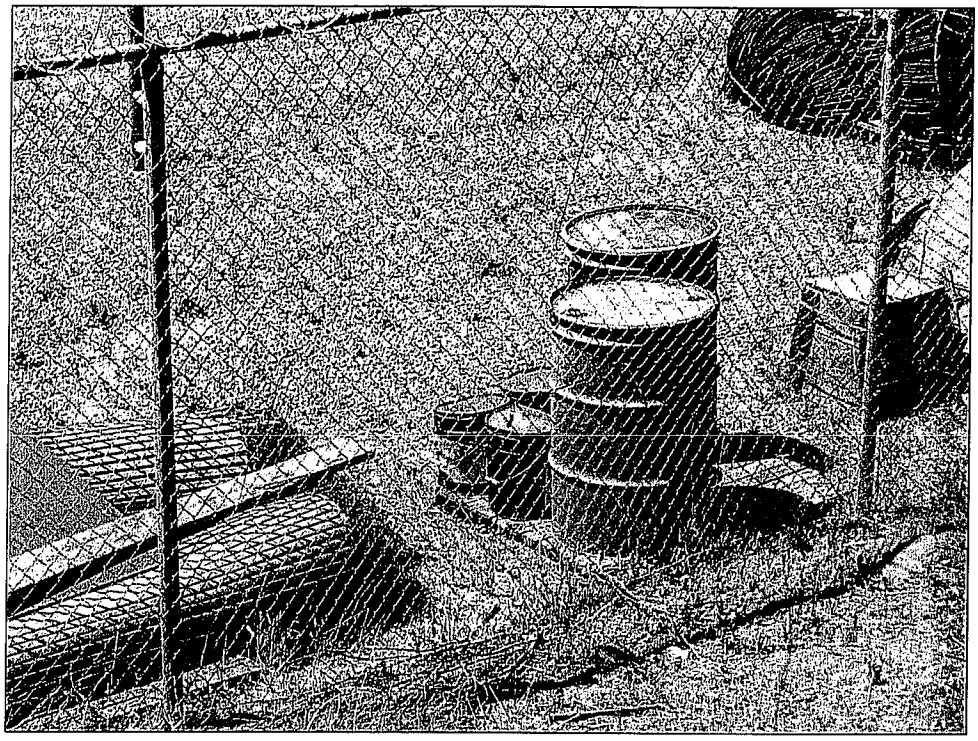
Photograph 9. View of metal drums and containers in north western area of the enclosed compound.

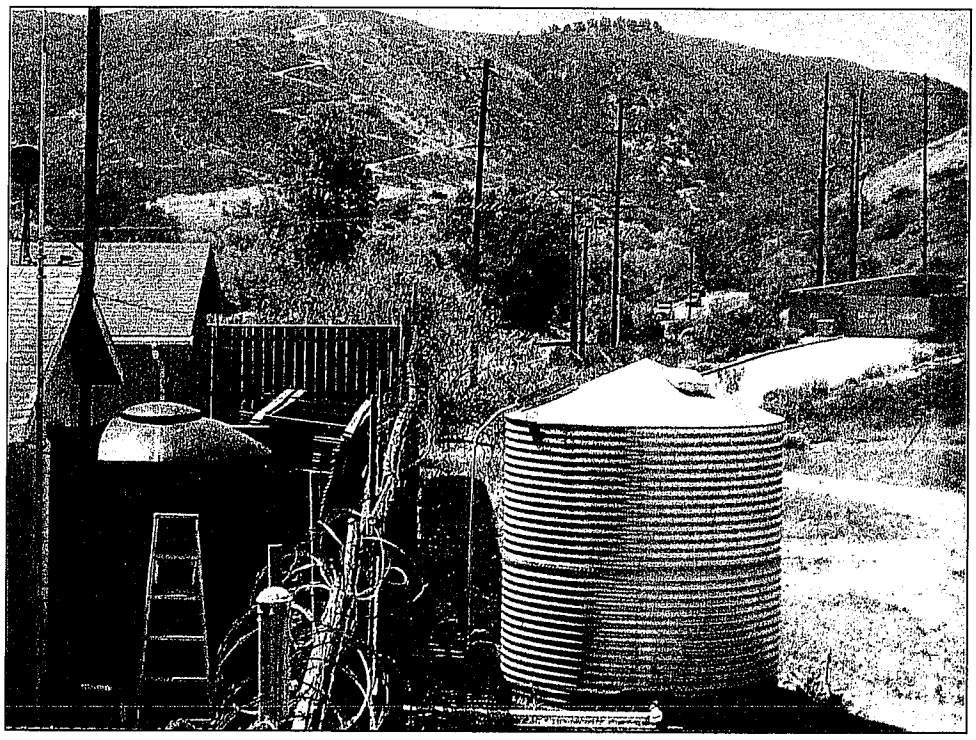
Photograph 10. View of water tank located west of the enclosed compound.

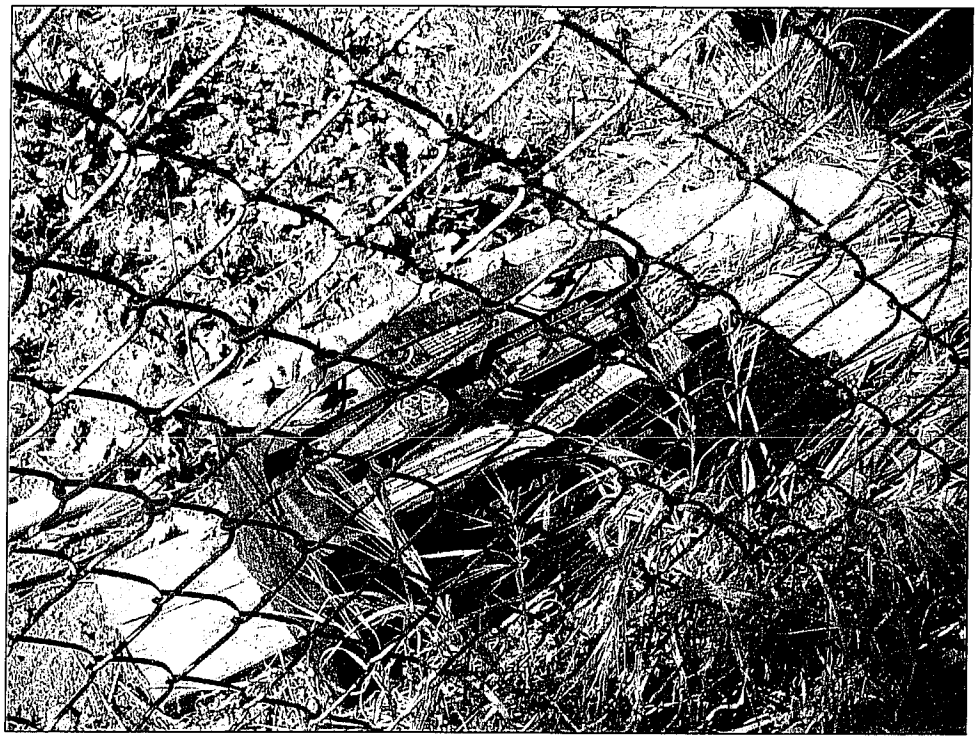
Photograph 11. View of vehicle battery in the northern portion of the enclosed compound.

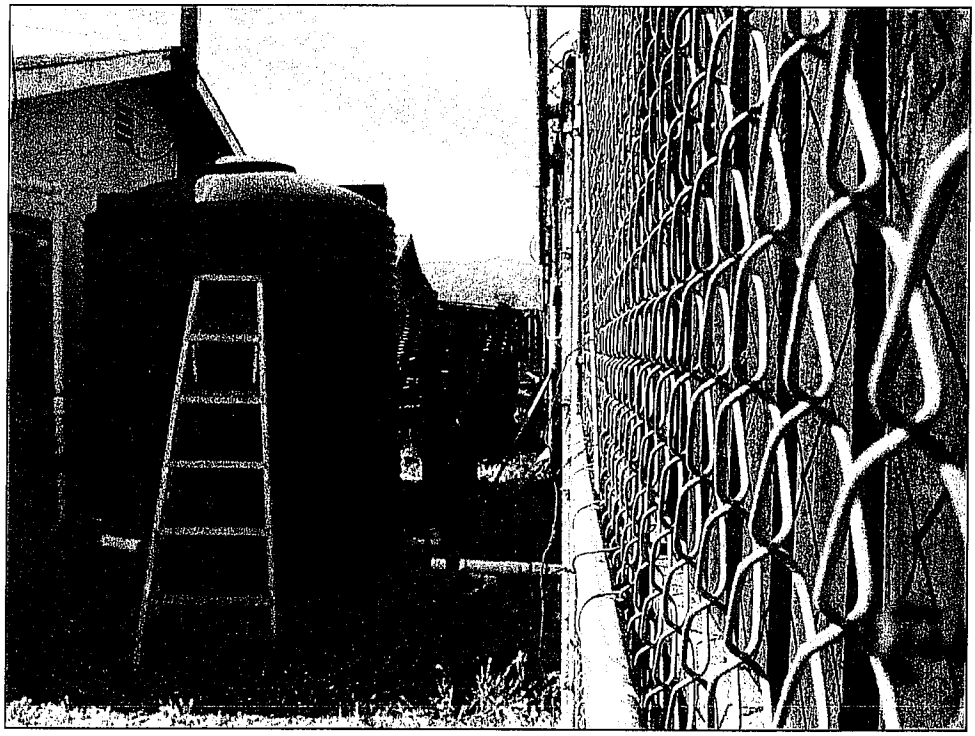
Photograph 12. View to the south of the water tank located within the enclosed compound.

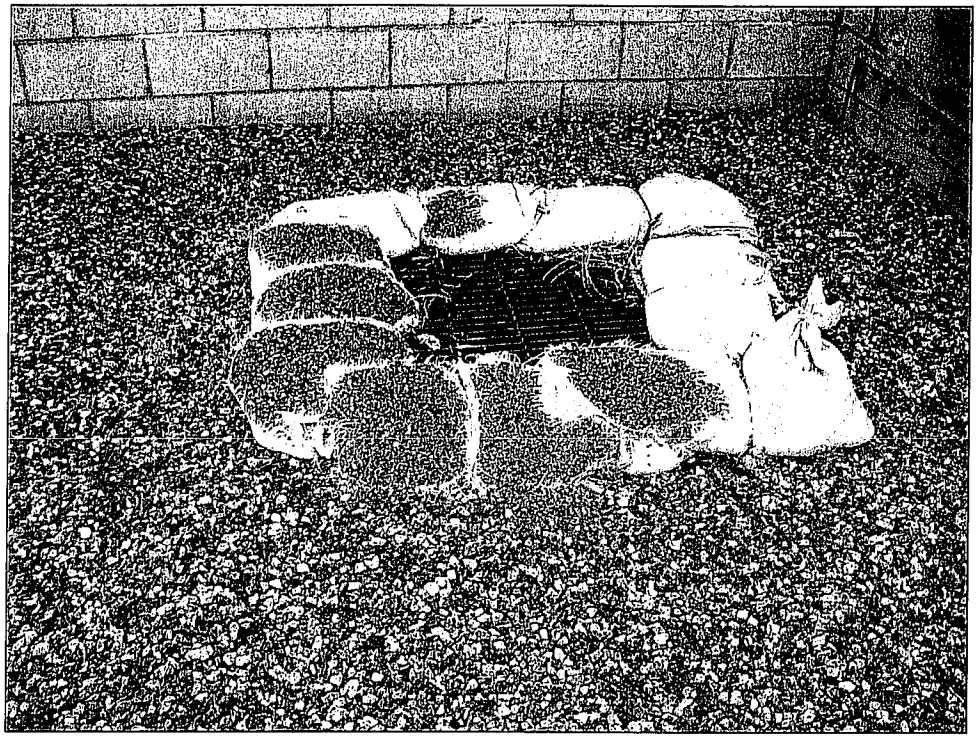
Photograph 13. View of the catch basin in south west portion of the substation.

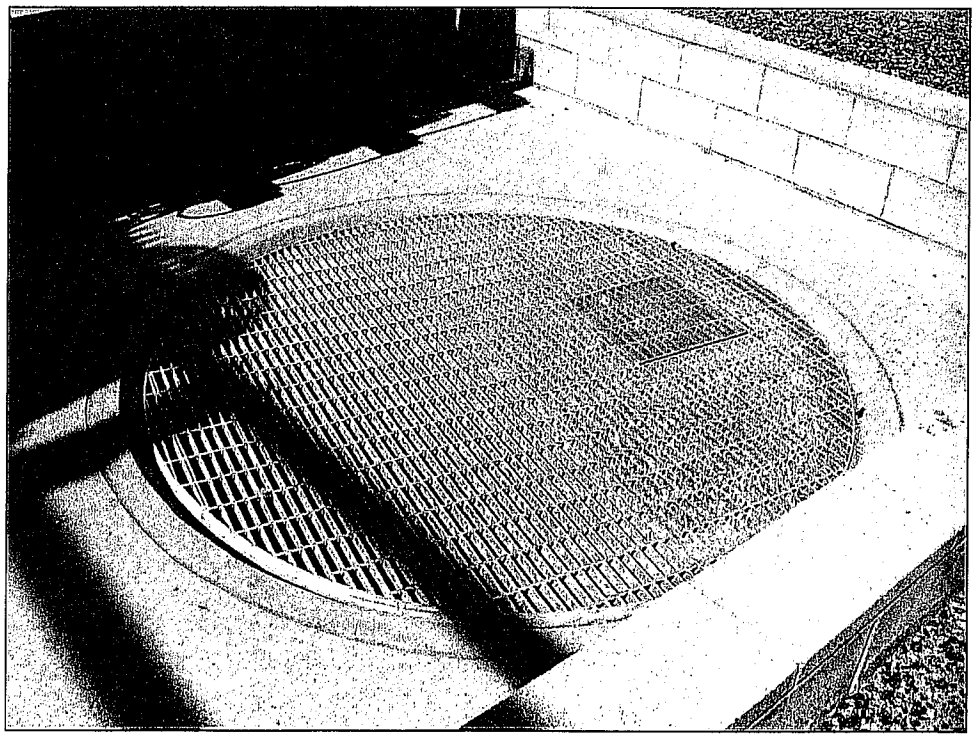
Photograph 14. View of sump within secondary containment surrounding the large oil transformer within the substation.

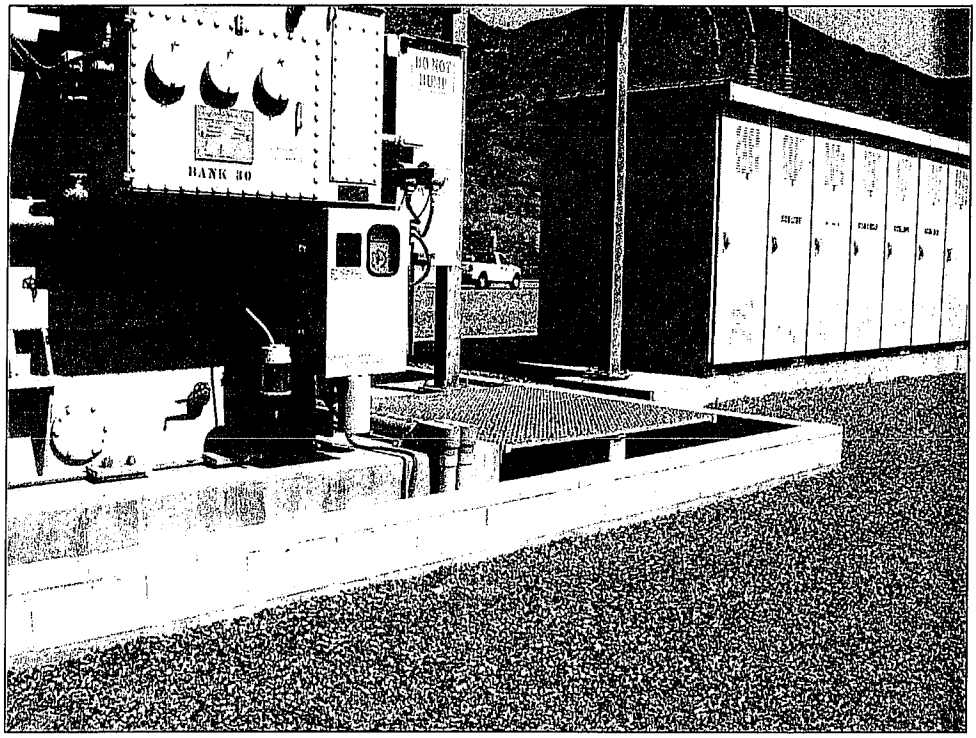
Photograph 15. View to the north of secondary containment surrounding the large oil transformer within the substation.

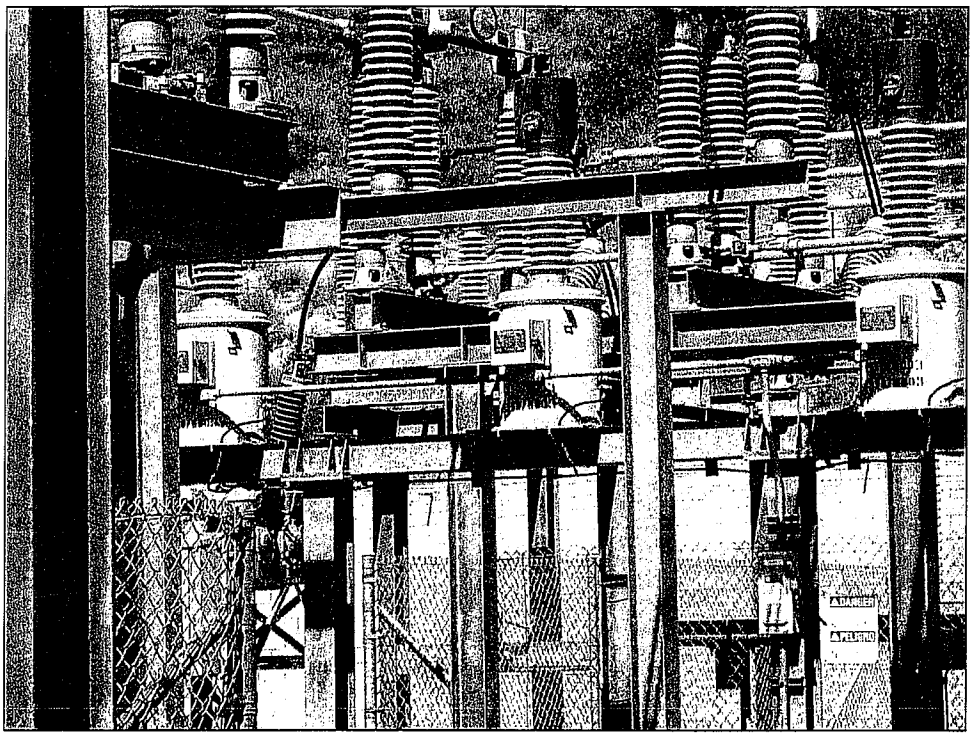
Photograph 16. View to the north west of the oil transformers within the substation.

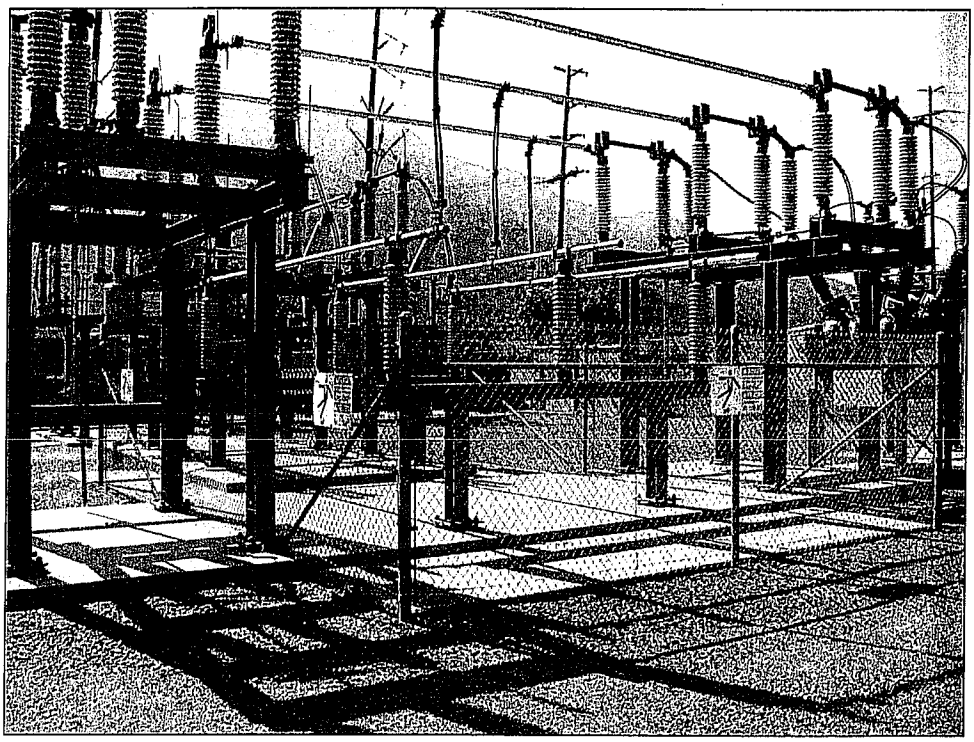
Photograph 17. View to the south west of the circuit breakers within the substation.

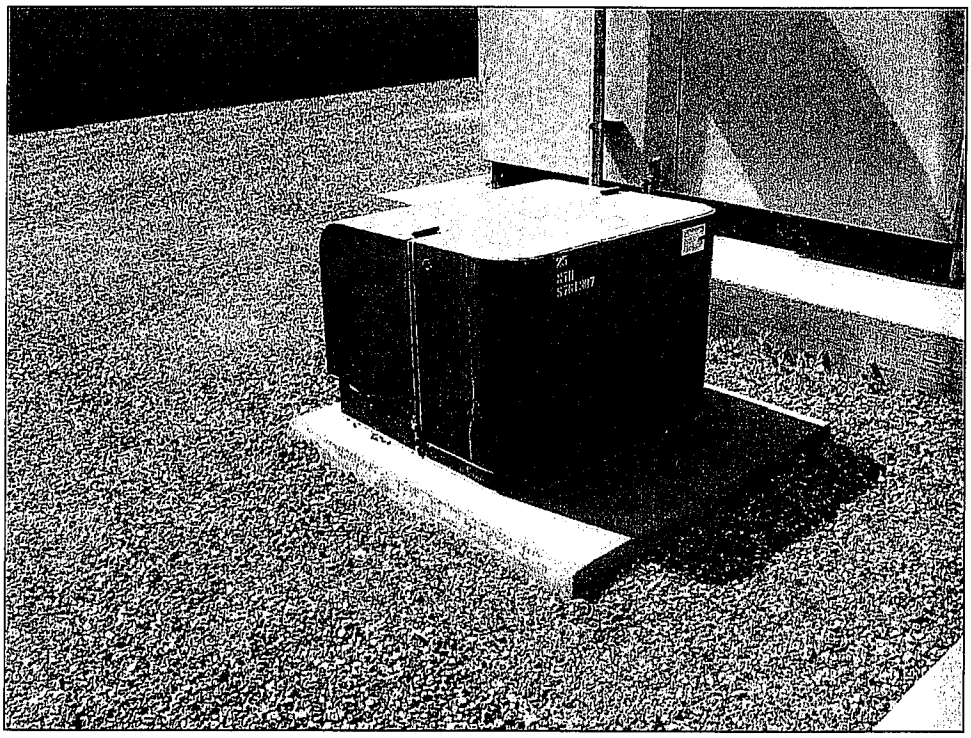
Photograph 18. View to the west of the small oil transformer within the substation.
