Report on the Step-Up Transformer Failure and Fire at Palomar Unit 1 - December 2010
August 10, 2011 Business Meeting Discussion Item

Geoff Lesh, P.E., Engineering Office
Siting, Transmission and Environmental Protection Division

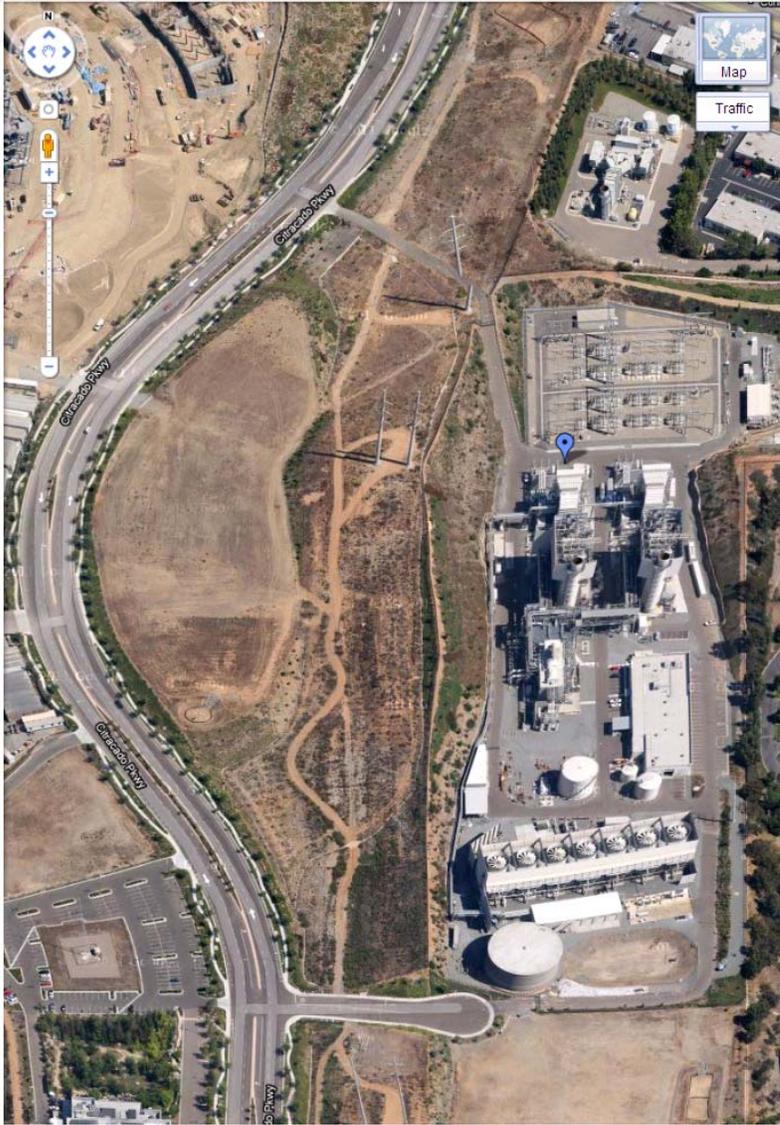
Appendix C. Aerial Photograph of Palomar Energy Center

Photograph of Palomar Energy Center with Citracado Parkway running north-south on west side. Marker indicates location of transformer that burned. An earthen berm lies between the power plant and Citracado Parkway.
