# WHY CERTAIN TELEPHONES NEED AN EXEMPTION UNTIL JULY 2008 FOR COMPLIANCE TO THE CEC RULES

Jim Haynes

Uniden America Corporation

# Recap of the CEA Presentation before the California Energy Commission (October 2005)

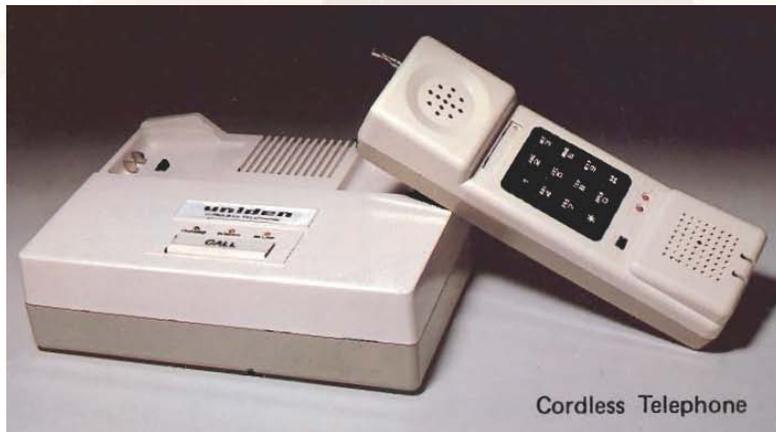
**Circa 1978 to 1980**

- Most Cordless Telephones connected directly to a standard electrical outlet

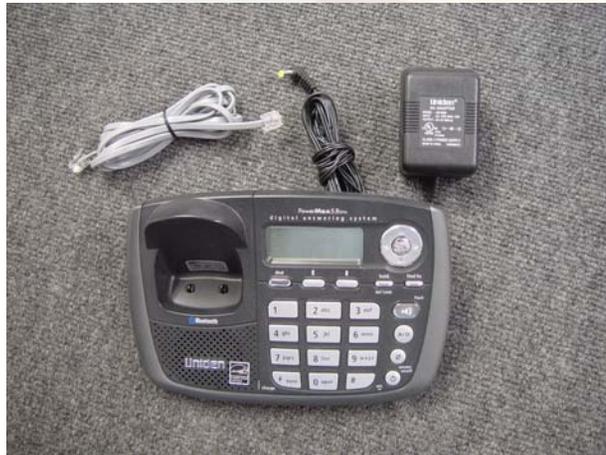
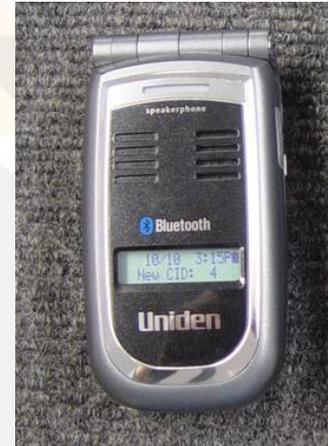
Uniden ELBT595

- Most all models today utilize an external power supply for providing electrical power to the base unit and for charging the handset batteries.
