DEMONSTRATION PROJECT REPORTS

TECHNICAL REPORT

February 2004
P500-04-009-A3

Demonstration Project Reports
Alternatives to Compressor Cooling
Contract No. 500-98-024

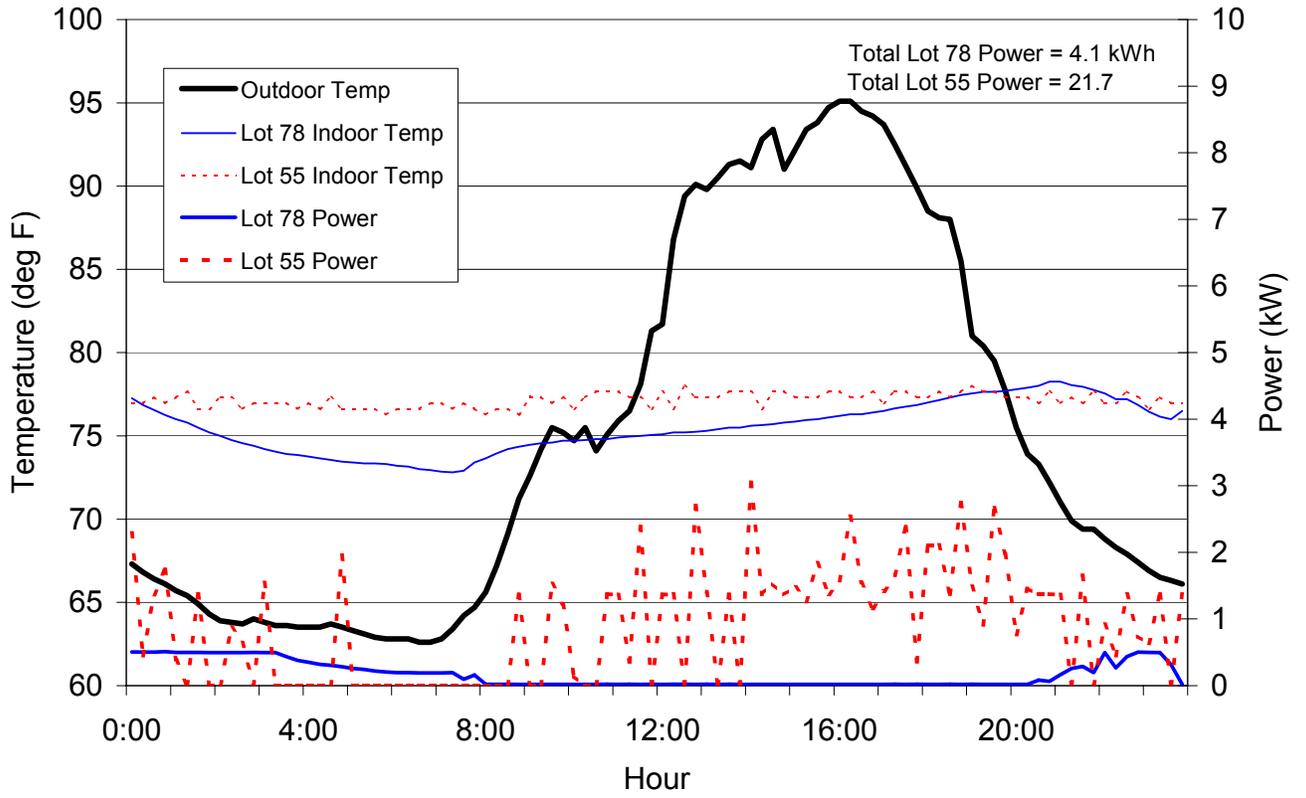
Side-by-side performance comparisons should not be taken too literally because of differences in occupant behavior. However, the differences shown in the figure below that compares the Lot 55 “control” house to the Lot 78 ACC demonstration house too great to explain by behavior. The figure below plots air conditioner power, indoor temperature, and outdoor temperature for the two houses for a typical summer day (7/25/03). The morning indoor temperature for the ACC house was about 4°F cooler, and the afternoon high was less than 1°F warmer than the Lot 55 control. At the same time the control house used 21.7 kWh of air conditioner energy to the ACC house's 4.1 kWh of fan energy (the air conditioner did not run). The frequent cycling of the air conditioner at the control house suggests the energy use was probably greater than estimated using the 1 kW per ton assumption.

Comparison of the Livermore ACC House (Lot 78) and the Control House (Lot 55)

A house built to the identical plan as the Livermore demonstration house and located on Lot 55 of the Los Olivos development was equipped with portable dataloggers to measure indoor temperature, attic temperature, fan status, and air conditioner status. The HVAC system included a single 5-ton 10 SEER air conditioner. Ducting was divided into two zones. Although air conditioner power was not measured, it can be approximated from the status data using a 1 kW per ton assumption.
