# CORONA TESTING OF DEVICES USED TO MITIGATE BIRD COLLISIONS

**PIER FINAL PROJECT REPORT**

September 2004  
500-04-086F

EDM International, Inc.  
Neil Hurst, Primary Author  
4001 Automation Way  
Fort Collins, Colorado 80525  
Contract No. 500-01-032

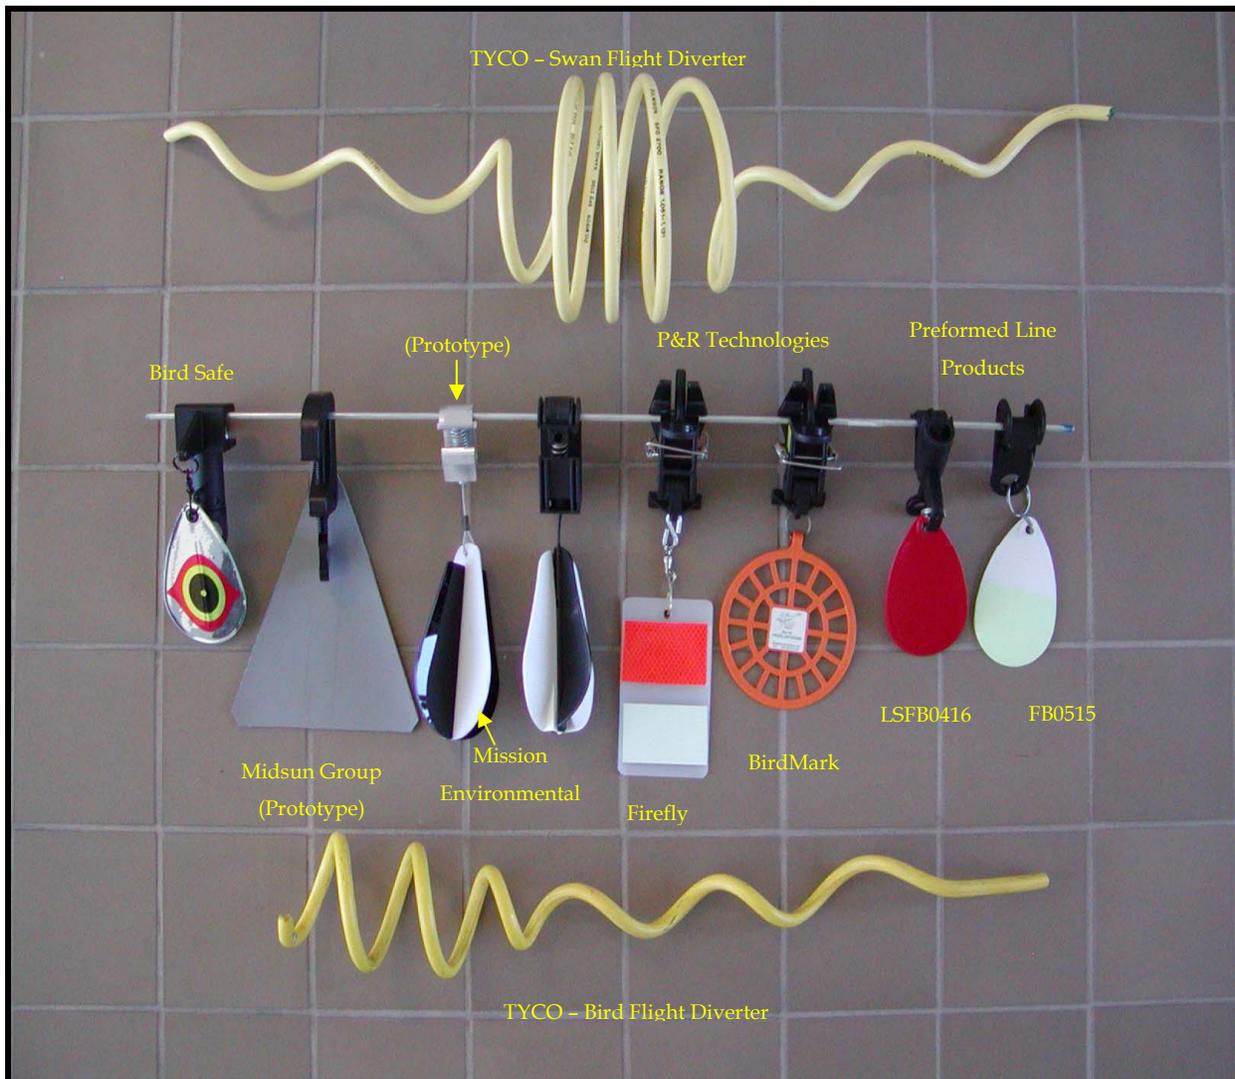
**Figure 1. Flight diverters tested as part of the project**

Bird deaths resulting from power line collisions are a violation of the Migratory Bird Treaty Act and can result in federal fines. One of the most effective ways to reduce avian collisions with power lines is to mark wires, making them more visible. Although several products are available to mark lines, there can be engineering and/or maintenance issues associated with placing devices on energized wires. Some these devices have many uneven surfaces and sharp corners that project or hang from the conductor, so it is likely they can be a source of corona emission. The goal of this research project was to determine the relative extent of corona emission caused by ten commercially available flight diverters at typical transmission voltages. Table 1 identifies the flight diverters tested, and Figure 1 displays them.

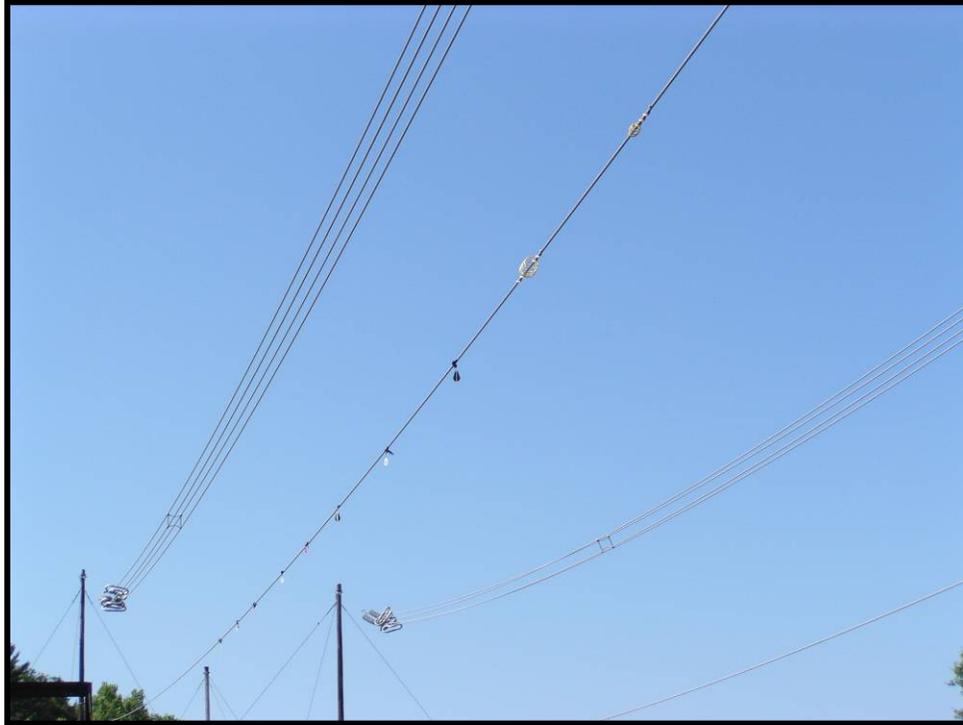
**Figure 2. Test setup**

- The devices were attached to an existing 550-ft test line at the EPRI Solutions laboratory in Lenox, Massachusetts (Figure 2).
- The devices were attached 10 feet apart so as not to influence the corona performance of adjacent samples.

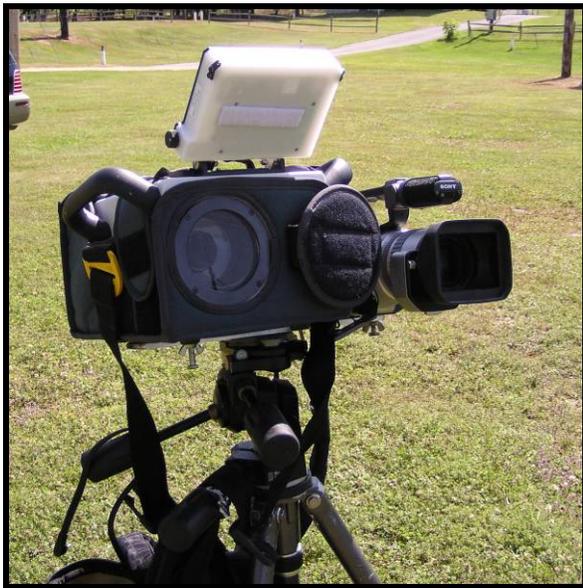
**Figure 3. DayCor II camera**

- The DayCor II camera was placed on the ground adjacent to the test line. Starting at the lowest voltage—and then increasing the voltage to the other two levels—observations of each sample were made and photographed with the DayCor II camera to determine corona activity. Figures 3 and 4 show the DayCor II camera during field use.

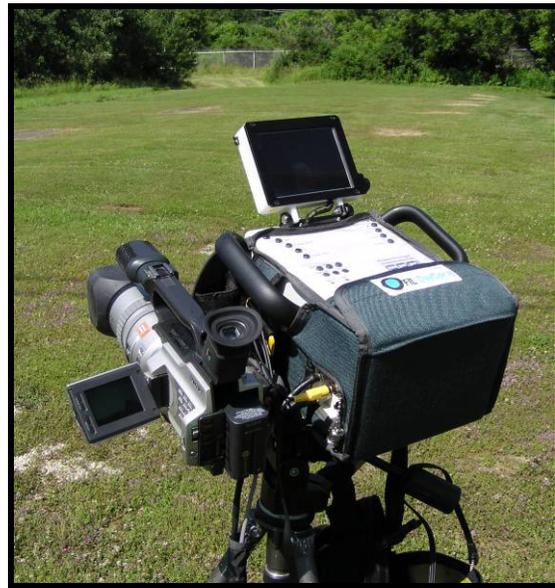
**Figure 4. DayCor II camera**

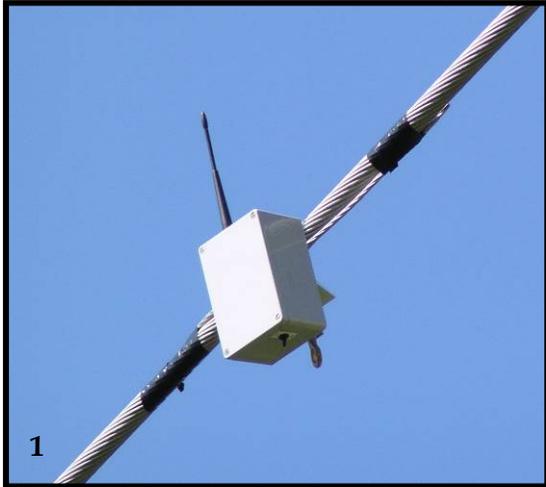
Figure 5. Bird Strike Indicator

In addition to testing bird flight diverters, the Bird Strike Indicator (BSI) was tested for corona. The BSI is an impulse-based sensor being developed to remotely detect and record bird strikes. The BSI is being developed under a separate research project supported by the California Energy Commission and Western Area Power Administration. The testing of the bird flight diverters created an opportunity to test the BSI at no additional cost.

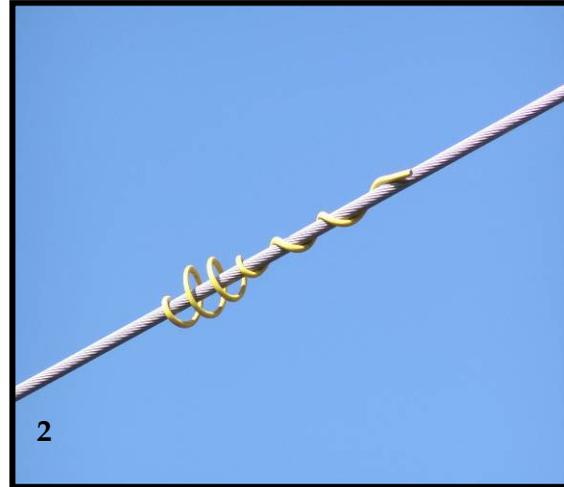
Figure 6. Bird Flight Diverter, Tyco Electronics (BFD2460)

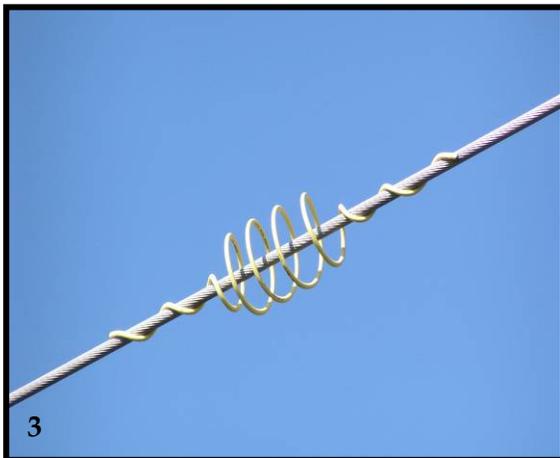
Figure 7. Swan Flight diverter, Tyco Electronics (SFD1960)

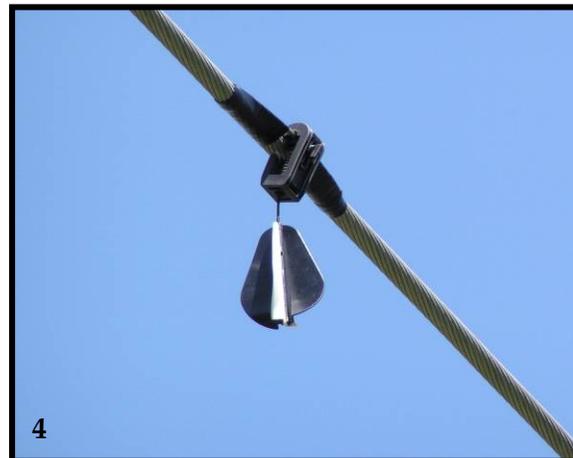
Figure 8. Bird Flapper, Mission Environmental

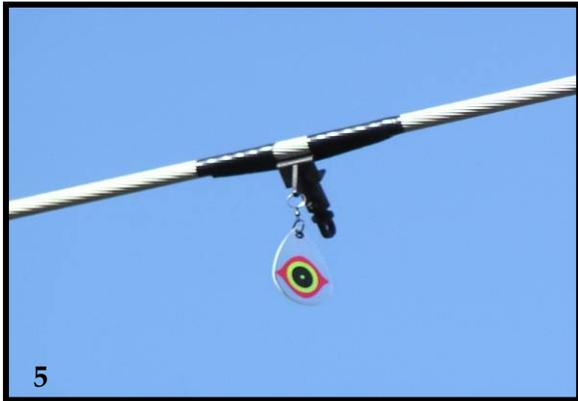
Figure 9. Bird Diverter, Bird Safe

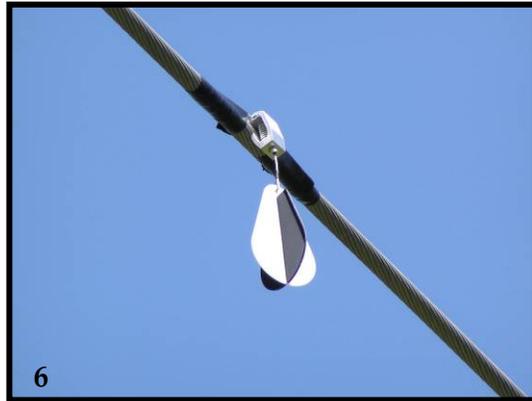
Figure 10. Bird Flapper - Prototype, Mission Environmental

At the 115-kV voltage, all the devices had very little or no corona, except for device #6, which had a high level of corona at 115 kV and a high and very high level at 230 kV and 345 kV, respectively. This device is the prototype to device #4, which had a reduced amount of corona at 115 kV.

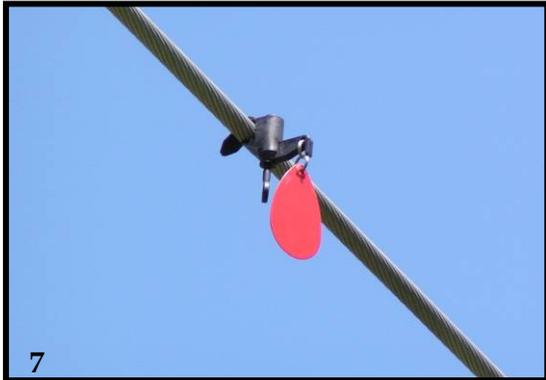
Figure 11. Bird Flapper, Preformed Line Products (LSFB0416)

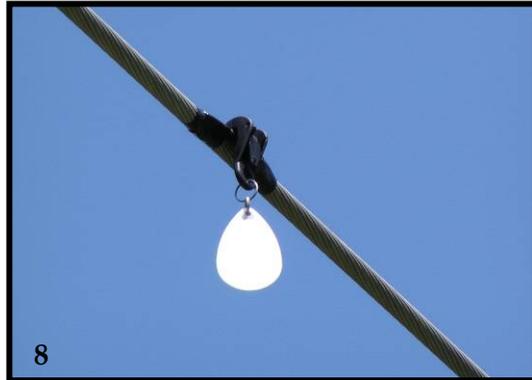
Figure 12. Bird Flapper, Preformed Line Products (FB0515)

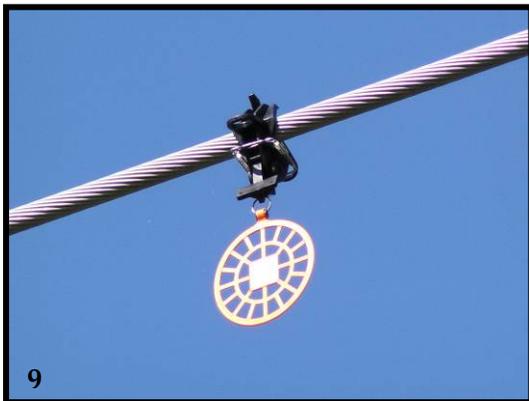
Figure 13. Bird Mark, P&R Technologies

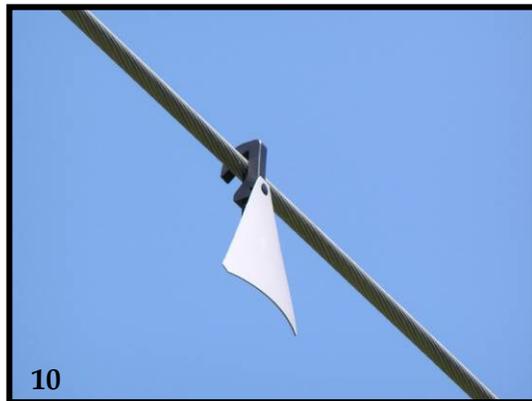
Figure 14. Bird Flapper - Prototype, Midsun Group

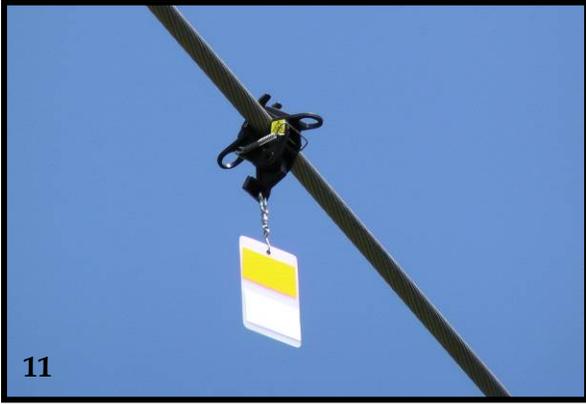
**Figure 15. Firefly Bird Flapper, P&R Technologies**

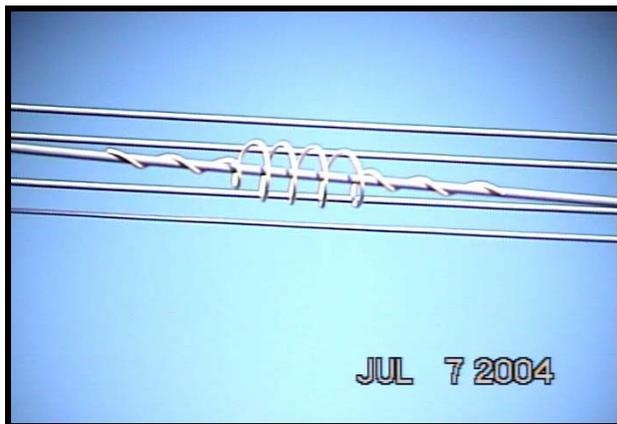
**Figure 16. Level 0: No corona**

Figures 16 through 21 are images captured from the video stream and illustrate the relative levels of the scales described above.

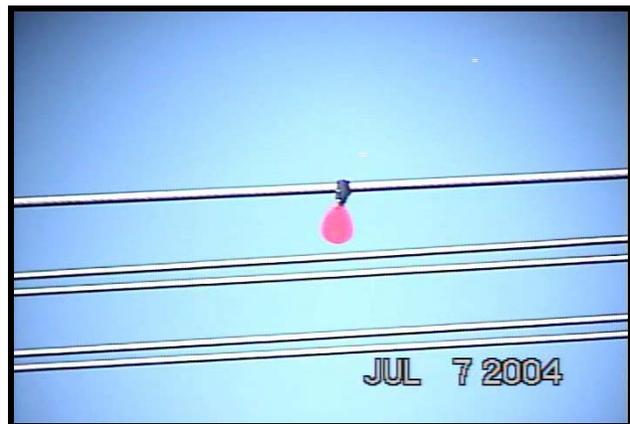
**Figure 17. Level 1: Barely detectable corona**

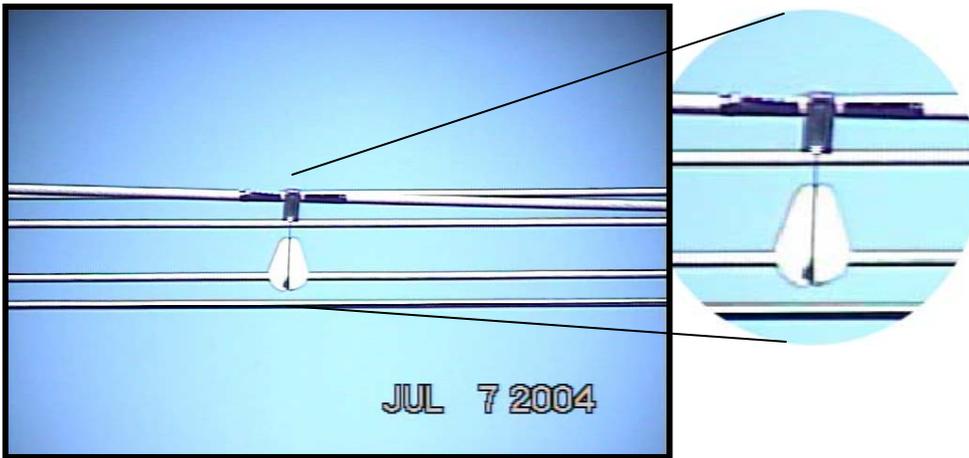
Figure 18. Level 2: Definitely detectable corona (*at bottom of cable clamp*)

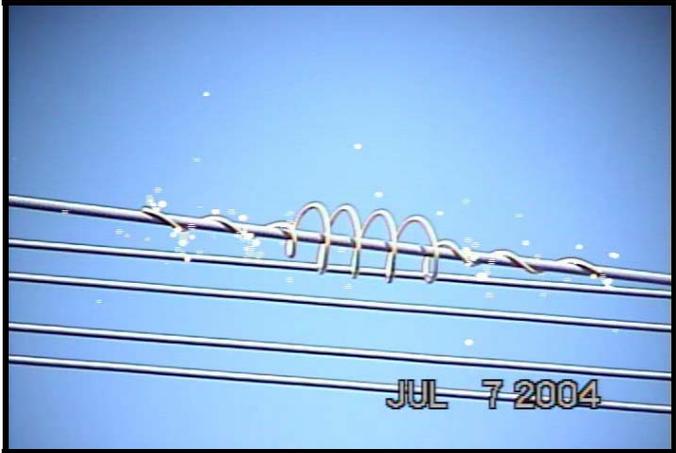
Figure 19. Level 3: Medium level of corona

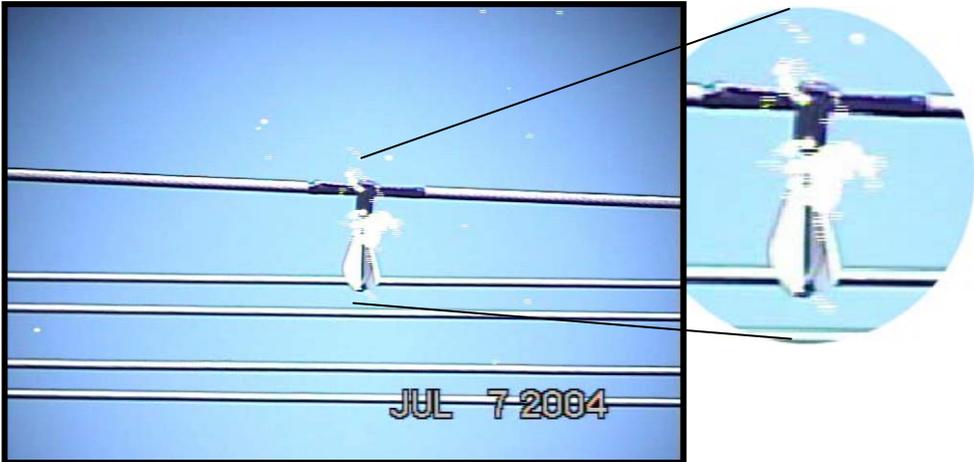
Figure 20. Level 4: High level of corona

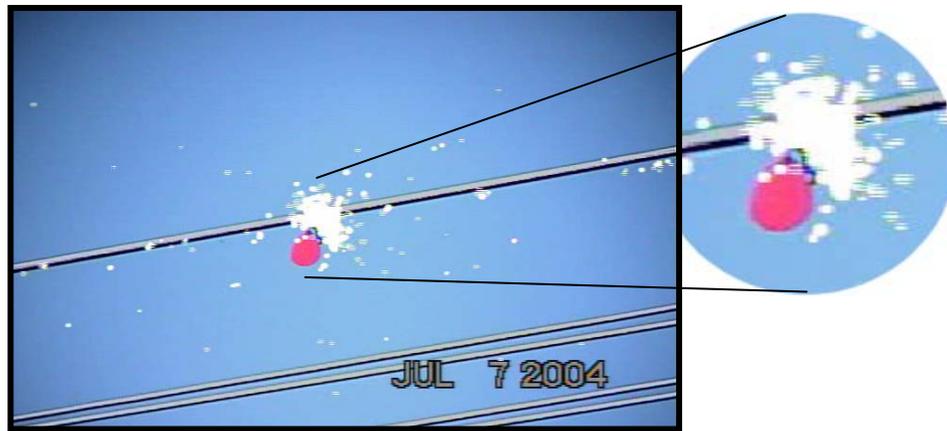
**Figure 21. Level 5: Very high level of corona**

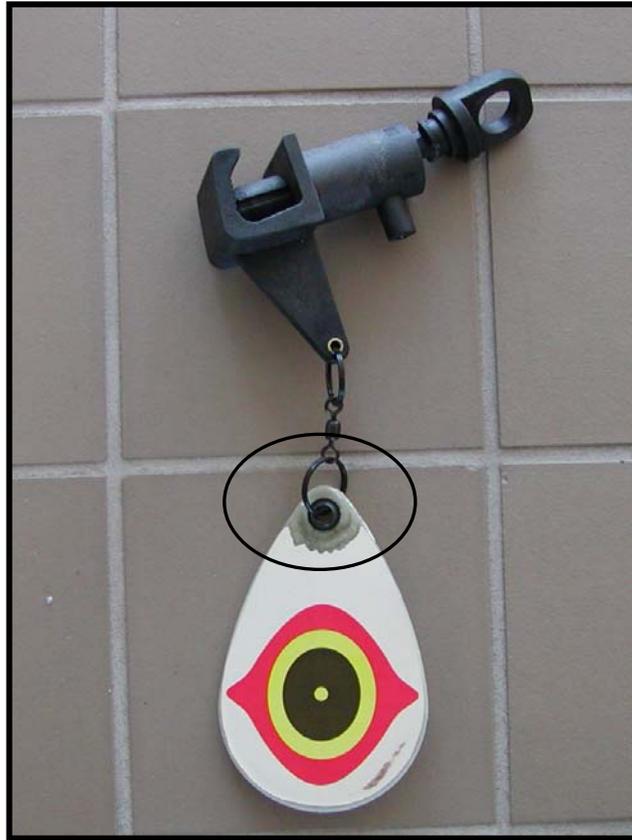
After testing was completed, the flight diverters were visually inspected for any signs of physical damage due to corona discharge. No damage was observed, save for device #5, where the mylar label on the flapper had disintegrated around the attachment grommet (Figure 22).

During testing this was the only flapper where the entire flapper was engulfed in corona at 345 kV.

**Figure 22. Corona-induced damage on diverter #5**

The extent or rate of decay the flapper materials experience due to the corona discharge is unknown and was not ascertained from the test results. The only visibly detectable decay was found on device 5, where a portion of the mylar film on the flapper disintegrated around the mounting grommet.
