**FIGURE 6.13-9
SCENIC ATTRACTIVENESS EVALUATION FORM FOR
SENSITIVE VIEW AREA AND KOP NO. 3**

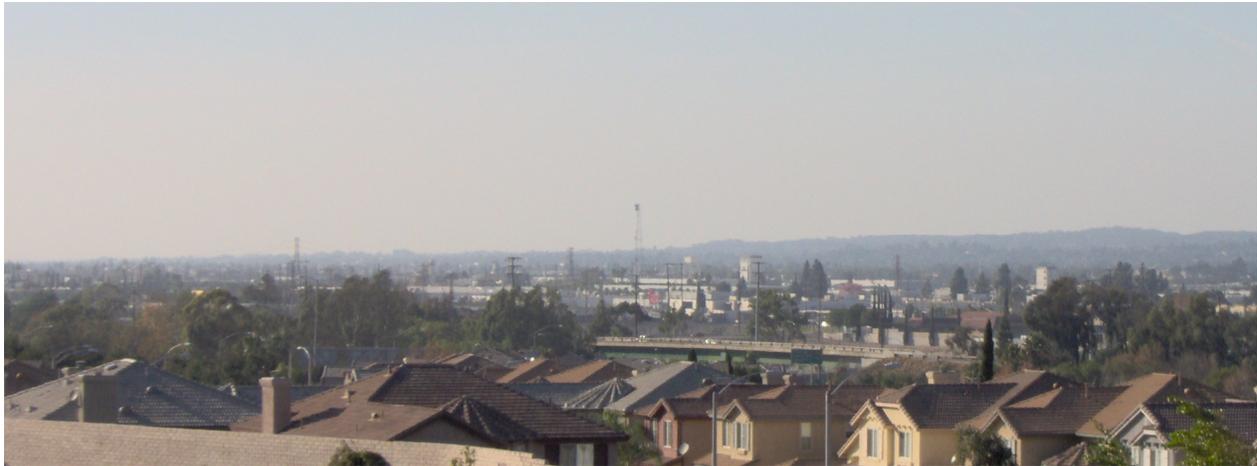
Narrative Landscape Description and Photograph. This image was taken from the closest traveler view at the western terminus the County-designated scenic highway portion of SR 91, approximately 2.5 miles to the southeast looking northwest towards the CPP site (Figure 6.13-14, see also Figure 6.13-1 for KOP location). As a County-designated scenic highway, views from this highway are considered potentially sensitive and are included as a KOP. This view represents “worst-case” traveler views from the County-designated scenic highway SR 91 as well as other highways in the project area. Industrial/commercial structures, area topography, vegetative/physical screening adjacent to the road, and residential structures within foreground views create intermittent traveler view obstructions from the highway towards the CPP site. However, as previously stated, SR 91 slightly increases in elevation as the highway enters the Santa Ana Canyon. Due to the highway’s elevated position, travelers along the western terminus of the County-designated scenic highway SR 91 have distant views of the project vicinity for roughly two miles. This view is consistent with short viewing durations (i.e., from traveler views focusing on the road) and is therefore considered to have a moderate degree of severity. It should be noted that the most distinct visual characteristics along SR 91 are distant views to surrounding mountains, the Santa Ana River, and the topography within the Santa Ana Canyon. The ESIL from this area can be characterized as low.
